"Who, Me? I had No Idea!"
Multiple Cause Incident
Analysis as a Driver of Systems
Safety Engagement

Presented at WEDA Dredging Summit and Expo 2019 "Waves of Change: Oceans of Opportunity"

SAFETY ALERT

INCIDENT DATE	INCIDENT TIME	PROJECT#	EQUIPMENT / INCIDENT LOCATION
Jul 13, 2018	1400	72584	Dredge CAROLINA
ALERT TYPE		PROJE	ECT NAME
INJURY		Charleston Harbor - Contract 2	
SUPERVISOR		INVOLVED JOB TITLE	
Guadalupe Benavides Deck		nand

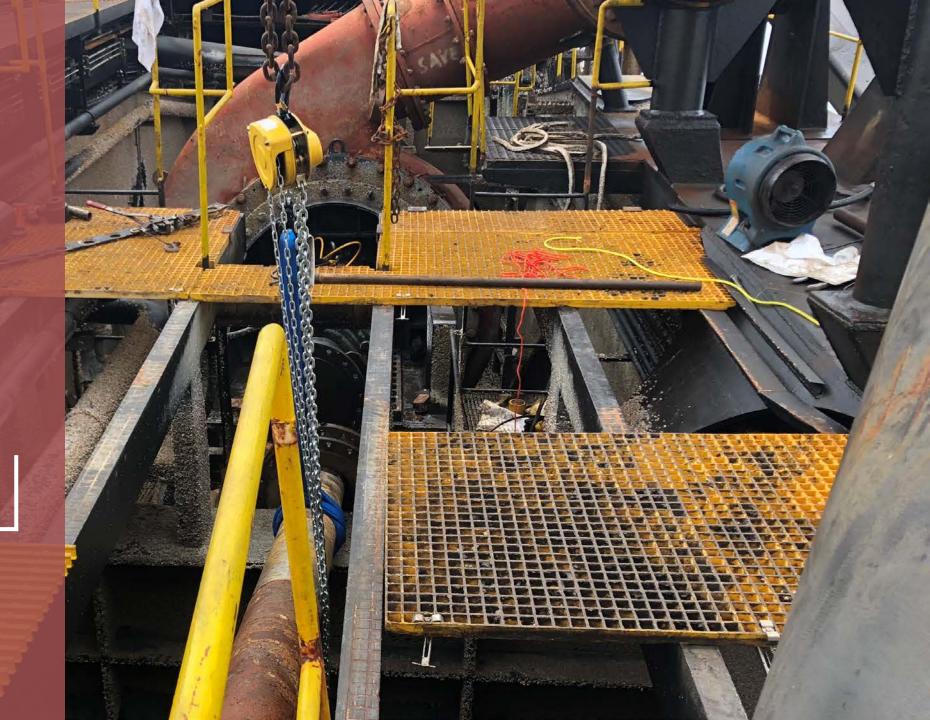
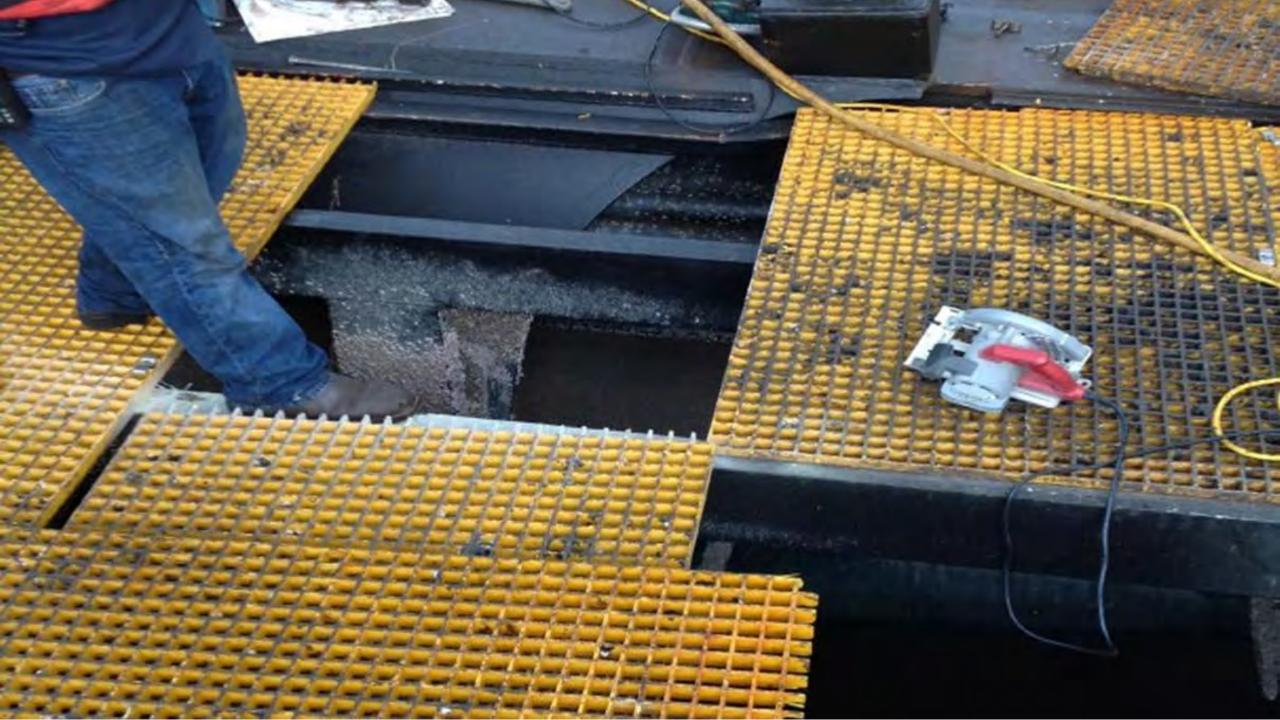
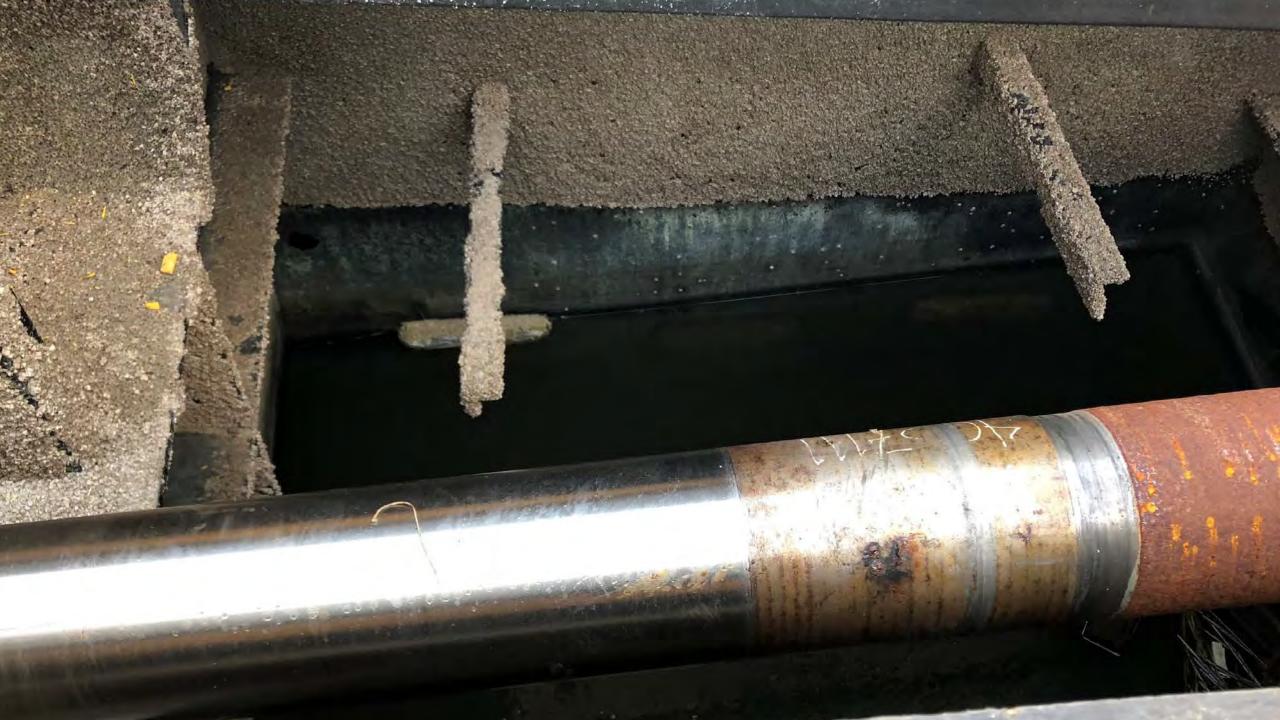
Replacing Dredge Carolina No. 2 pump shaft

The crew had setup to remove a shaft from the underwater pump. Due to the layout of the grating, 4(four) pieces of grating were removed in order to gain access to allow the shaft to be rigged. Upon removal of the grating, it was not identified that the grating was secured by interlocking with other pieces as compared to independently secured on the supports. As the deckhand was positioning himself to be closer to the chain fall to lift No. 2 shaft, he stepped across from one piece of grating to another that was not secured. The unsecured grating slid from under his feet; as result he went over board. During the incident the deckhand incurred minor scratches / skin irritation.

The crew immediately placed all grating back in place and locked/secured them together. The entire crew held a stand down and discussed the incident. Afterwards the crew cut out grating directly above the No. 2 shaft. All grating was back in place except for the portion over the shaft. Axiom was contacted to document the scratches and address any concerns.

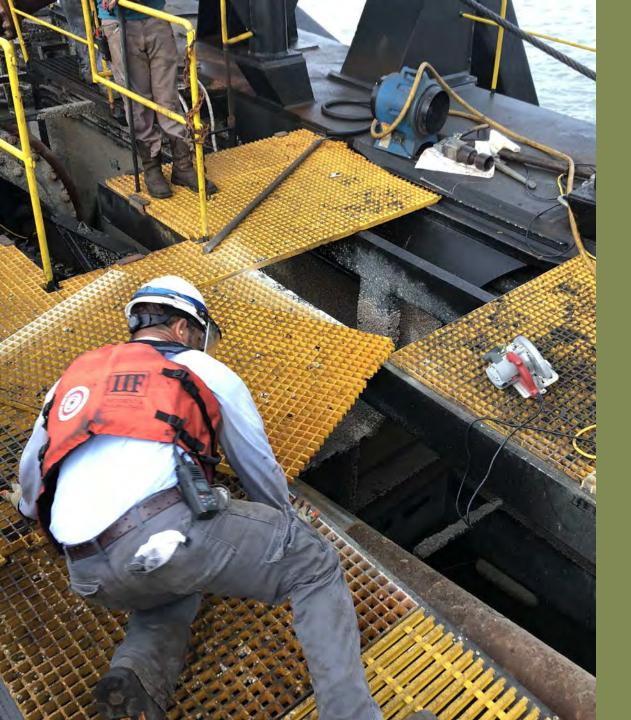
Grating Cut and Reinstalled

Training to be provided to Carolina crew about fall protection and available techniques. Schedule and conduct fall protection training with the entire dredge crew highlighting areas of confusion. Design grating connecting system for individual pieces Cut and reinstall grating so that the only area without grating is directly above the shaft. Show History Because the ladder position cannot be changed while personnel are working on it, cut and reinstall grating so that the only area without grating is directly above the shaft. Chief, Relief Captain & Deck Captain to be given performance accountabilities for not recognizing potential hazards during the task. Crew members involved with the task to be given coaching sessions by GLDD management to cover incident.

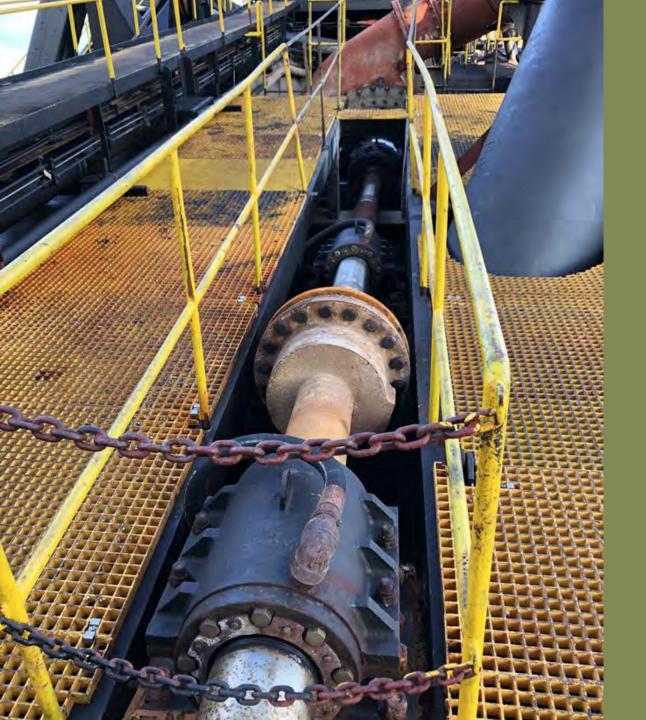
Grating Cut and Reinstalled
