Applying an Innovative Approach and Methodology to Reduce a Dangerous Shoal at Bullshead Reach Within the San Francisco Bay to Stockton Ship Channel in 2011.

'The Incredible Reappearing Shoal!'

Len Cardoza, Weston Solutions

Jeff Wingfield, Port of Stockton

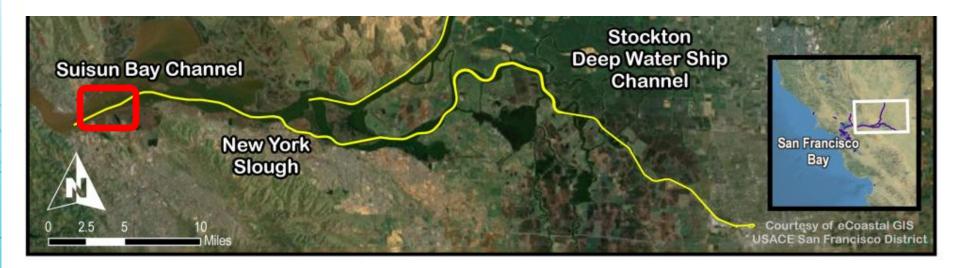
- Aug 1-10, 2011: Routine Maintenance dredging by Essayons
 -35' MLLW plus 2' O.D.
- Nov 14, 2011: Survey identified a shoal on centerline
 - -33.7' MLLW
- Navigation safety concern due to proximity to bridges.

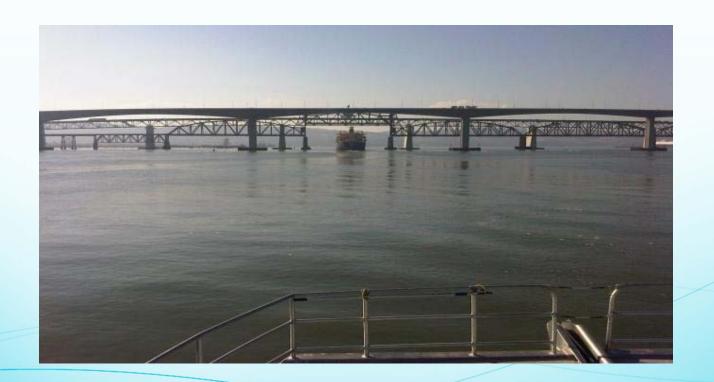
Vessel in transit through Bullshead

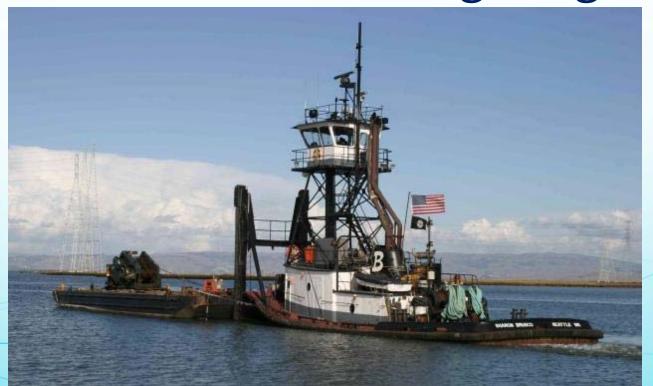
Knockdown / Grading Equipment – Drag Barge

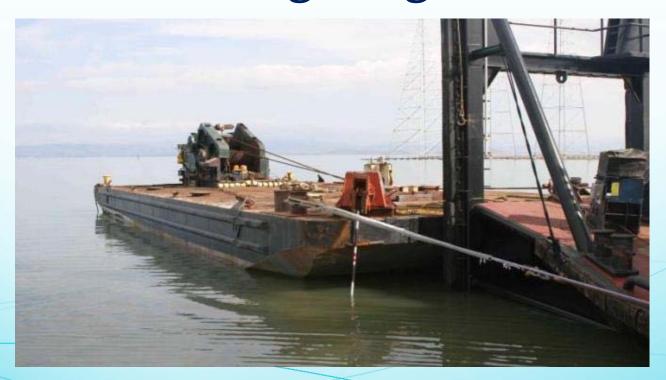
Knockdown / Grading Equipment – Drag beam deployed from barge

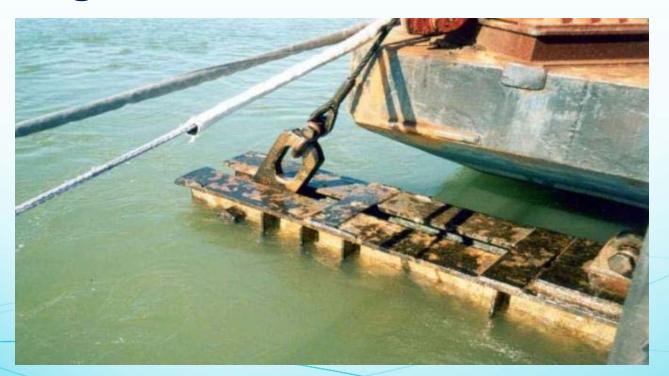
Survey during knockdown / grading operations

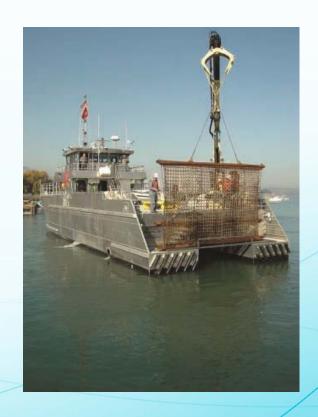
Drag beam and chain ready to deploy

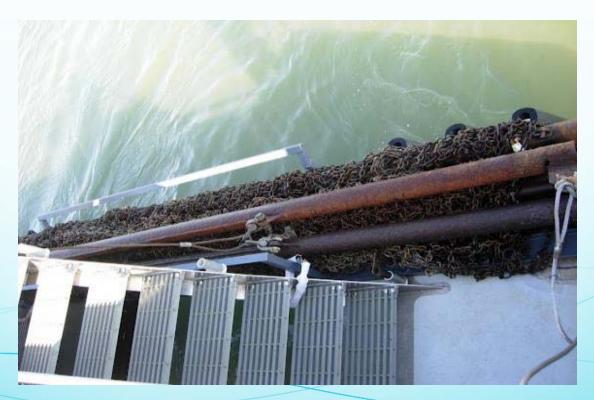
Drag beam being deployed from crane

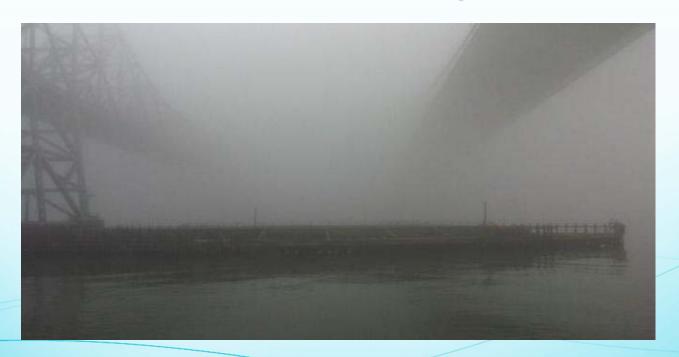
Bridge during knockdown operations – GPS positioning of ship
