Maintenance Dredging in Portland Harbor

Wesley Thomas, EIT

**WEDA Pacific Chapter Meeting
September 7, 2012**

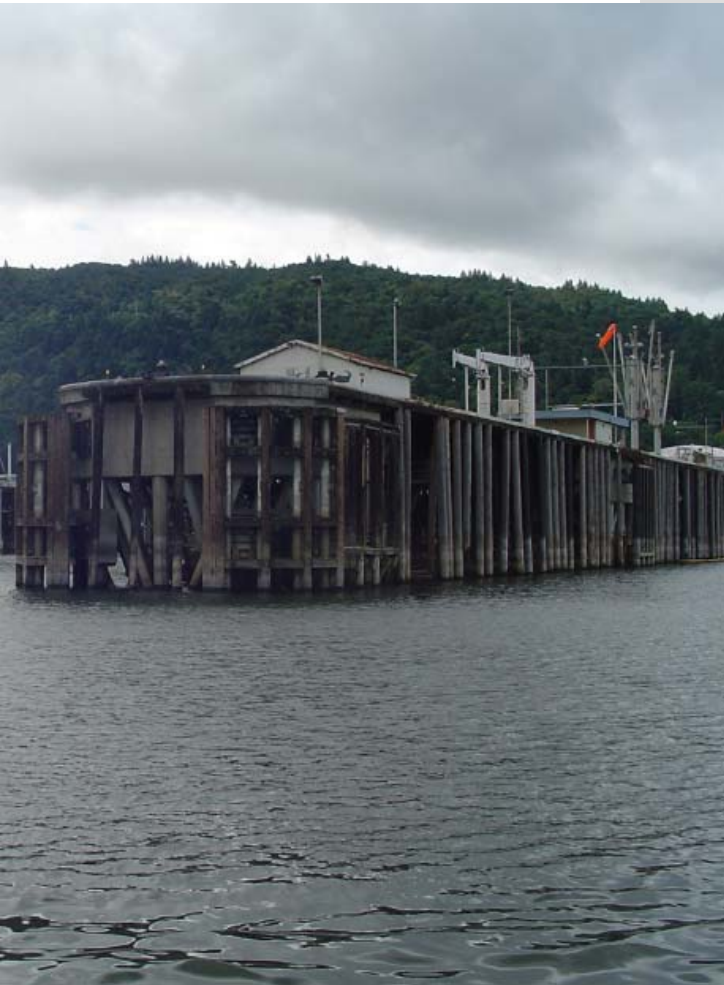
Site Background

- Bulk petroleum fuel terminal within Portland Harbor
- Has been in continuous operation for more than 100 years
- A recent infrastructure project increased capacity by 20% to approximately 63 million gallons
- Deeper ship berths (40 feet below Columbia River Datum (CRD)) were required to accommodate larger Double Eagle Class Ships
- Previous elevations of ship berths for were 38 feet below CRD

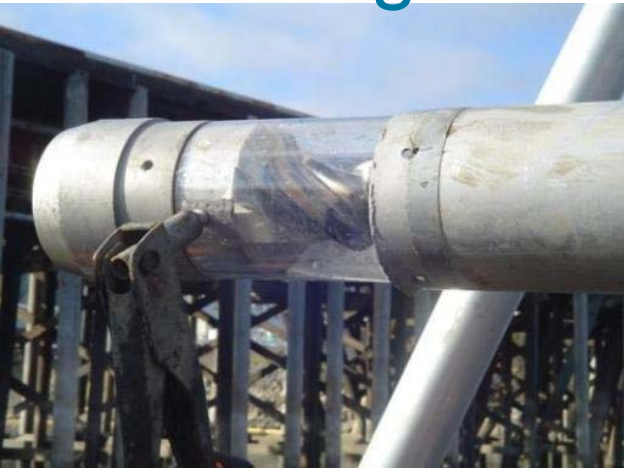
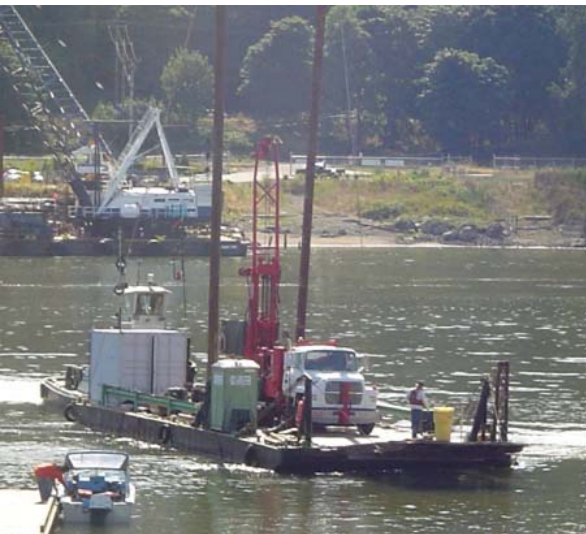
Pre-Design Investigation

- *Northwest Regional Sediment Evaluation Framework (SEF)* developed by the United States Army Corps of Engineers (USACE) guided sampling efforts
- Characterize sediment within dredge prism (chemical and physical properties)
- Evaluate disposal options by comparing sediment chemistry to regulatory guidance
- Characterize post-dredging new surface material
- Evaluate stability of the dredge prism side-wall
- Characterize side-wall sediment chemistry that may slough into dredge prism

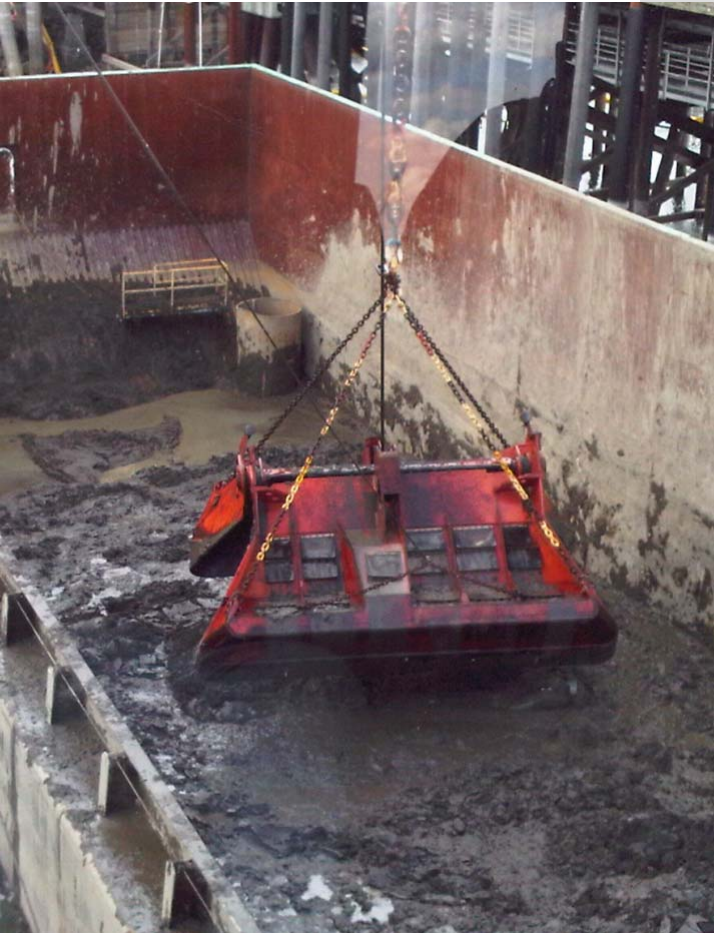
Design Parameters

- Estimates of dredge volumes and production rates
- Dredge type specifications
- Analysis of riverbank soil stability and dredge prism side slopes
- Decant water mass balance and water management
- Sediment disposal
- Construction monitoring requirements

- Dredging design was based on the use of a 16 CY barge mounted environmental bucket
 - Production rates were estimated to be approximately 125 CY/hr
- Dredge horizontal to vertical slope of 2:1 along shoreline and no dredging in the toe of slope along the shoreline
- Overdredge allowance of 1 foot
- Dredge material dewatered in bin barge and barged to transload facility, solidified and trucked to landfill
- Decant water discharged to City of Portland sanitary sewer pending analysis
- In-situ volume of dredge material = 26,700 CY
- Decant water volume = 1,000,000 gal
- Stabilized dredge material weight = 37,600 tons

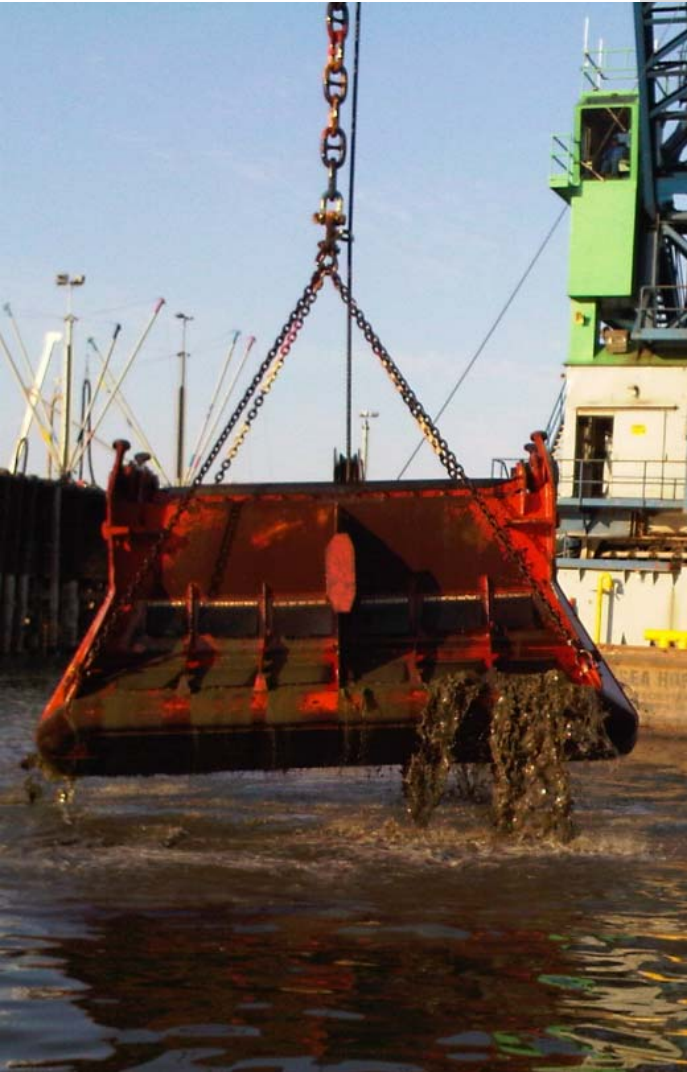
Implementation

- Hickey Marine Enterprises (HME) performed maintenance dredging activities between September 8 and October 13, 2011
- Dredging activities occurred during active terminal conditions
- Dredge material was transported by barge to a transload facility in The Dalles, OR and then trucked to Wasco County landfill for disposal
- Target depth of 40 feet below CRD was achieved

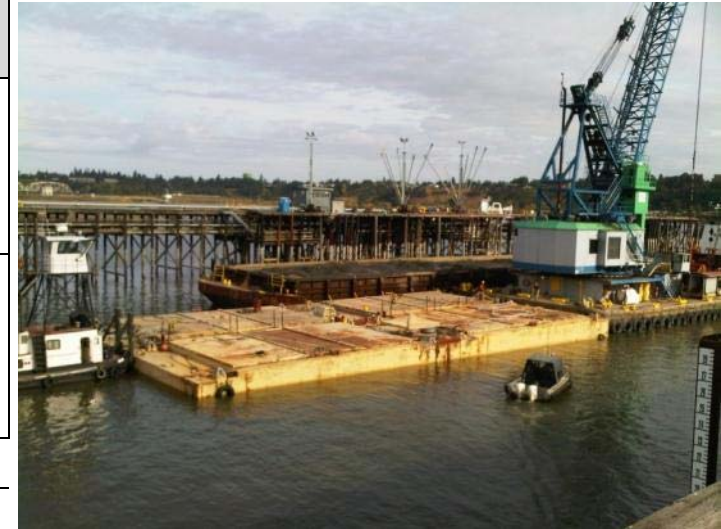
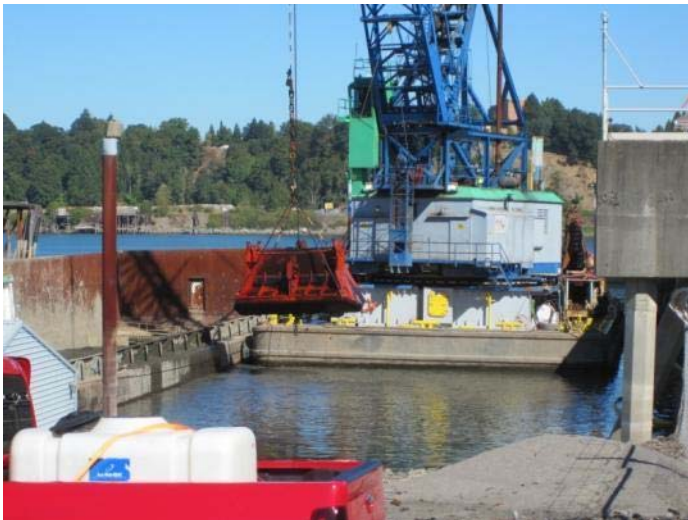
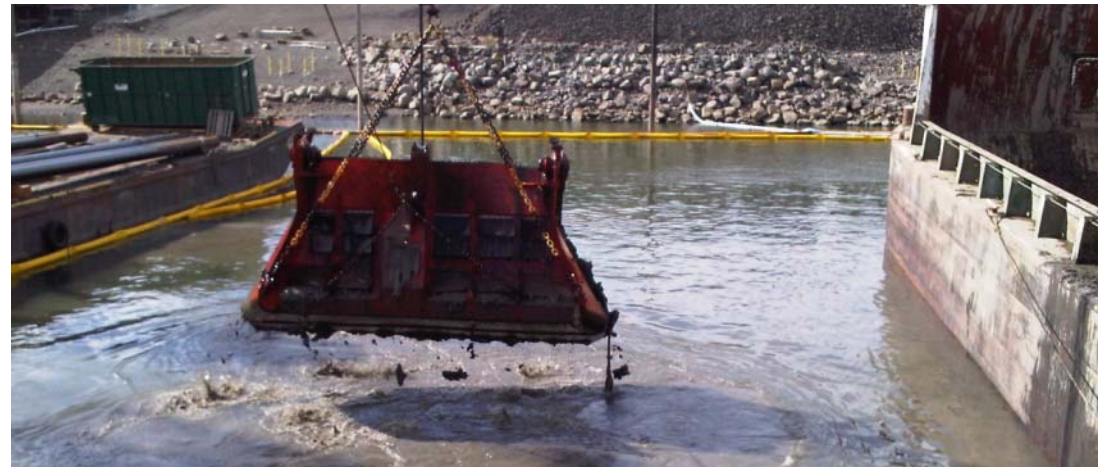
Summary of Dredging Activities

Dredge Material Management Unit	Relative Location	Dredging Dates	Minimum Dredge Elevation	Volume Dredged
DMMU-1 (88,450 sf)	Downstream Slip	9/8, 9/13-9/16, 9/19, 9/28-9/30, 10/13	-40 ft CRD	13,559 CY
DMMU-2 (77,221 sf)	Upstream Slip	9/20, 9/22-9/23, 9/27, 10/3-10/5, 10/10-10/11	-40 ft CRD	12,393 CY
Total Volume Dredged				25,952 CY
