Shoreline MGP Site Remediation

GREAT LAKES
ENVIRONMENTAL &
INFRASTRUCTURE

INTRODUCTION

- Interim shoreline maintenance project
- Former MGP site and power plant
- Scope of work involved removal of existing debris, excavation of soil and MGP waste, installation of reactive core mat (RCM), placement of rock revetment
- Challenging conditions working in high visibility urban setting and client concerns with environmental regulatory oversight
- Work completed in the winter of 2010
- Contract value approximately \$1M

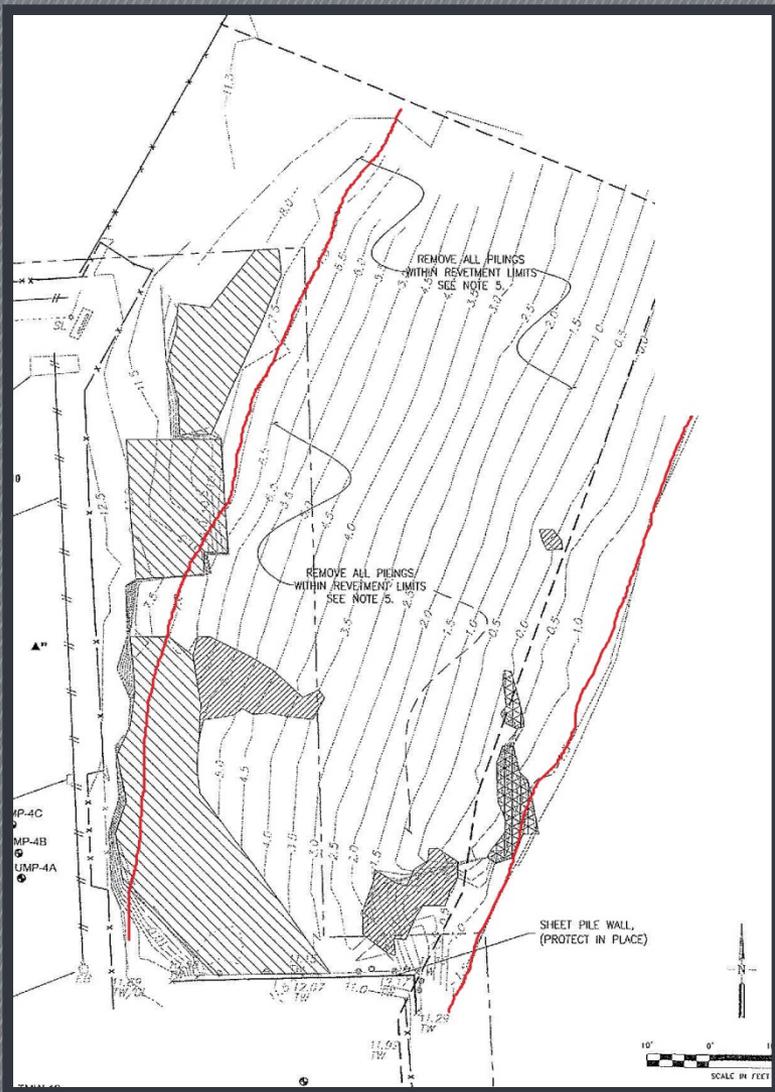
REVETMENT SITE PLAN

- Revetment Area approx. 135' x 65'
- Removal of 100 TN debris
- Excavation of 500 CY MGP waste
- Placement of 9,000 SF RCM
- Placement of 800 TN Filter Rock
- Placement of 1500 TN Armor Rock
- Work within the tidal zone
- Tides range from -1.5 to +7.0 ft-msl
- Work performed during low tide cycles

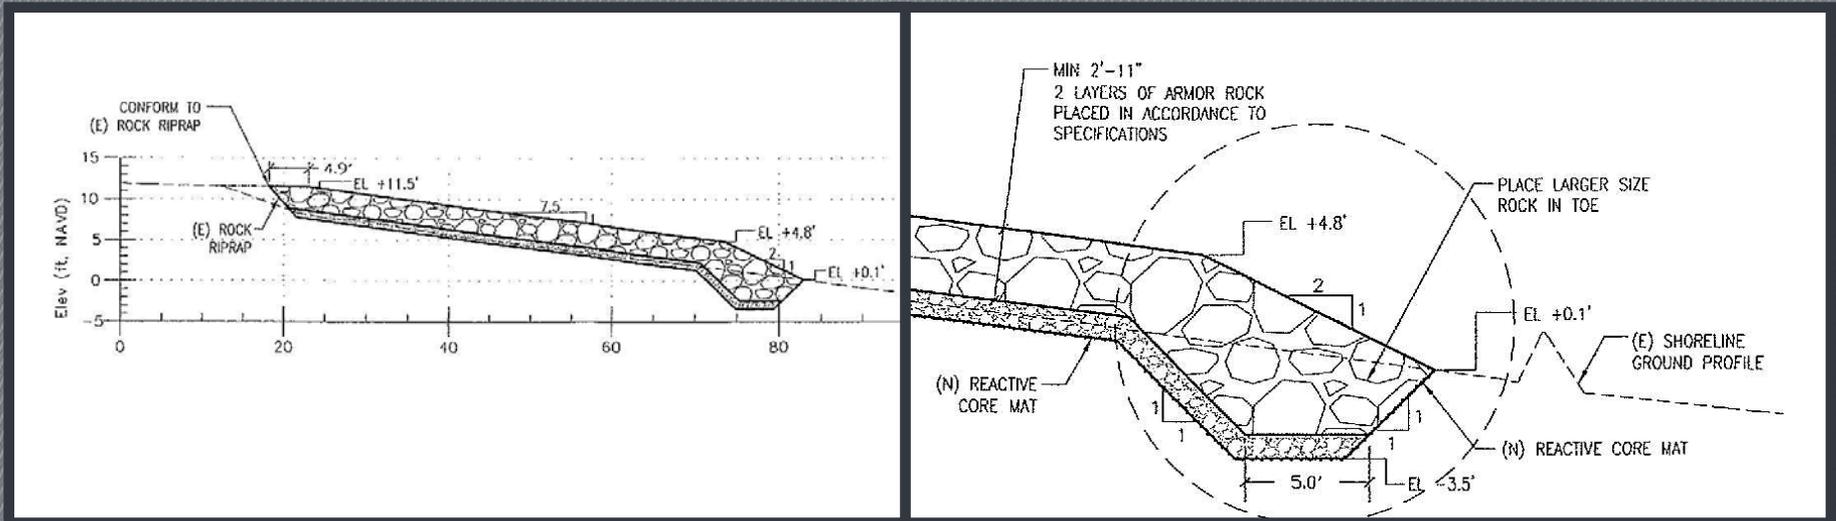
REVETMENT CROSS SECTION

- Excavation primarily at toe of revetment
- RCM placed over excavated surface
- 6" of filter rock, min. 2' 11" of armor rock
- Final slope at 7.5:1 (toe at 2:1)

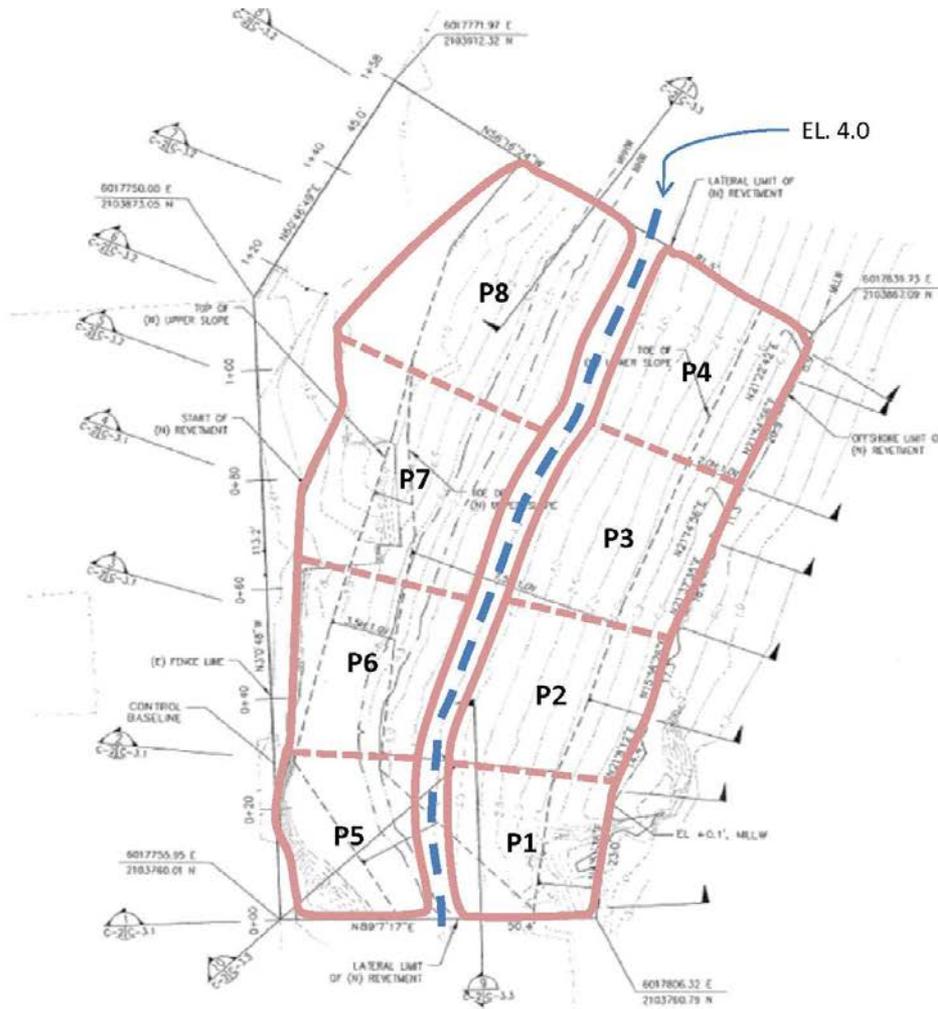
RCM PANEL LAYOUT

1. Panels numbered in order of construction sequence
2. Panel dimensions are approx 30' x 30'; will vary.
3. Each panel will consist of a min. two (2) strips of reactive core mat placed parallel to the direction of slope
4. Longitudinal overlaps will be minimum 12 inches. End-of-roll overlaps will be minimum 24 inches.
5. Mat will be placed immediately upon completion of excavation in each panel; mat will be temporarily anchored with sand bags or drain rock
6. Panels P1 - P 4 will be completely excavated and matted prior to placement of drain rock and armor rock
7. Similar process will be implemented for Panels P5 - P8.

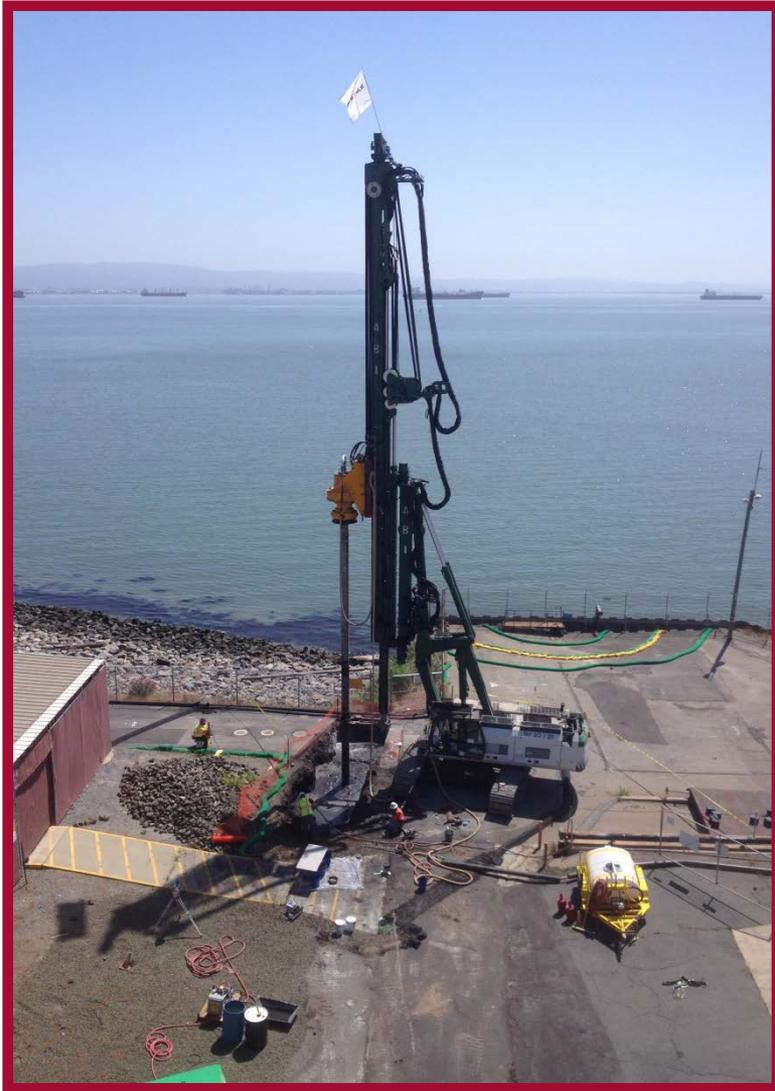
UPLAND IN-SITU STABILIZATION (ISS)

- Completed upland ISS pilot study in 2014
- Stabilization of site soils using slag-cement, Portland cement, and bentonite
- Stabilized depths between 35 and 55 ft bgs, using 3 – 8 ft diameter augers
- Multiple mix designs utilized to achieve minimum unconfined compressive strength (UCS) and leachability standards
- Work expected to be performed in 2017

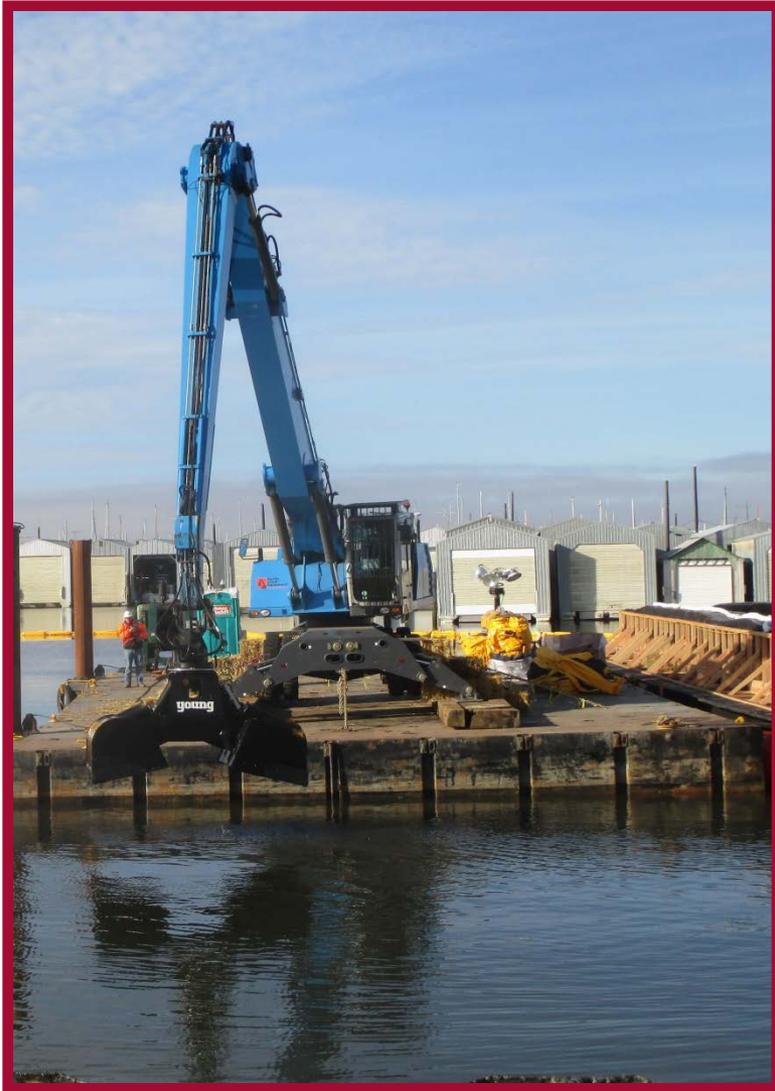
OFFSHORE SEDIMENT AREA

- Dredging of nearshore and offshore sediment
- Long reach excavator / mechanical dredge with Young bucket
- Upland management and disposal of dredged sediment
- Placement of sediment cap
- Work expected to be completed in 2018
