Whatcom Waterway Multiphase Remediation Project: Summary of Phase 1 Activities and Phase 2 Planning

Adam Fulton, Brian Gouran (Port of Bellingham)
Matt Woltman, Tom Wang (Anchor QEA)

WEDA Pacific Chapter 2018
October 23 to 25, 2018

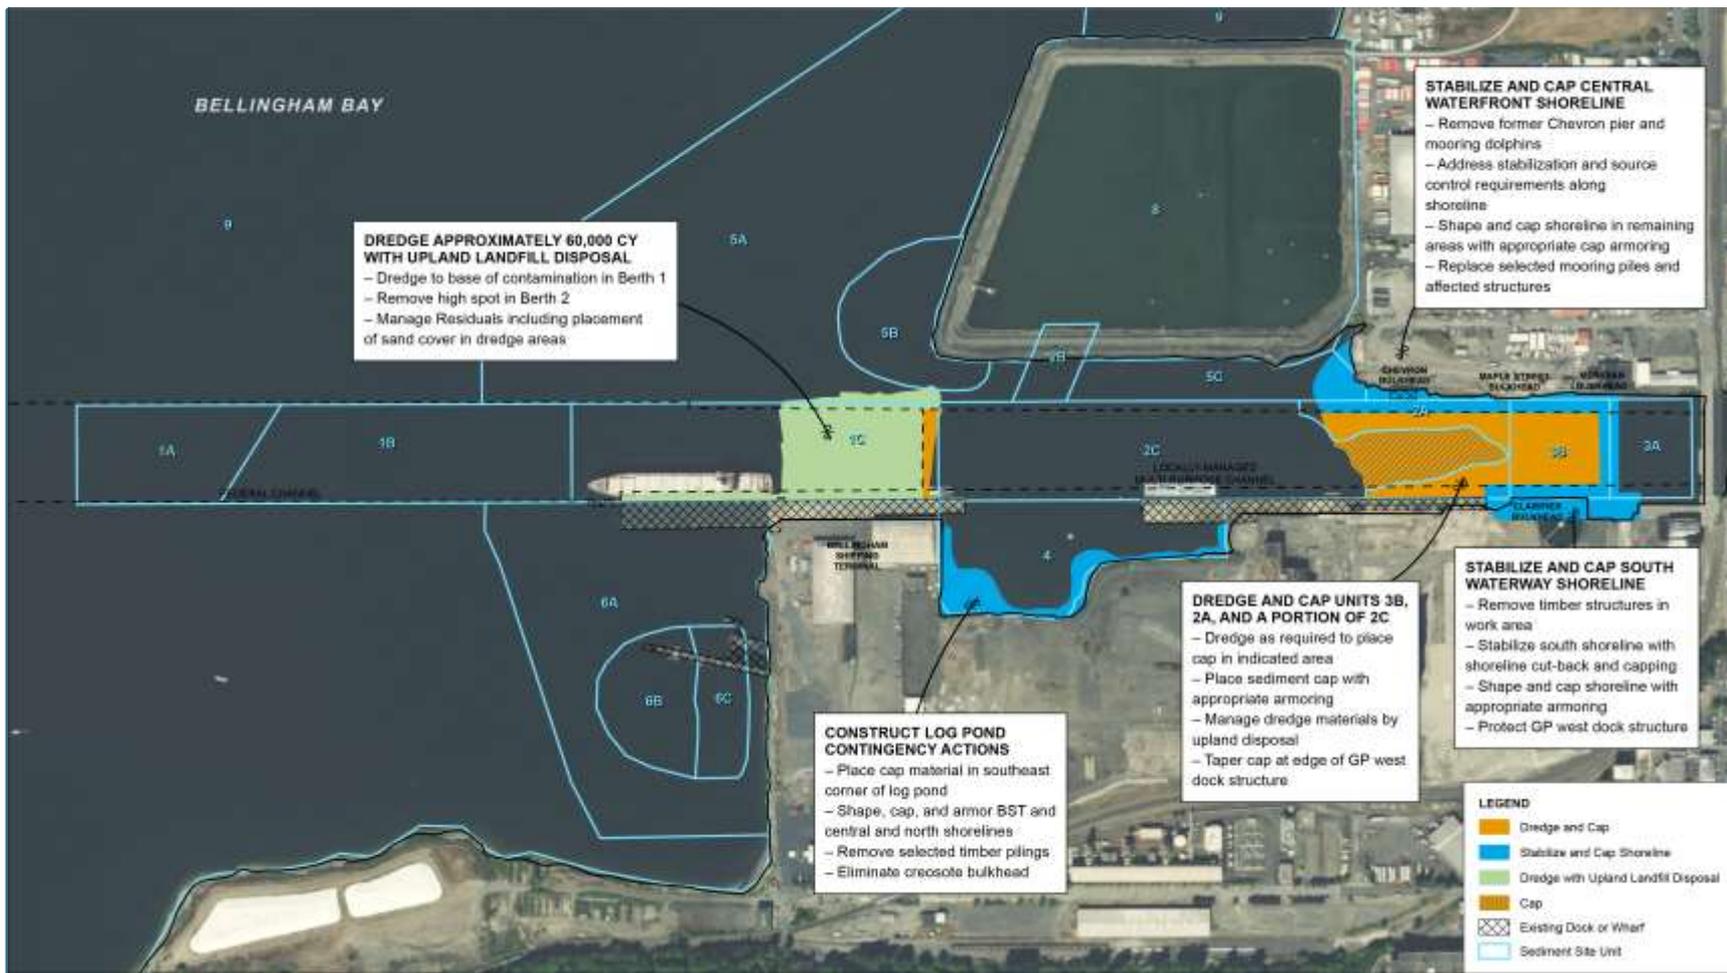
Phase 1 Remediation/Construction Overview

- Dredging for off-site disposal = 111,500 cy
 - Material barged to offload facility near Seattle, WA
- Engineered cap material placement = 12.9 acres
 - Sand, filter, and armor materials in engineered cap
- Residuals management cover material = 5.4 acres
 - Thin sand layer to mix with dredge residuals
- Shoreline remediation wall = 720 lineal feet
- Water quality monitoring
 - Silt curtains not required during dredging
 - Achieved turbidity requirements throughout construction

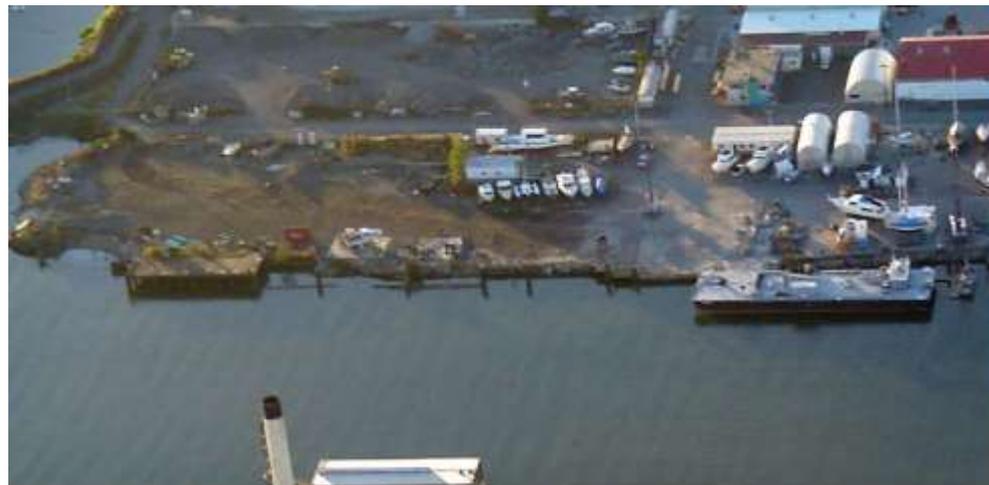
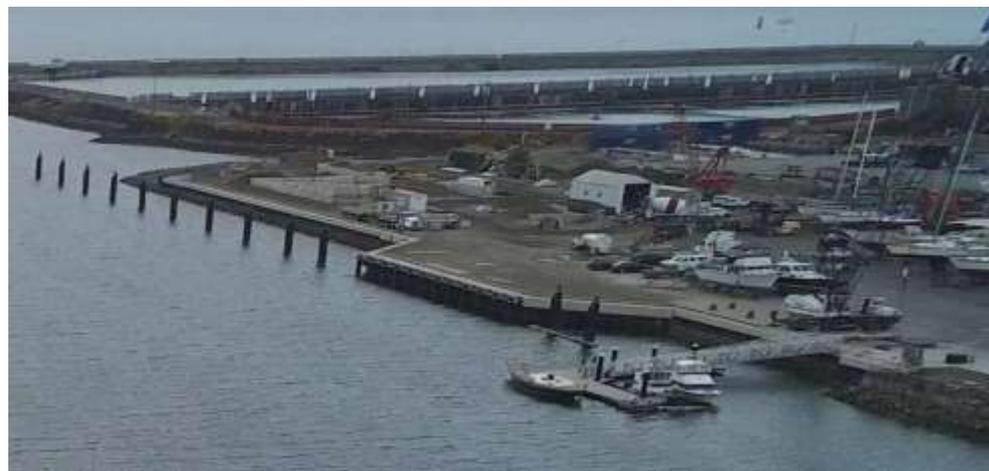
- Pre-Construction
 - Unstable shoreline conditions
 - Failing structures
 - Source control concerns
- Post-Construction
 - Stabilized shoreline
 - New infrastructure
 - Source control addressed

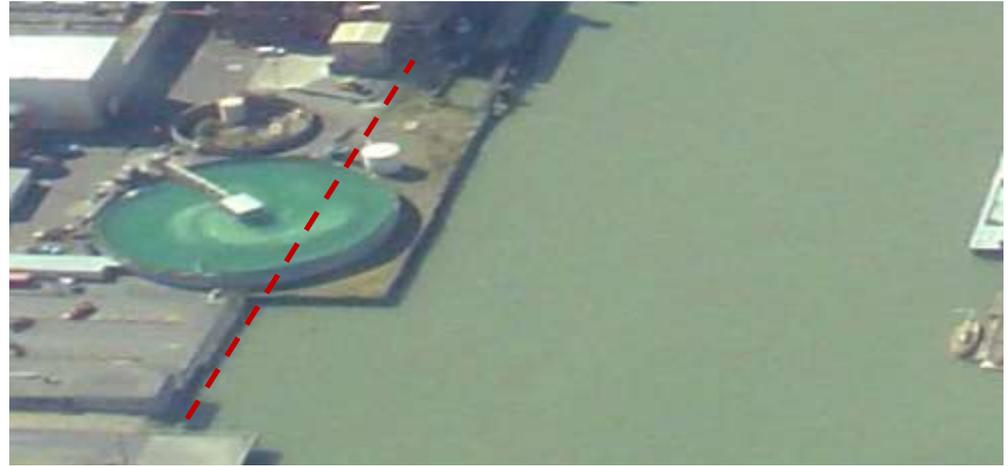
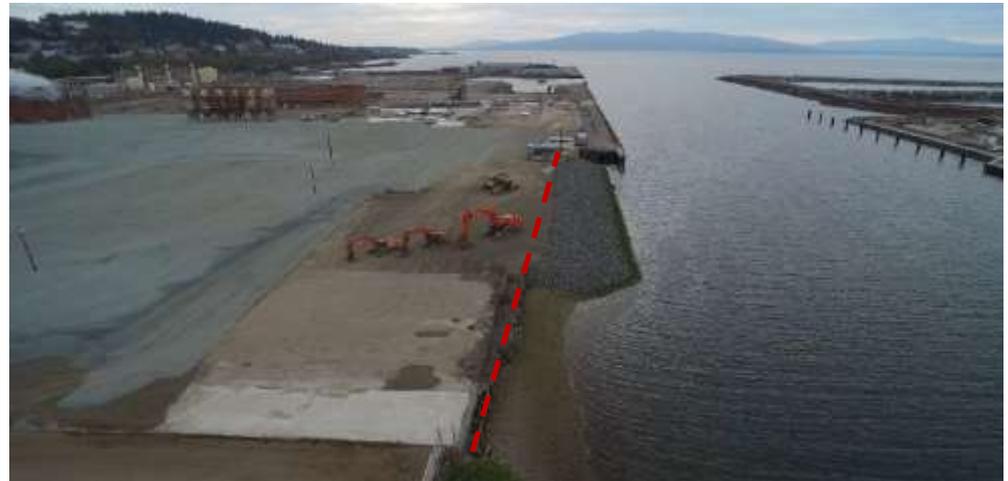
- Pre-Construction
 - Vertical bulkhead
 - Clarifier structure and foundation
 - Shoreline debris
- Post-Construction
 - Softened shoreline
 - Clarifier removed
 - Access and upland development potential

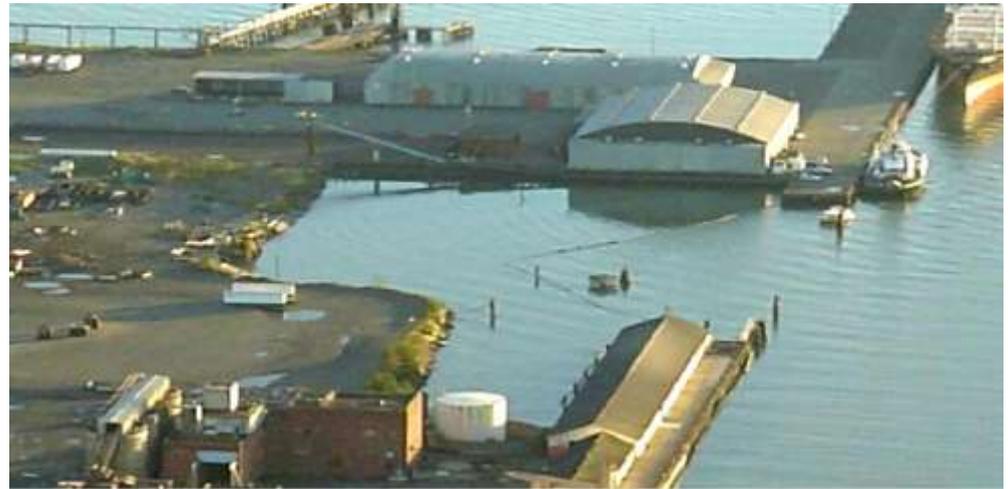
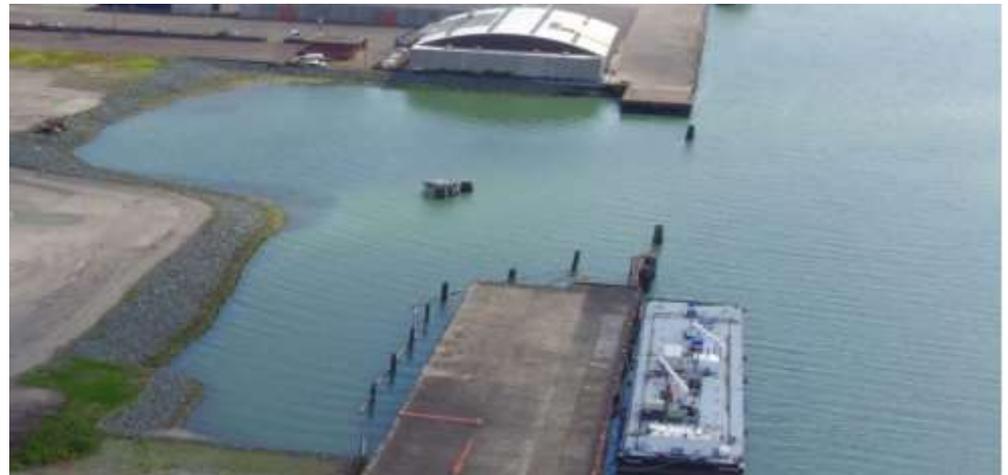
- Pre-Construction
 - Significant shoreline debris
 - Shoreline erosion
 - Derelict creosote piles/structure
- Post-Construction
 - Stabilized shoreline
 - Piles/structure removed
 - Additional cap material placed

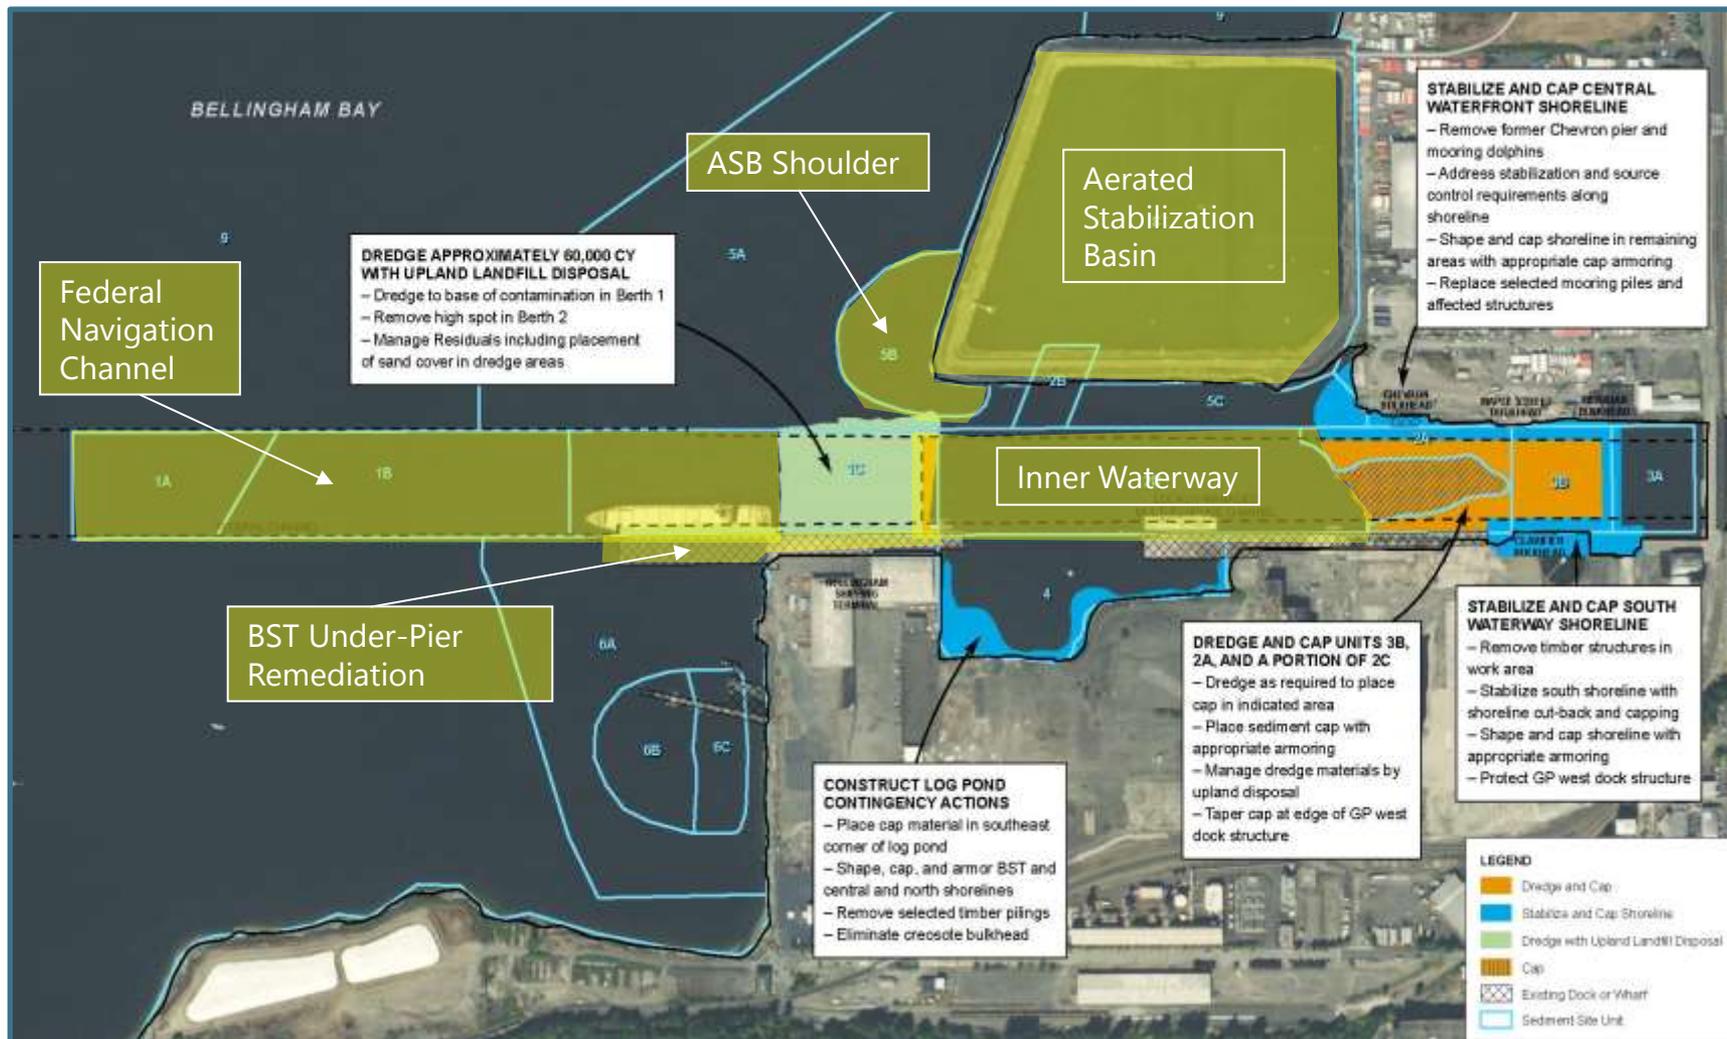
Phase 2 Remediation Overview (cont.)

- Material Volumes by Area (approximate)
 - Dredging
 - Aerated Stabilization Bank (ASB) = 310,000 cy
 - Federal Navigation Channel = 166,000 cy
 - BST Under-Pier Area = 9,400 cy
 - ASB Shoulder = 21,600 cy
 - Capping
 - Inner Waterway Sediment Cap = 76,000 cy
 - Dredge Residuals Management
 - Federal Navigation Channel = 25,000 – 35,000 cy
