## **Journal of Dredging**

**Volume 19, No. 3, August 2021**

## **BENEFICIAL USE OF DREDGED MATERIAL FOR MARSH, DUNE AND BEACH ENHANCEMENT IN A COASTAL NEW JERSEY WILDLIFE REFUGE**

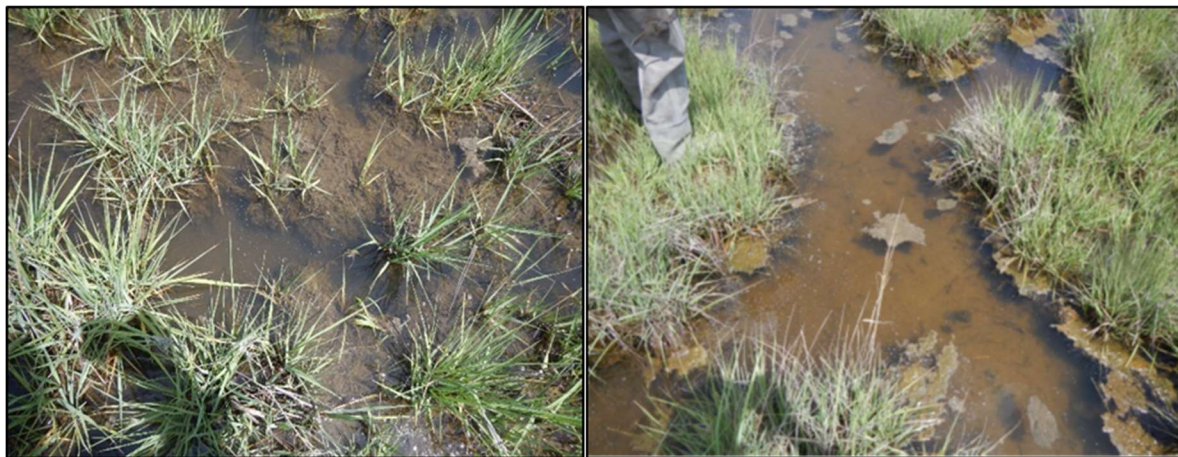
**Figure 4. Examples of unstable marsh platform observed at Fortescue WMA during site visits. Portions of the marsh were characterized by low vegetation cover comprised of wobbly hummocks of *Spartina patens* and *Spartina alterniflora* surrounded by unconsolidated mud.**

multiple characteristics typical of stressed marshes, including undulating terrain, extensive mosquito control ditching, depressions, erosion, an unstable marsh platform (wobbly hummocks of *Spartina sp.* surrounded by unconsolidated mud), minimal faunal use, and sparse and stunted vegetation (Figure 4).

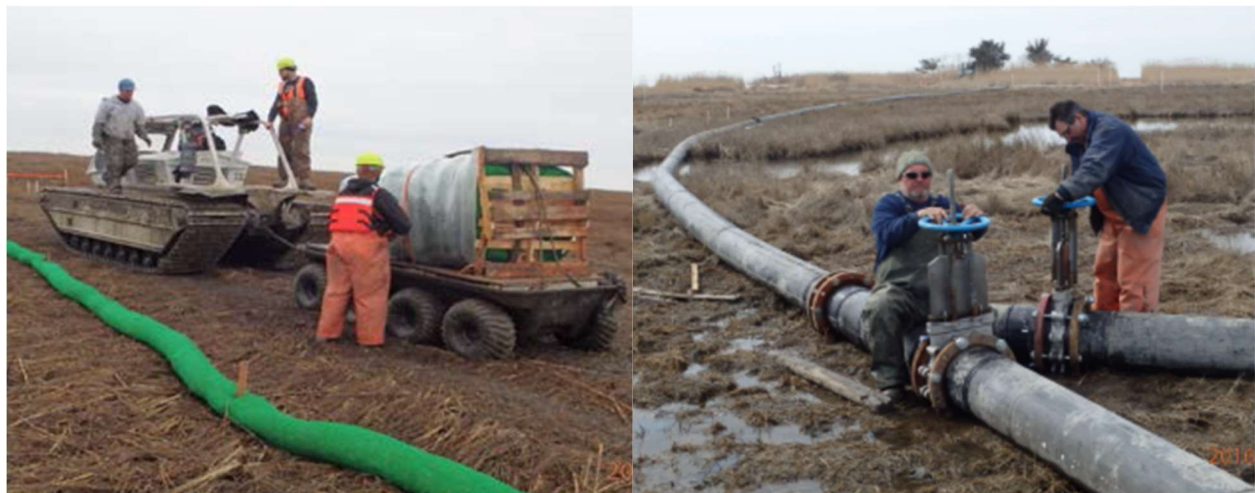
**Figure 6. Perimeter containment installation (a) and contractor utilized distribution array (b)**

The first step in construction was installation of the sediment enclosure. This required over 20,000 feet of Filtrexx® tubes and took four weeks to install (Figure 6a). During the installation, considerable damage was done to the marsh by vehicles. The second step was to install the distribution array. In an effort to reduce vehicle use, the sediment distribution array was constructed in phases, with the first phase going directly to the furthest area from the waterway with a backup line directed to the largest and deepest pool area in the center of the marsh. A “Y” valve was installed to allow the crew to switch between the two placement areas as needed (Figure 6b).

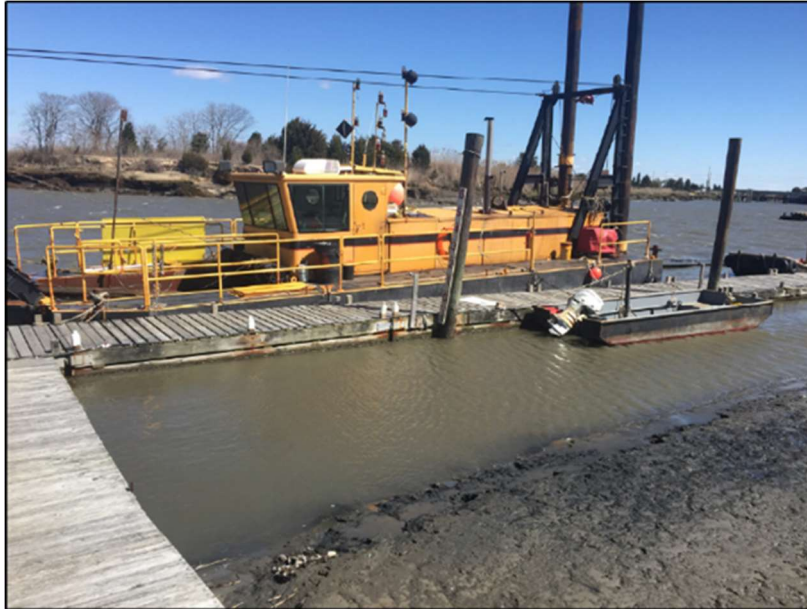
**Figure 7. AMMCO 12” Hydraulic Cutterhead dredge plant**

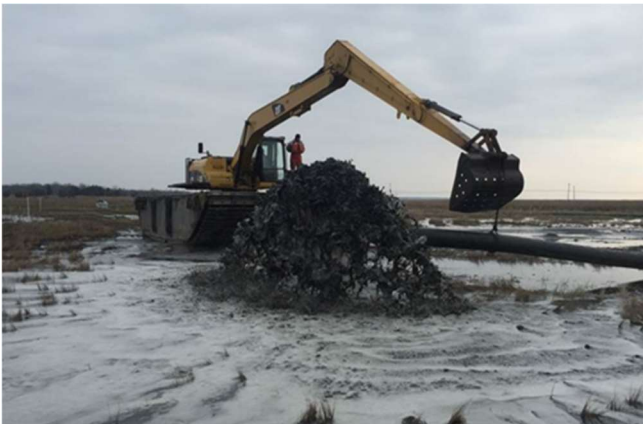
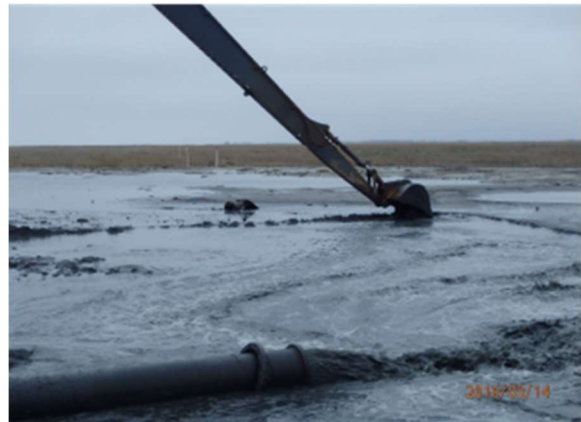
**Figure 8. Dredged slurry being pumped on marsh (a); distributed with long reach excavator (b)**

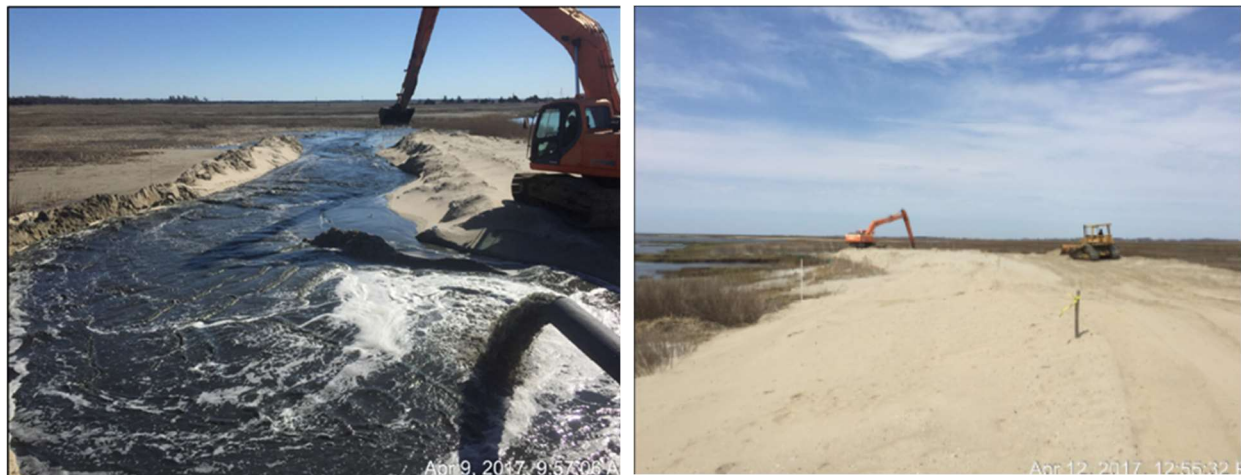
**Figure 9. Settling trench for dune construction (a) and shaping of dune with grade stake in foreground (b).**

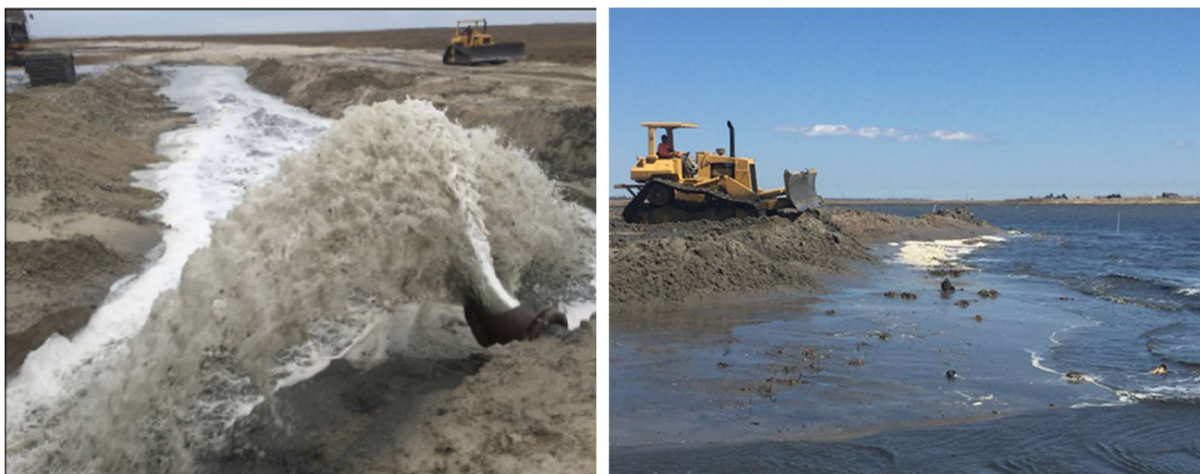
**Figure 10. Settling trench for beach placement (a) and bulldozer grading sand to beach template (b).**

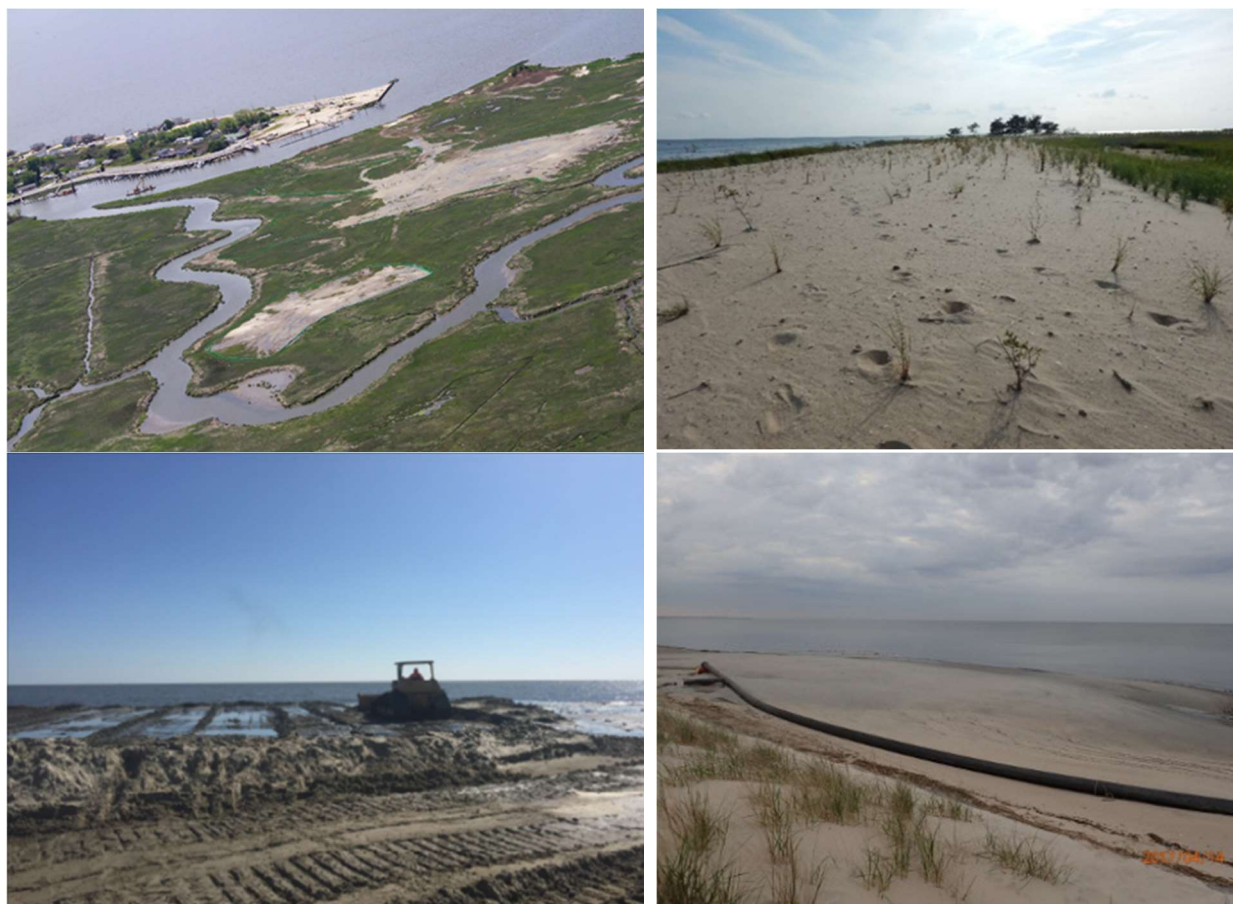
Figure 11. Completed project areas, clockwise from left, marsh, dune, wildlife beach, bathing beach.

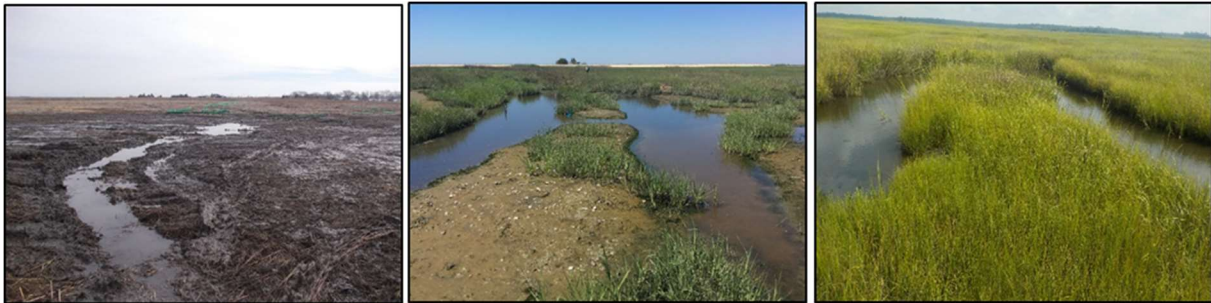
**Figure 13. Marsh damage caused by extensive vehicular traffic and a damaged area showing regrowth, but continued ponding between 2016 and 2019.**

It was apparent during the installation of the dredged material containment that the marsh platform was not stable enough to support the marsh equipment used by the contractor. This resulted in rutting and damage to marsh grasses, and in some cases cutting of the marsh platform in softer areas (Figure 12). Rather than construct the full array of pipes and nozzles originally planned, it was decided to first place material in those areas of marsh requiring the most fill. Once those areas were filled, the discharge pipe was moved using an excavator to either fill the next closest area, or the slurry was directed out across the marsh. Regular observations were made of fill levels, and containment was checked to ensure it remained in place, was not overtopped by the dredge slurry, nor was dredged slurry observed to flow into the site drainage waterways. Movement of the dredge outflow pipe to direct placement where needed was adequate to avoid overfilling. In cases where coarse-grained material built up to a level higher than the target placement elevation, these areas were easily graded down with machinery to below the maximum elevations.

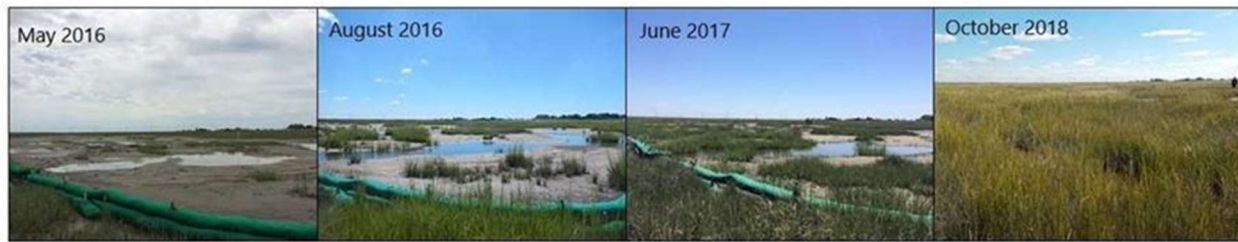
**Figure 14. Time series of marsh placement area at Fortescue site over three growing seasons.**

Overall vegetative cover significantly decreased in the placement areas one-year post-construction, with a return to baseline and matching control site conditions by the third year after construction (Figure 14). As

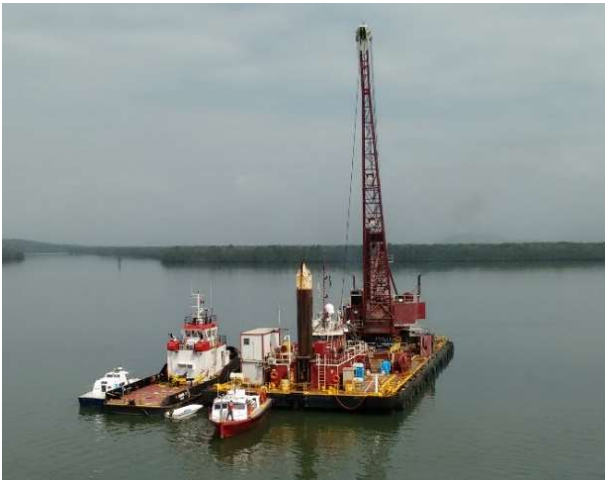
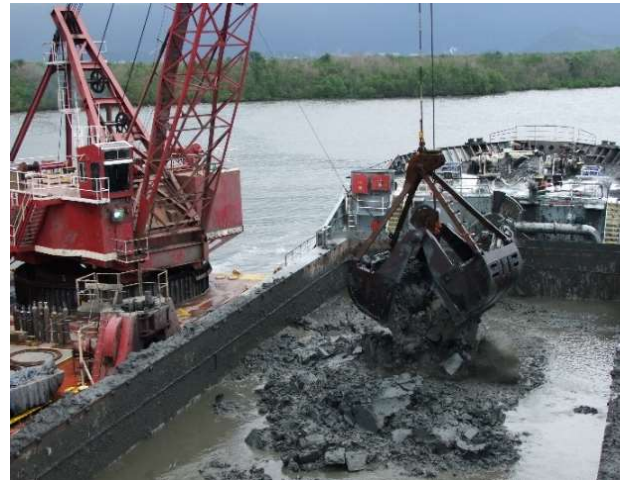
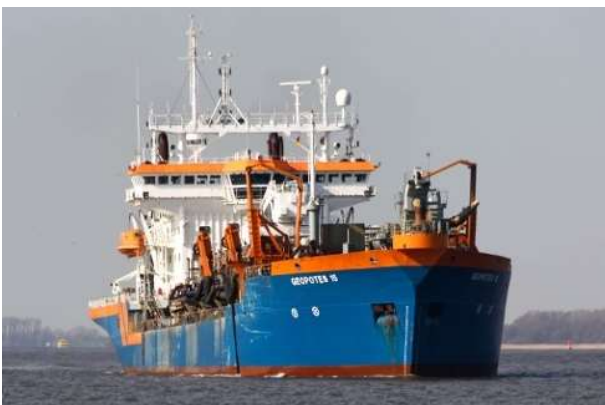
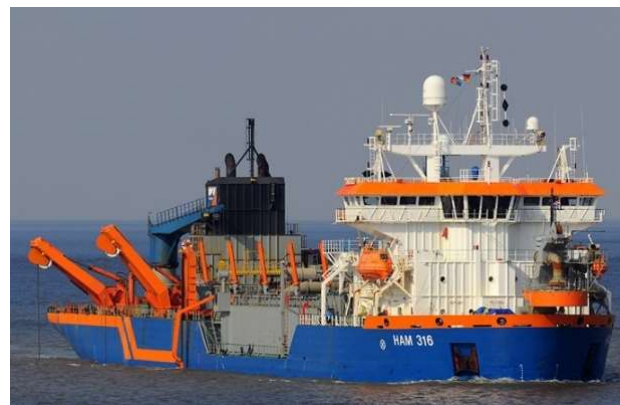
**Figure 4. Equipment used during the CAD opening.**

approximately 3.5 million cubic meters were dredged in the CAD opening phase. Figure 4 shows images of the equipment used during the CAD opening.

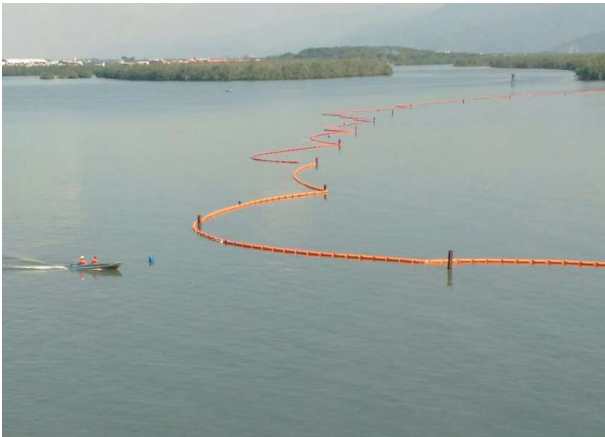
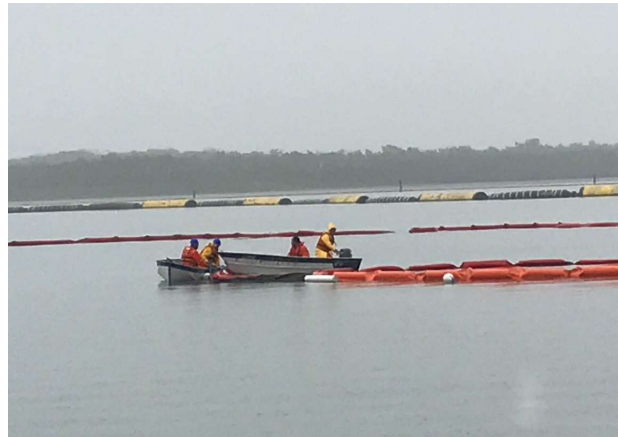
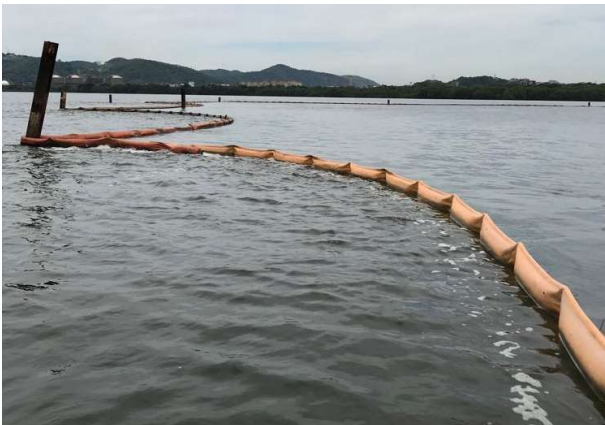
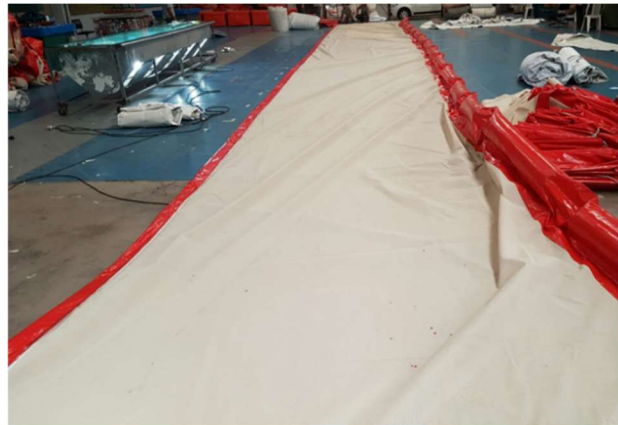
**Figure 5. Silt curtain implemented around the entire perimeter of the CAD to control the dispersion of suspended solids.**

Silt curtains are flexible floating barriers that partially block the plumes of suspended solids during dredged material placement, reducing the dispersion of these solids beyond the perimeter created by the curtain. Such curtains are widely used in dredging operations and the effectiveness of their use has been demonstrated by various laboratory and field studies, especially when the barrier is not open and when there

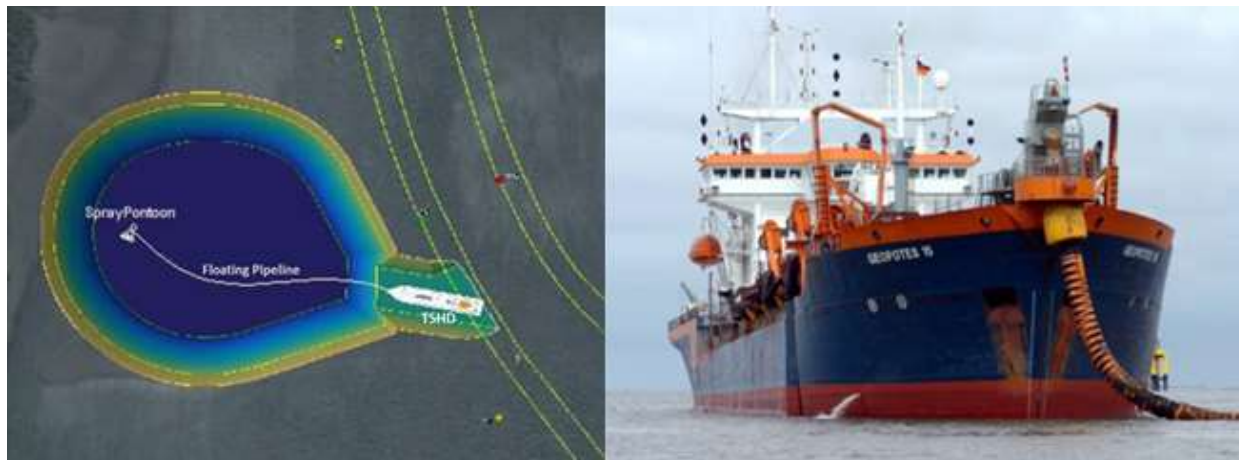
**Figure 6. Illustrative image of the material disposal method within CAD and detail (right) of connection between TSHD and floating piping.**

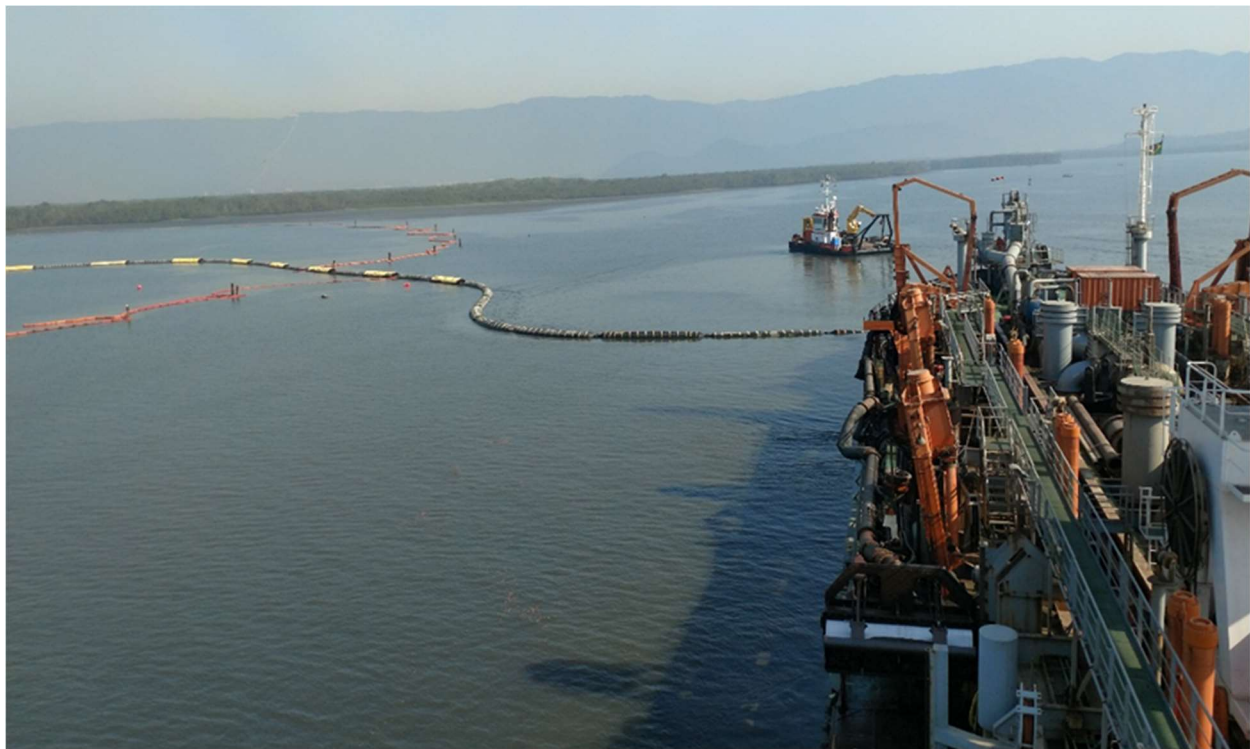
**Figure 7. TSHD performing pumping through HDPE piping to fill the CAD.**

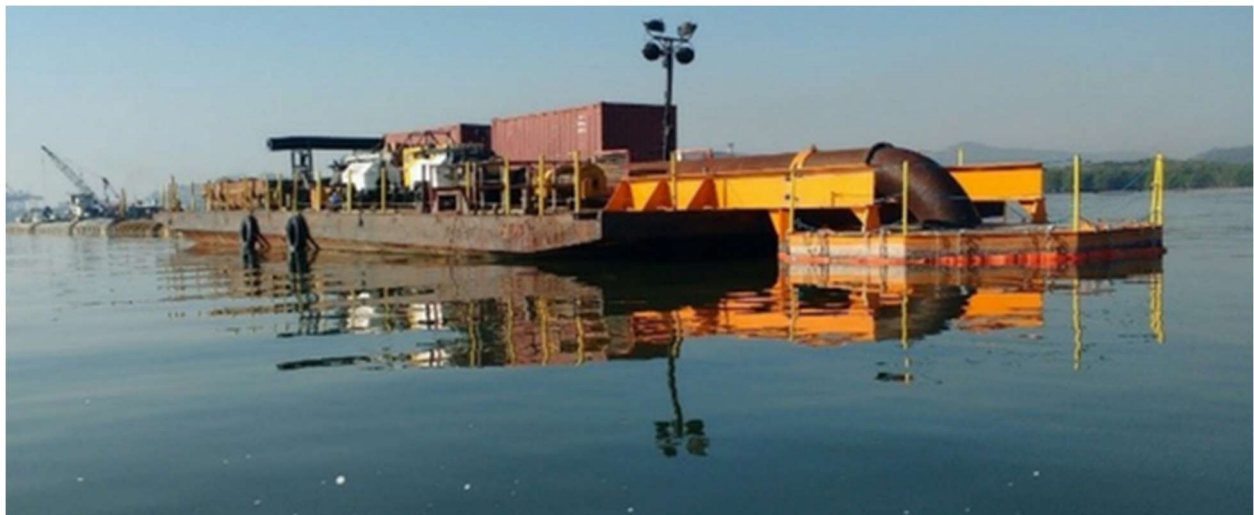
**Figure 9. Pontoon and diffuser.**

A submerged diffuser was installed at the end of the tube with the objective of directing the fluidized material to the bottom by reducing the transport velocity. Its position was controlled through anchors by the crew. The objective of the diffuser was to minimize the effects of turbulence during the descent and dispersion of the sediment plume upon impact on the bottom of the CAD cell.

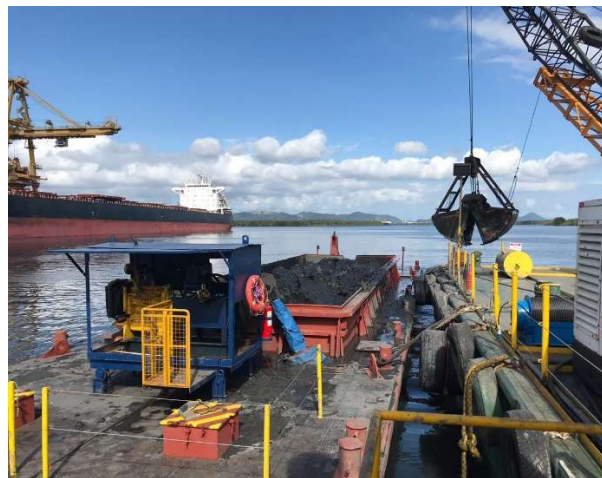
**Figure 10. Equipment used during the second step of CAD filling.**

The second step of filling occurred irregularly during 2018 and 2019, using mechanical dredges and split barges (Figure 10) for the more precise excavation of hot spots (isolated points with higher contamination). During this step, around 500 thousand cubic meters was removed from hot spots in the Piaçaguera Channel, just 20% of the total amount dredged for the Piaçaguera Channel clean-up project. These sediments were placed by opening the split-hull barges inside the CAD. Some sectors of the channel were dredged until a depth of 14.5 meters was attained. Filling ended in November 2019.

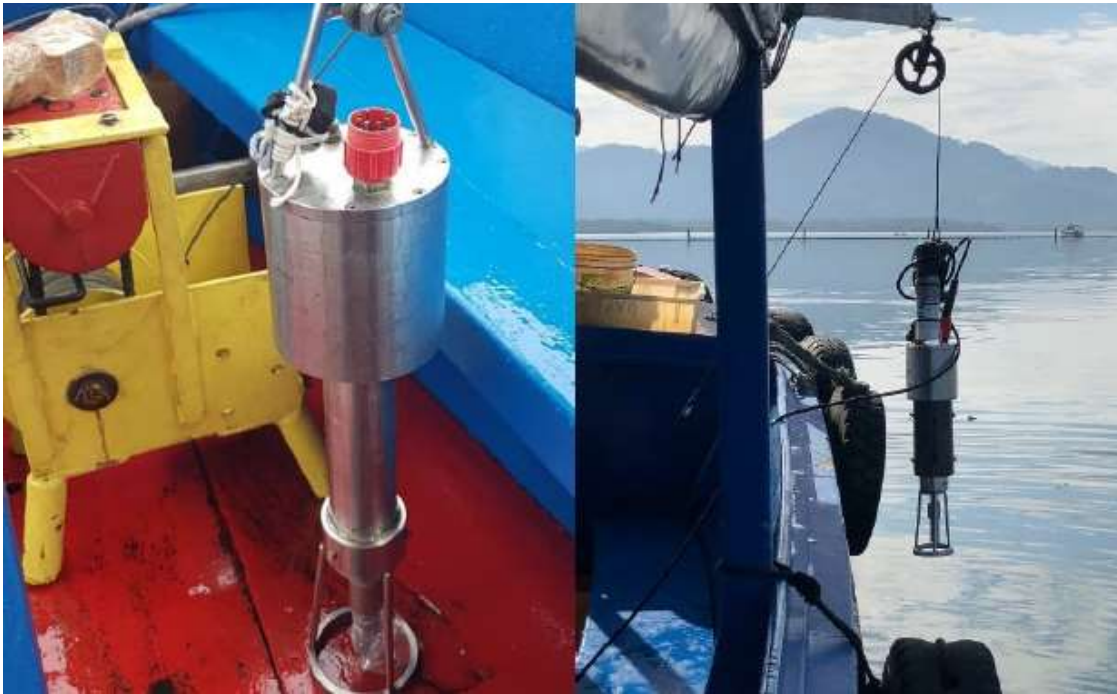
Figure 11. Inside CAD material density survey monitoring using DensiTune equipment.

The density survey was conducted using a dual frequency bathymetric sensor (24 and 200 kHz) and an in-situ density profiler manufactured by the Stemma Systems (<https://stema-systems.nl/equipment/>). In parallel, several environmental monitoring campaigns were executed, to confirm that safe environmental conditions were maintained around the CAD area during the stand-by time for the material consolidation.

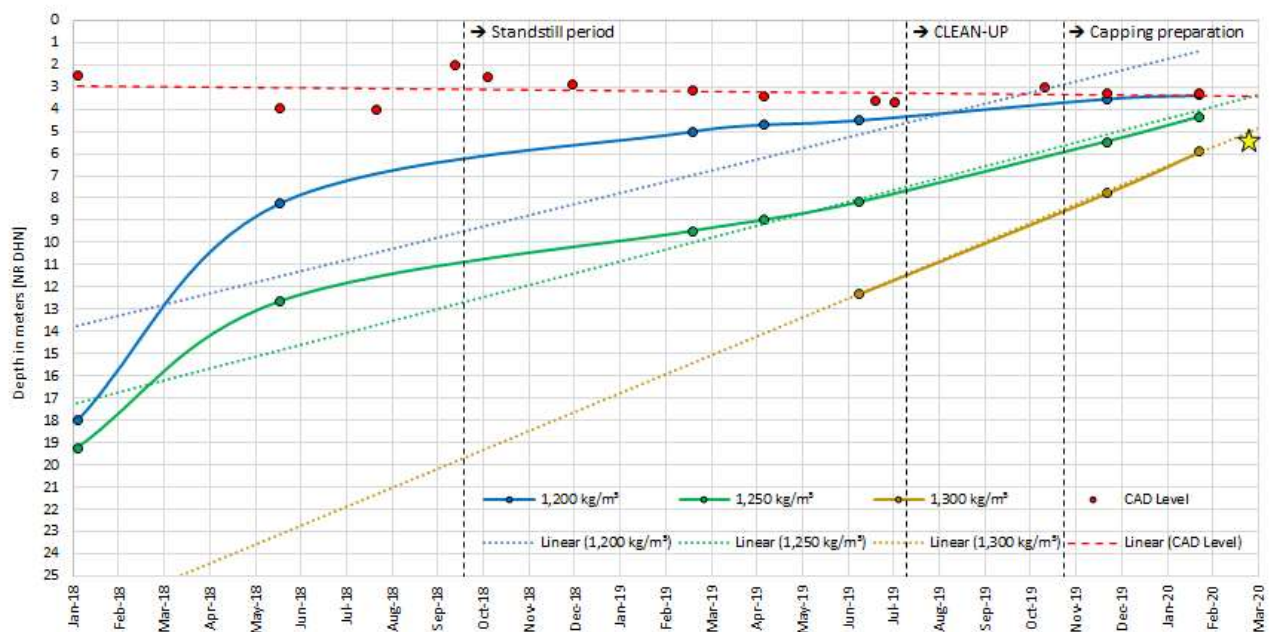
Figure 12. Projection of the density gain curve along time, based on the average density measured on the profiles, used to determine the best timeframe or capping placement.

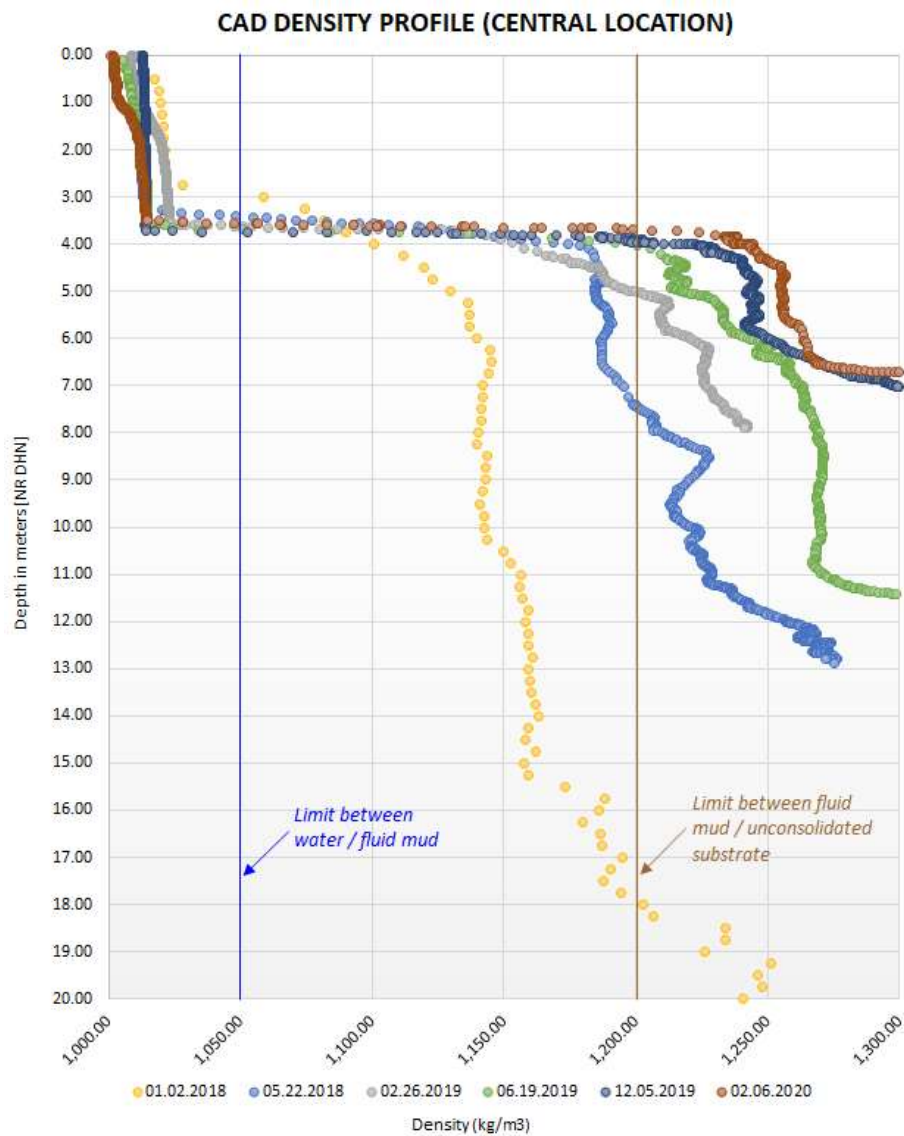
**Figure 13. Evolution of density profiles measured at the central monitoring point of the CAD over time. The different colored profiles show the distinct density monitoring campaigns.**

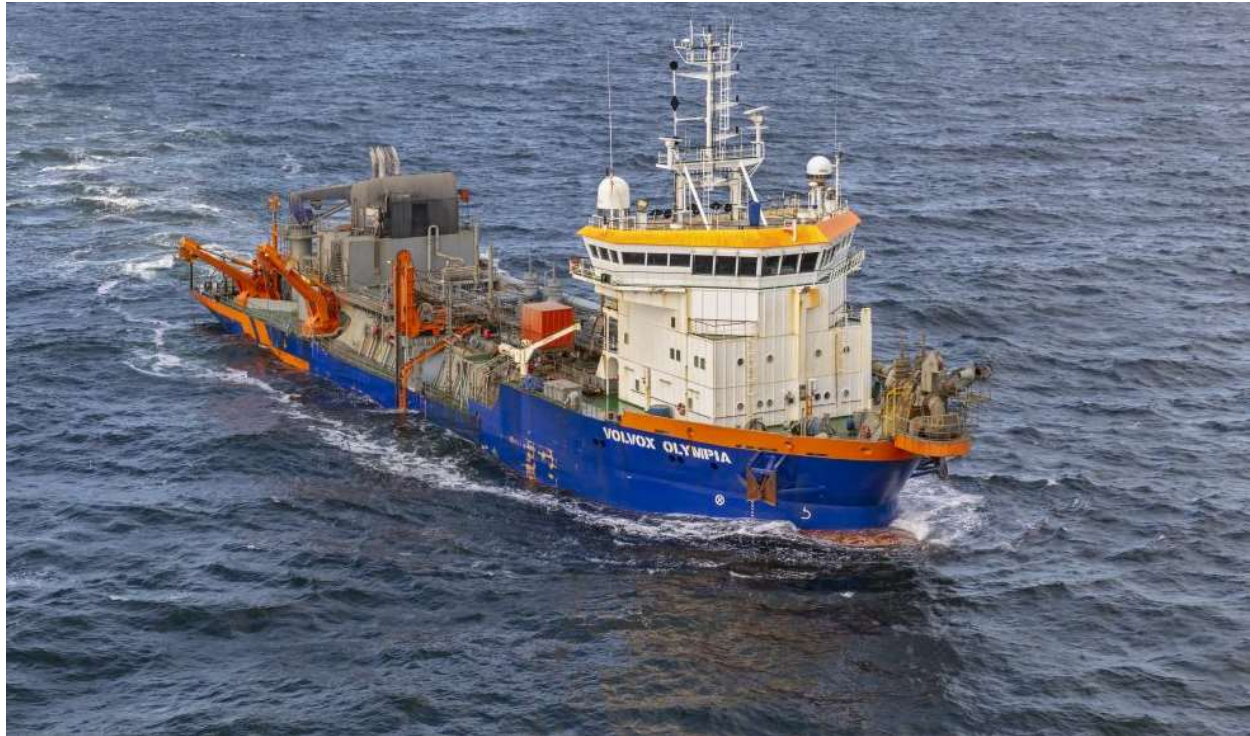
**Figure 15: THSD dredge used during the CAD capping.**
