Siltation Management of Dam Reservoirs through Dredging

Konrad Mech Sales Director, Coasts, Ports and Inland Waterways

Case Study 1: Run of River Hydroelectric Reservoir Dredging

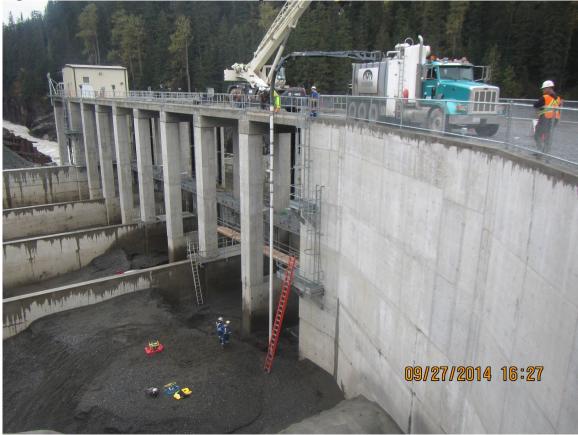
20 scans within 30 hours, showing sand waves and dredging activity

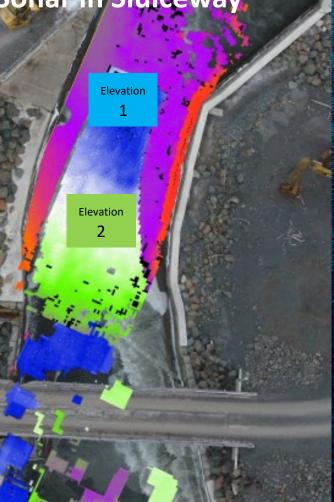
Cowlitz Falls is located in Southwestern Washington and operated by Lewis County Public Utility District (LCPUD)

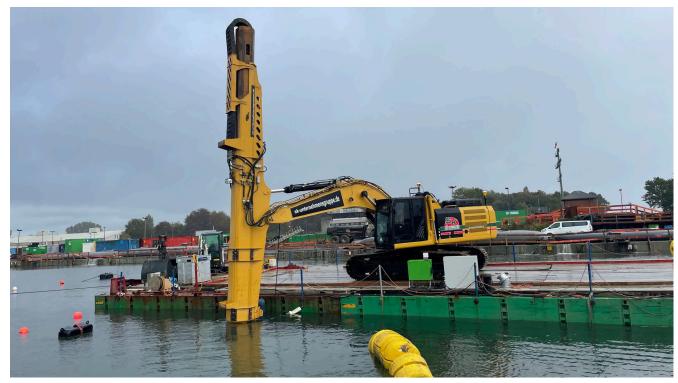
Surgical Dredging now possible in operator's cab
