Port of Anchorage Transitional & Maintenance Dredging

- Safety - Anchorage, AK
- Anchorage, AK
- Maintenance Dredging
- Transitional Dredging

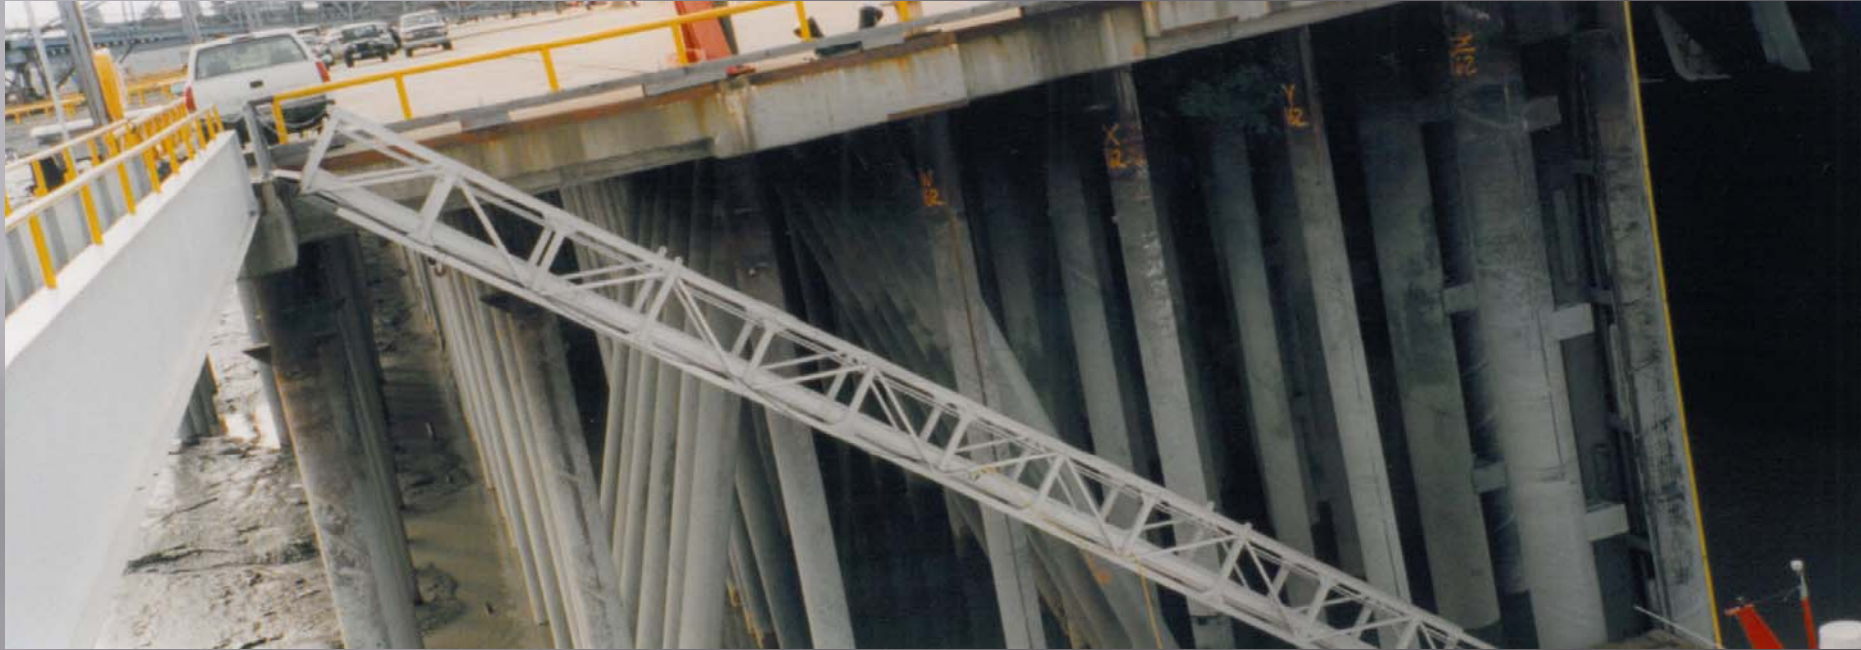
Extreme Tides

Tides can change from a -4.5 to a +34

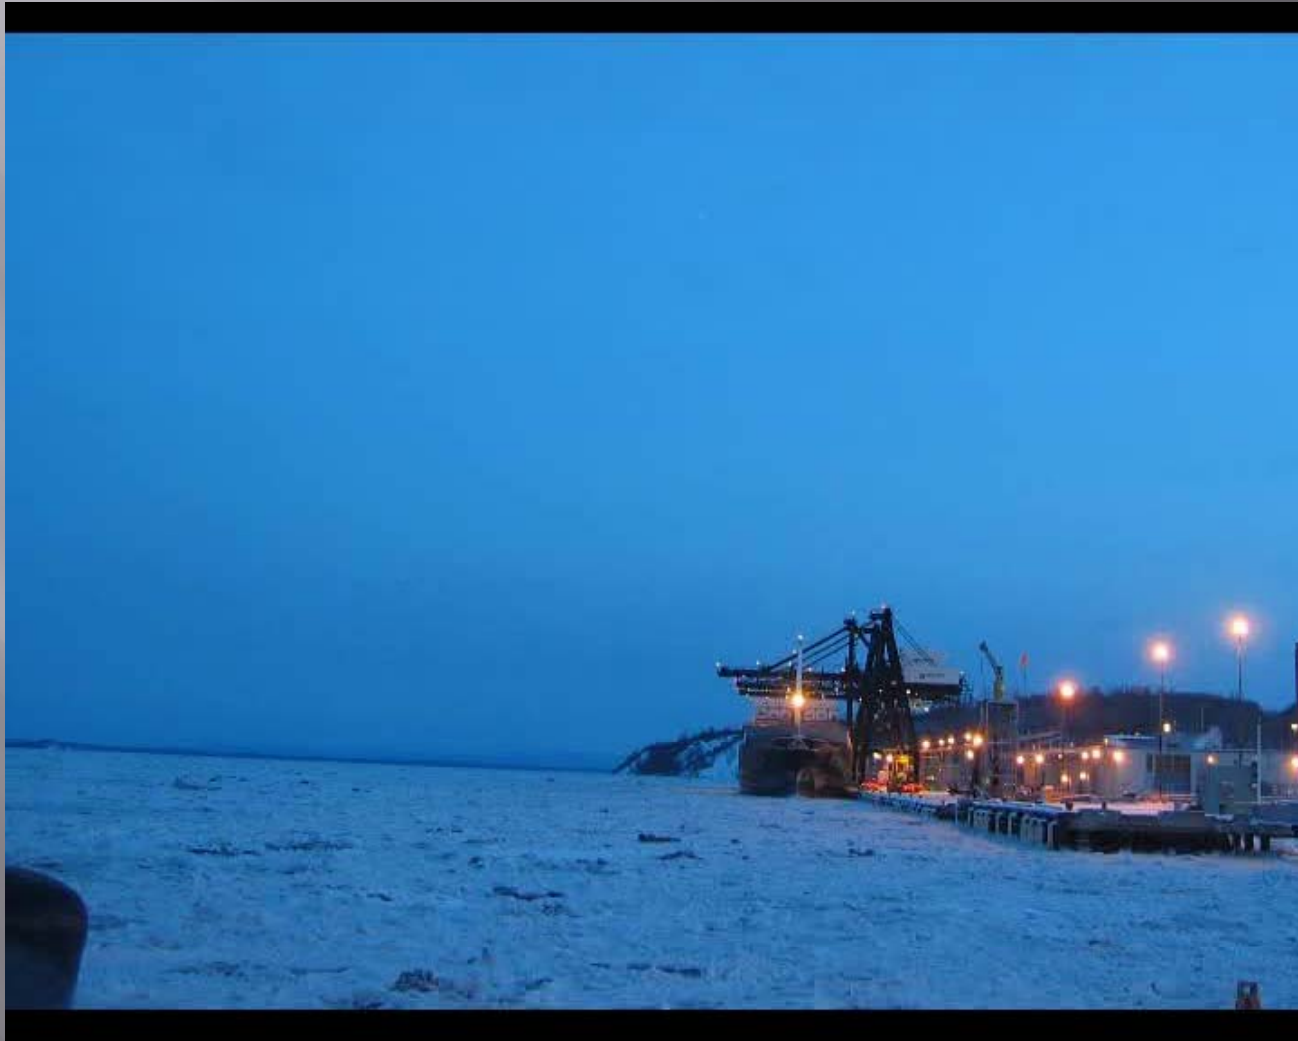
Winter 06 Tidal Change

Photo taken every 10 minutes throughout the tide cycle.

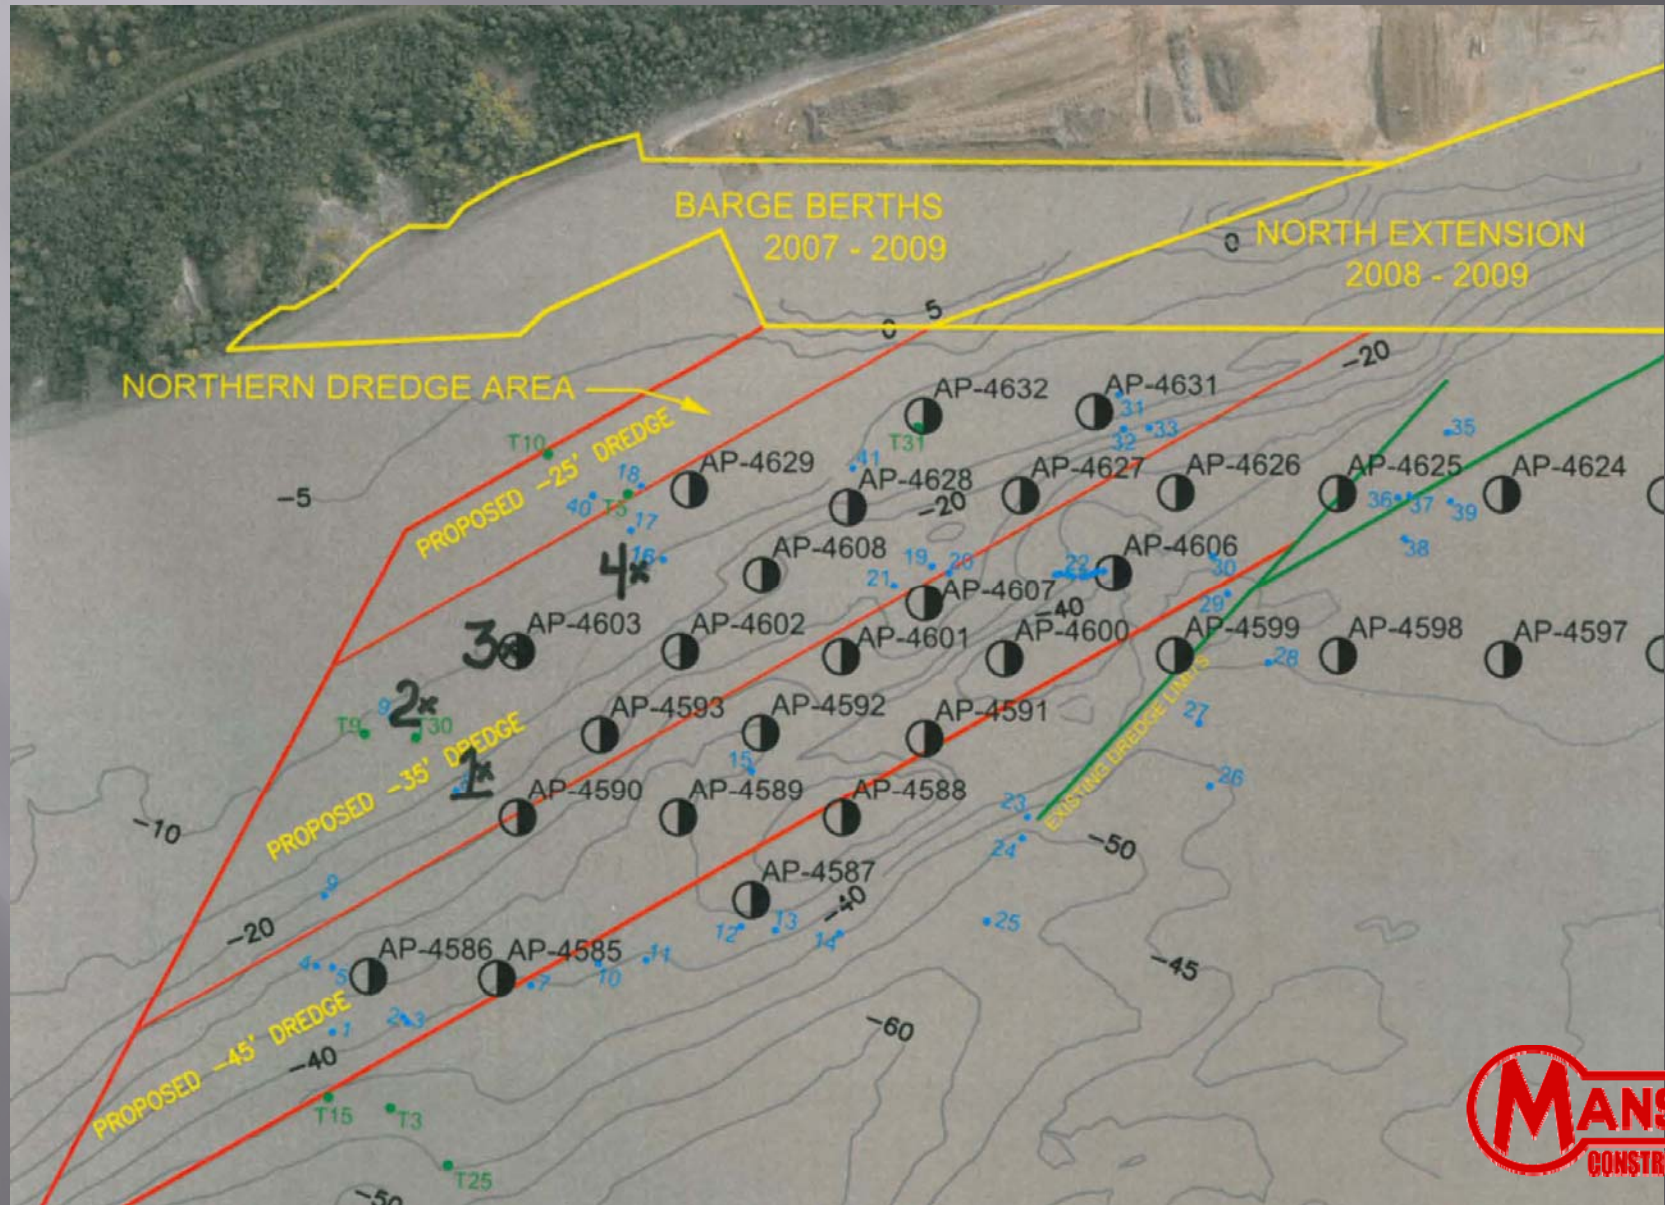
Test Holes

Completed towards the end of the 2009 dredge season

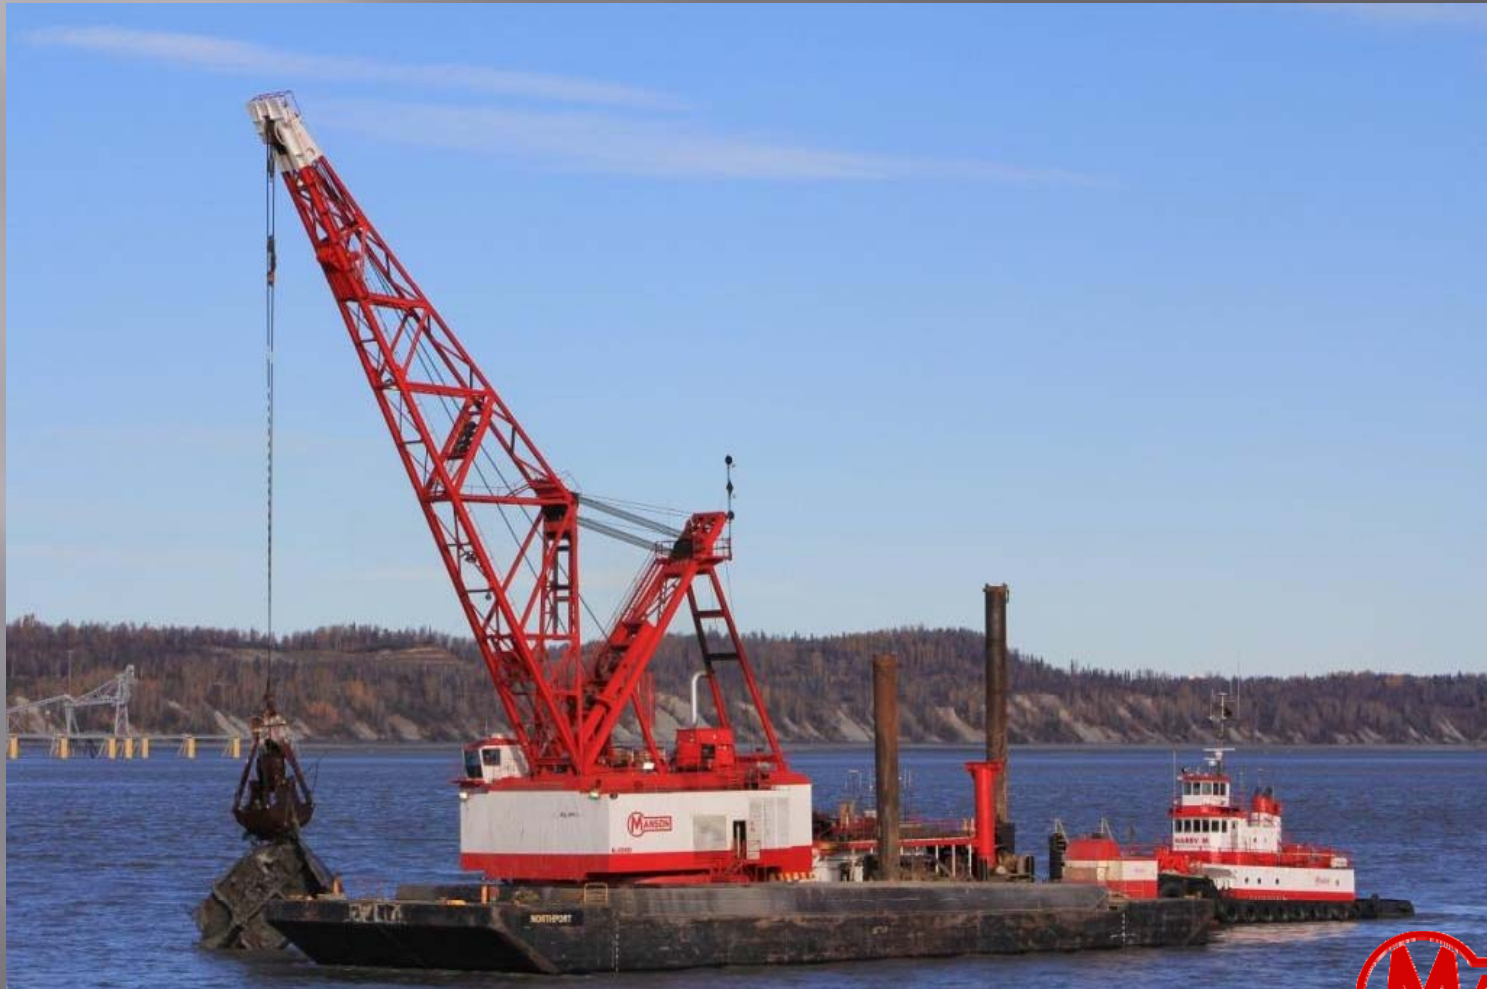
Njord removing pill box from the North Expansion

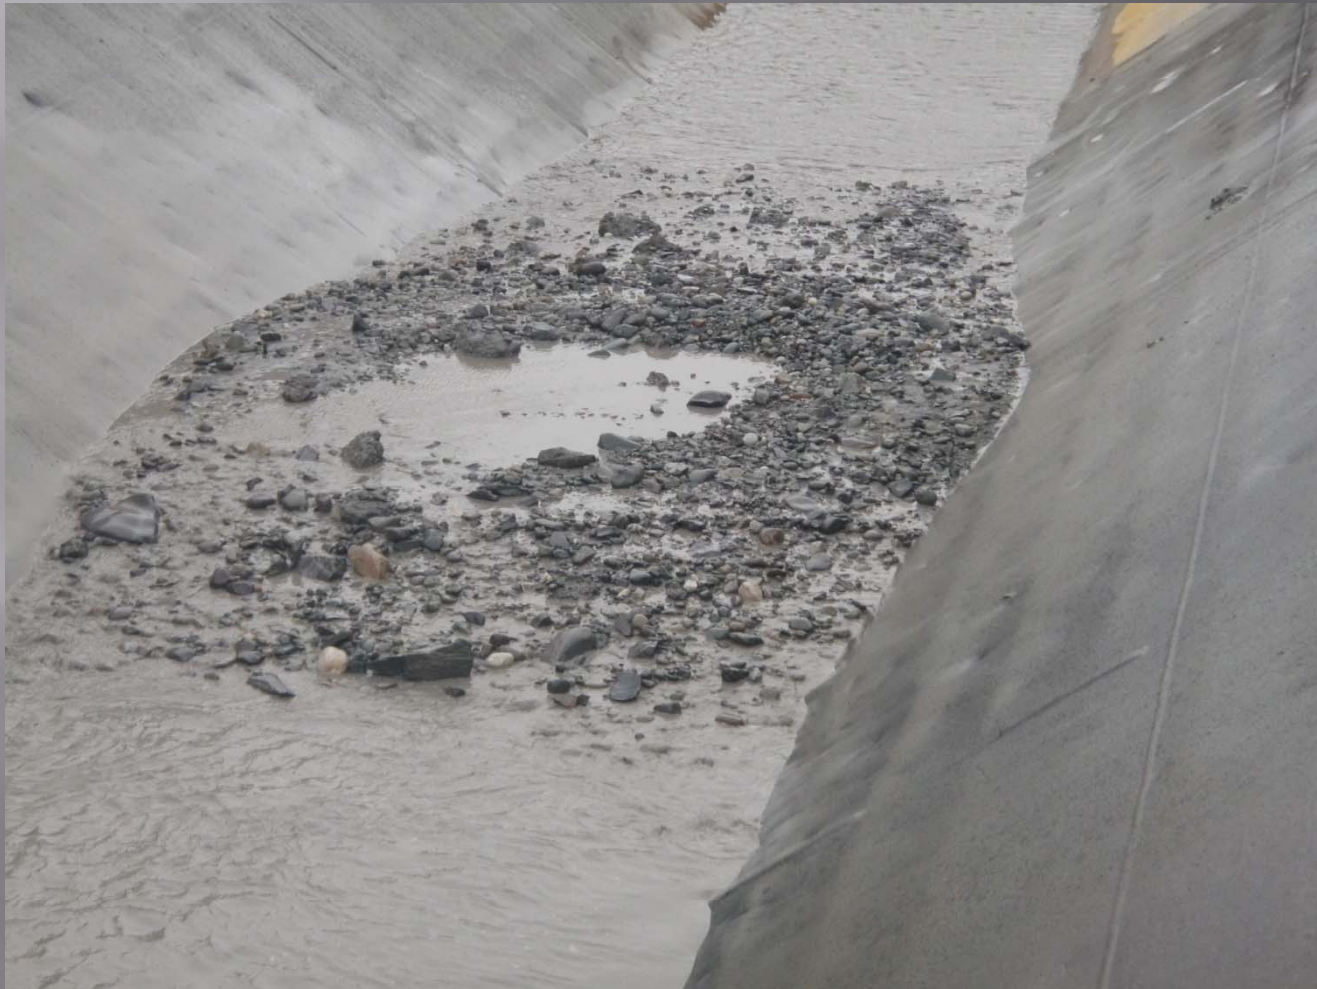
Sandy Gravel with Cobbles

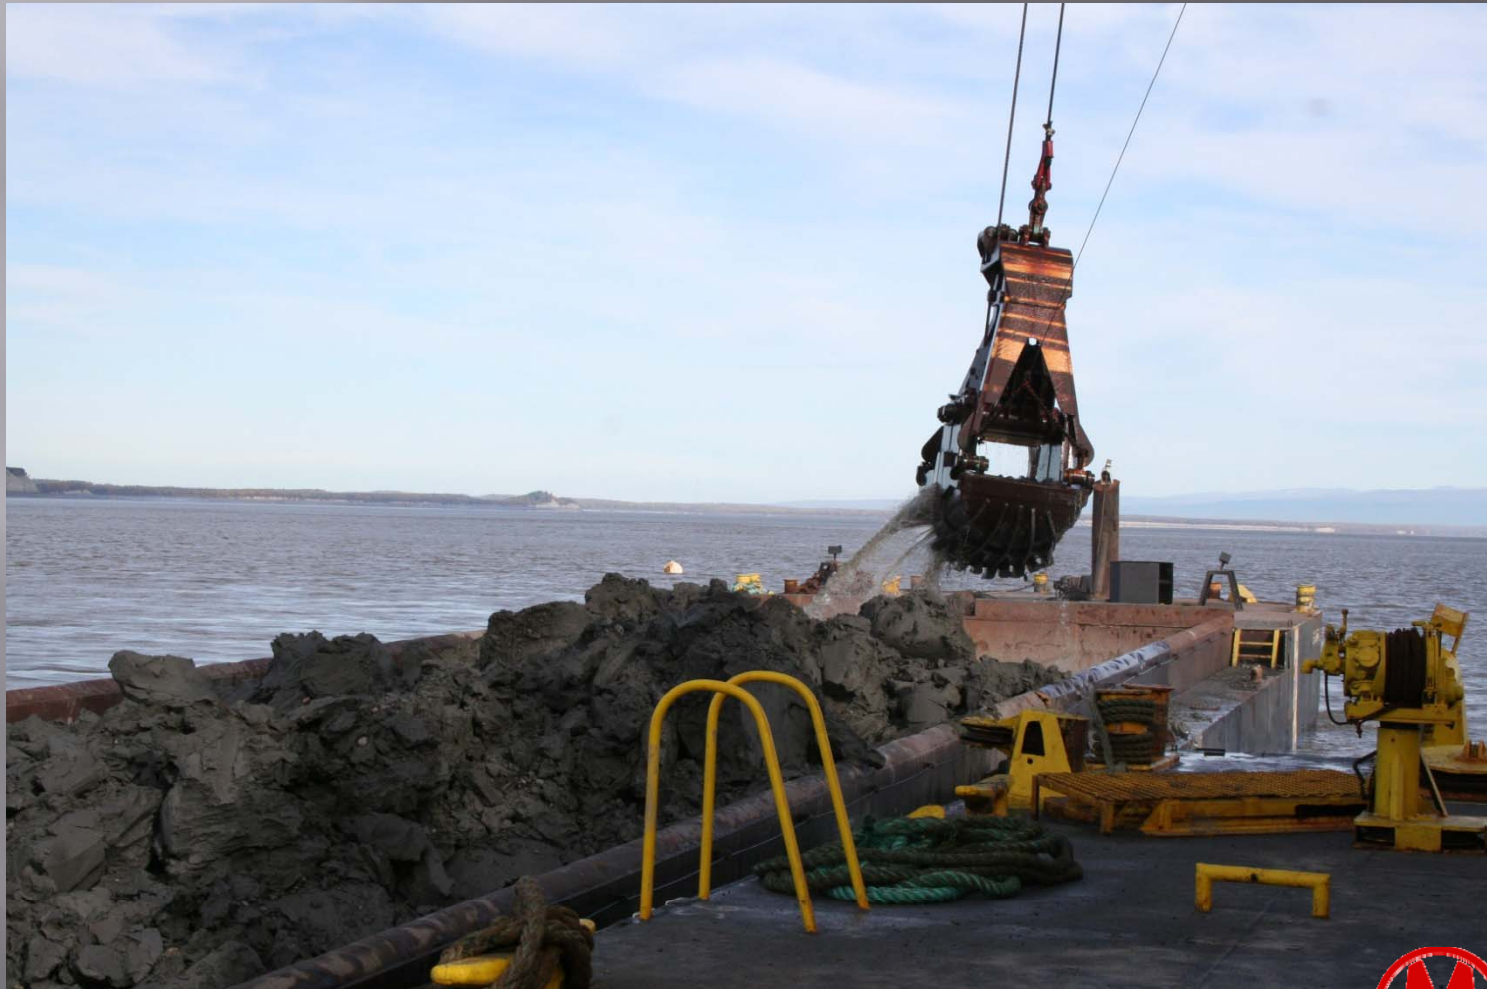
Dense Clay
