Shoalwater Bay Shorline Erosion Dredging

ROSS ISLAND SAND & GRAVEL CO.

Saving the Tokeland Peninsula

Willapa Bay & Tokeland Peninsula

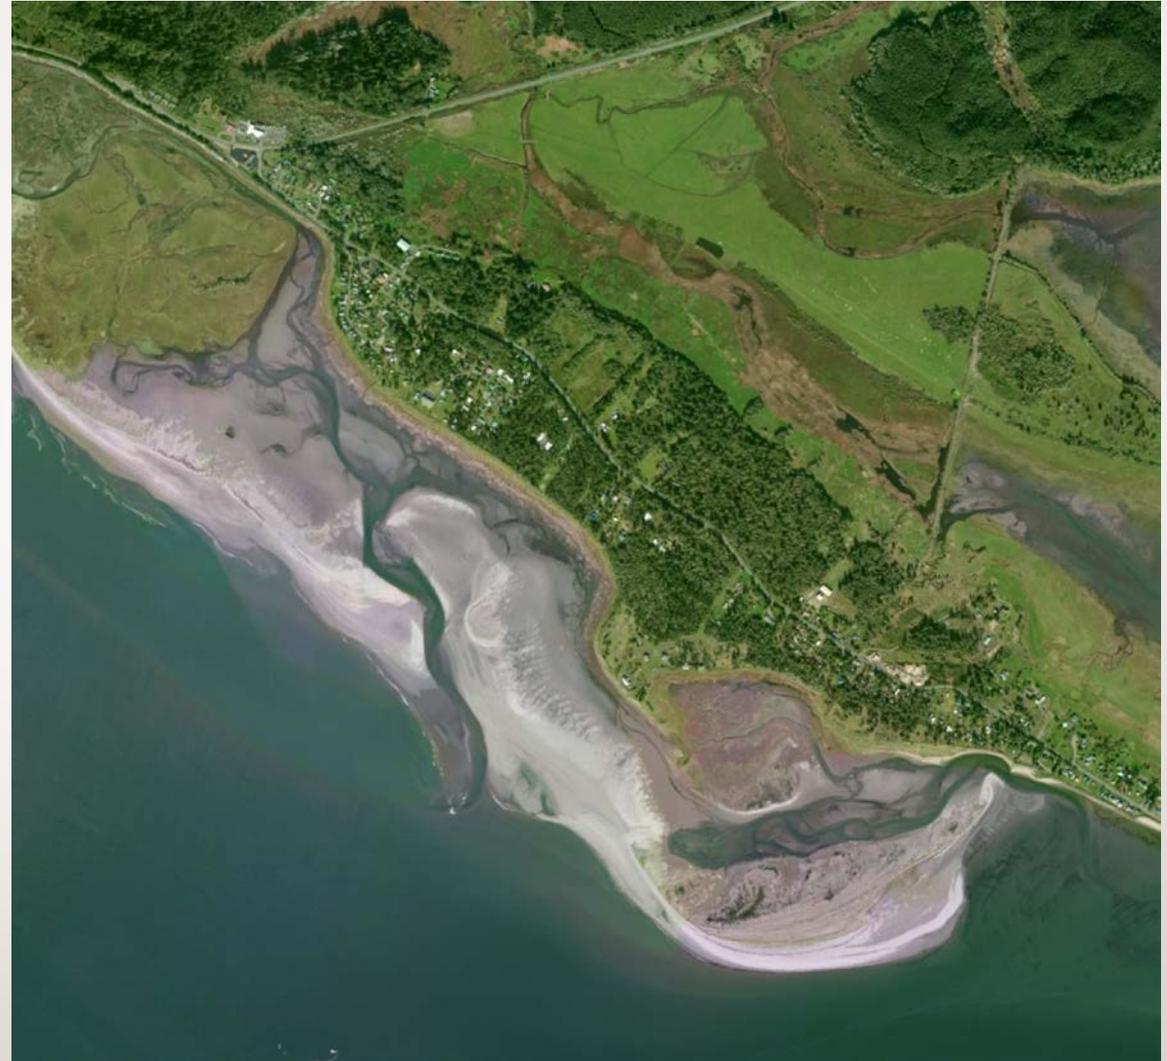
Design and Contracting

- Berm Design to Stop Dune Breaches and Promote Tidal Channel Flows
- Borrow Site Chosen on a Localized & Quantitative Basis for the Dune Design Quantity
- 719,000 Cubic Yards to be Dredged and Placed

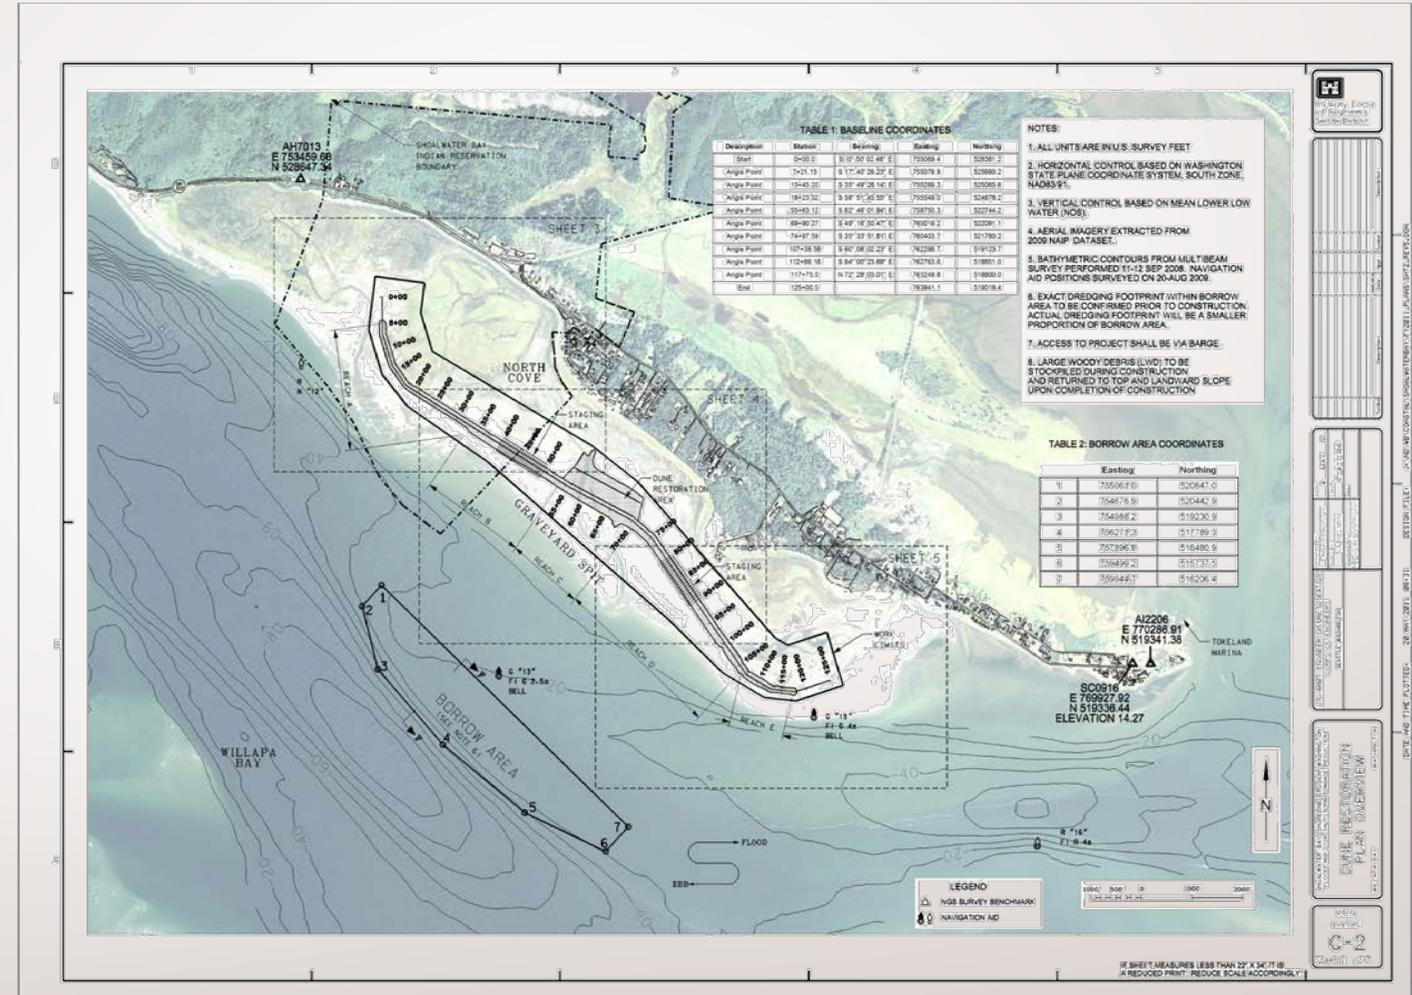
2012 Mobilization

- Ross Island Dredge #7
- Dredge Tender Santiam
- 8,000 LF 24" O.D. HDPE Discharge Pipeline
 - Landing Barge UB-4
- Submersible ABS Transport Barge RISS-9
- Upland Equipment (Dozers & Loader)

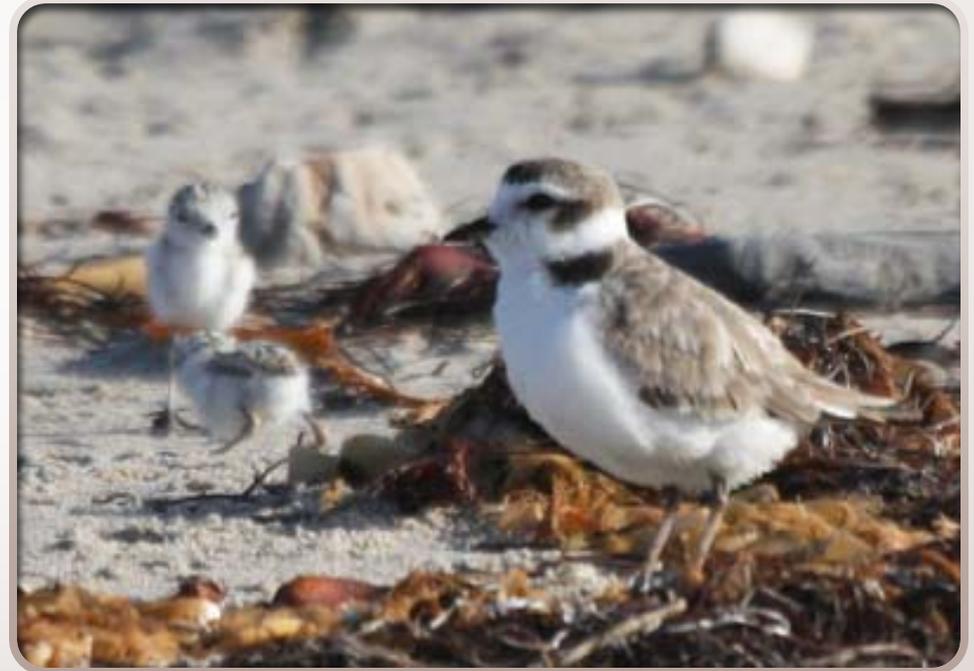
Dune Breach Channel Re-Design

- Breach Channel Had Extended Southward Prior to Construction
- Re-Design Provided Additional Materials Be Placed to Extend Wide (+12' Bench & 50:1) Portion of Berm South to Close Recently Shifted Breach

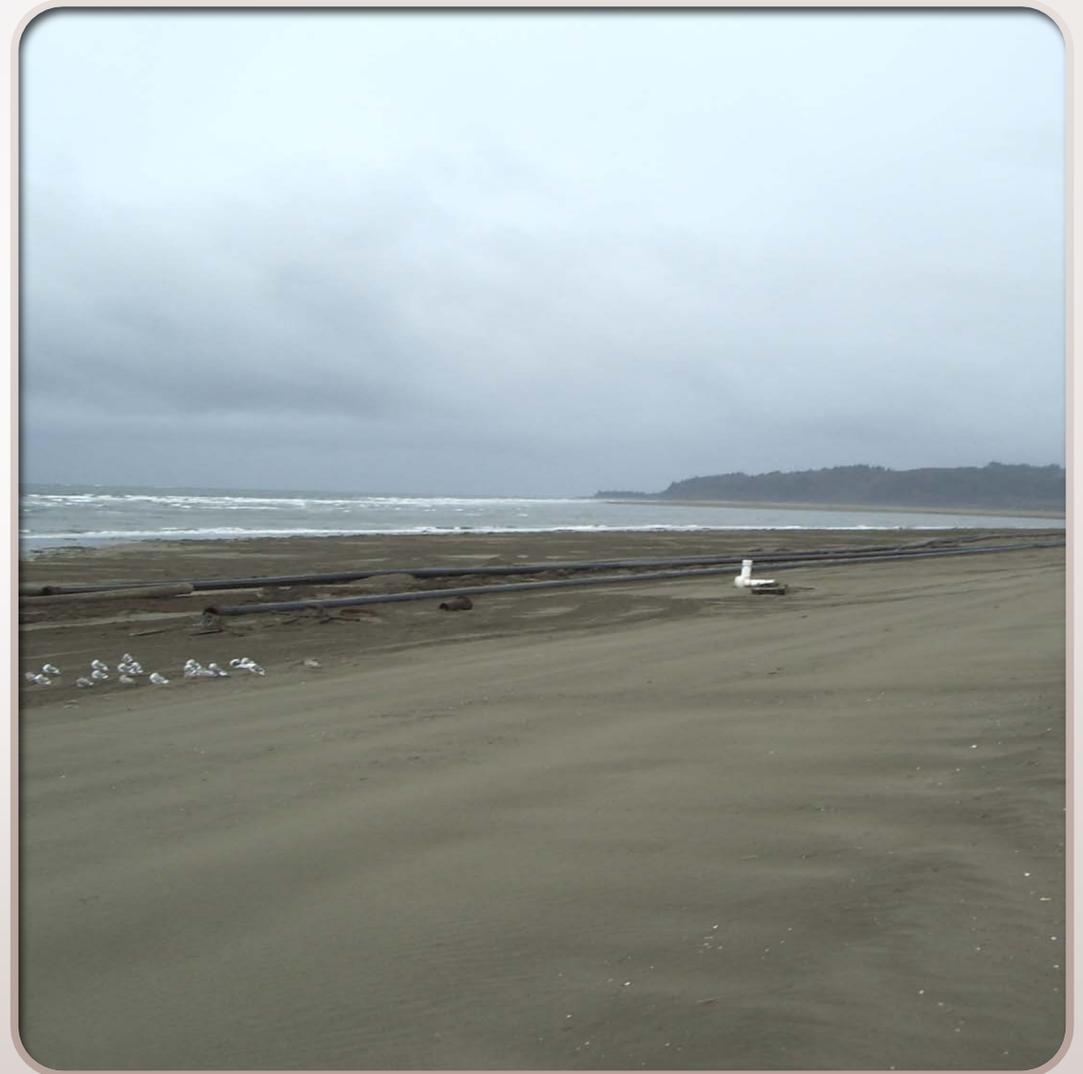
Dredge Modifications and Storm Avoidance

- Borrow Site Deeper Than Represented In Specification
- Remove 47' Ladder & Reinstall 87' Digging Ladder
 - Result: Can Keep Material In Pipe
- From Mid September to Early October - 17 Days of Dredging Were Possible Due to Adverse Weather
- 2012 Dredging Did Not Proceed After 11/11/12
- 180,000 Cubic Yards Dredged and Placed in 2012

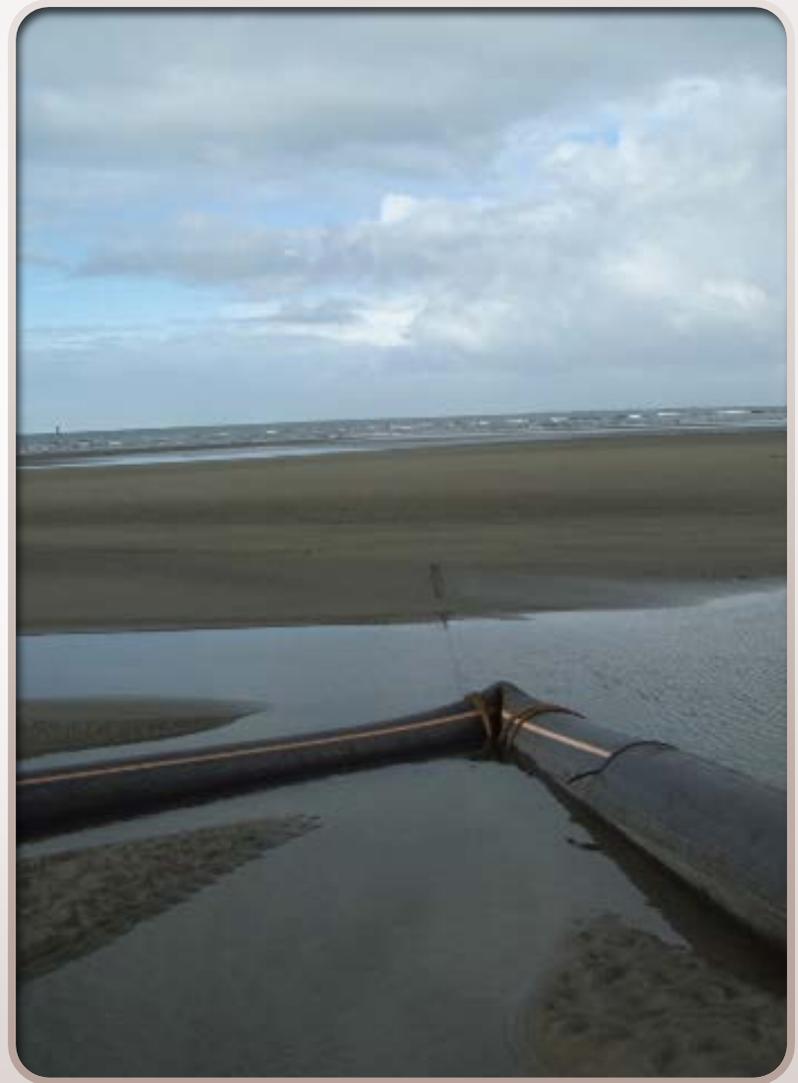
2012 Winter Mitigation Measures

- Construct 12' Dozer Berm Across Historic Breach to Prevent More Breach Damage to Shoreline Tribal & Private Properties
- Relatively Successful - South Breach Re-Formed and Required Later Closure

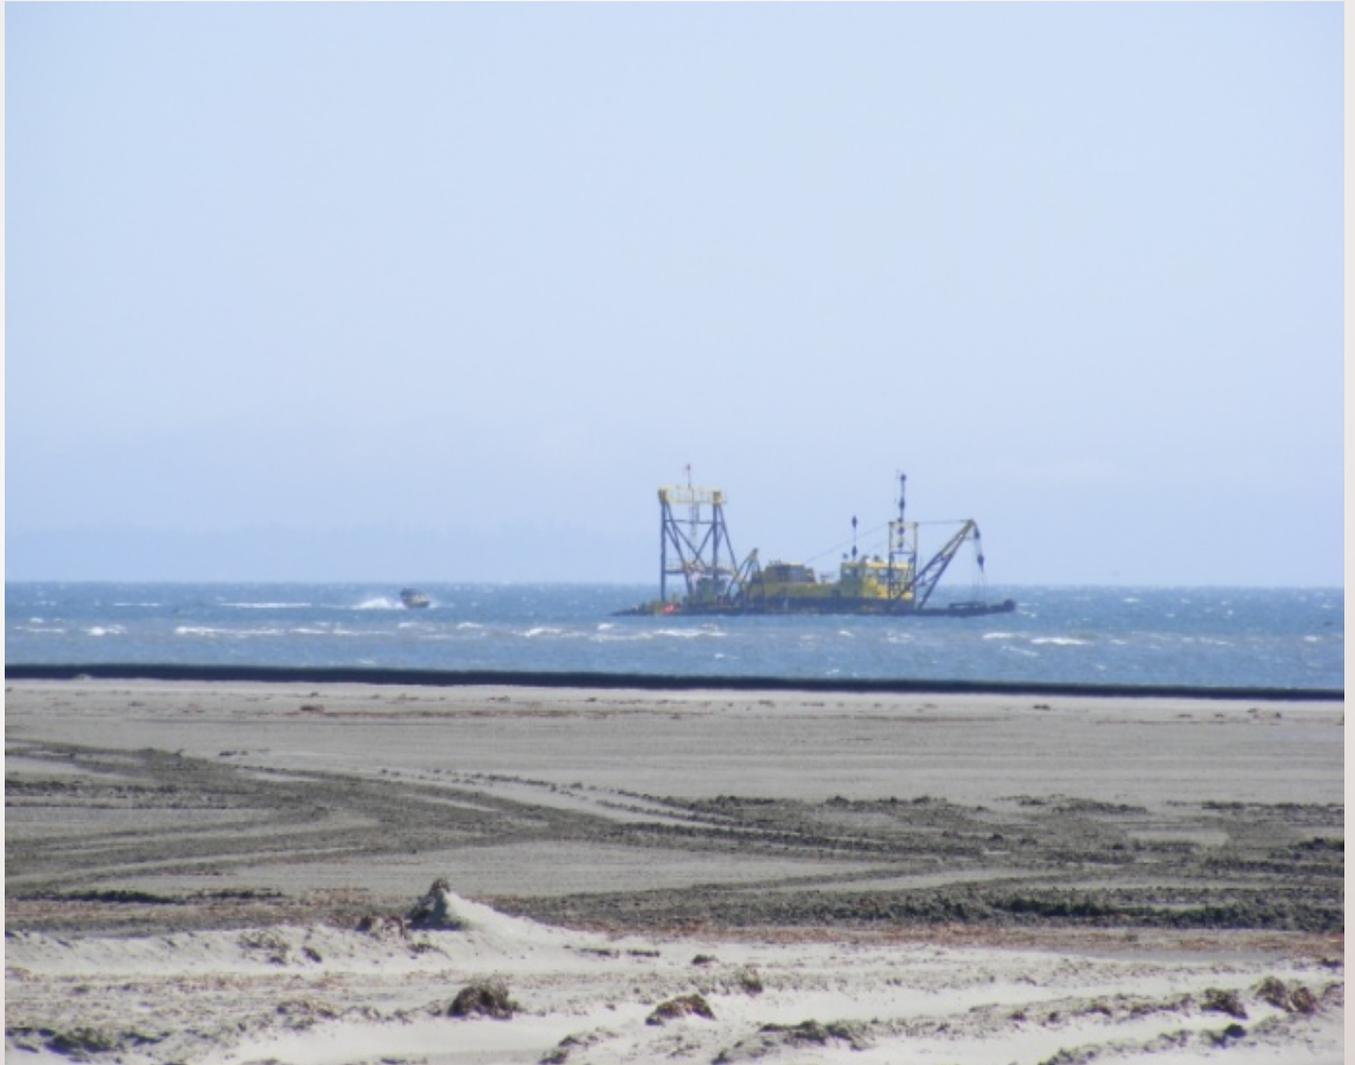
2013 Contractor Adjustments

- Utilize a “Static” Pipeline from Borrow Site to Landing Point
- Opposing 3000# Anchors every 300' of Pipeline
- Majority of Pipeline Stays at Berm Toe, But Creates Pumping Distances Up to 12,000 If
 - Multiple Dredge Tenders to Maximize Pipeline Launch/Connect and All Pipeline Anchor Moves With Given 1 to 1.5hr Slack Water Tides

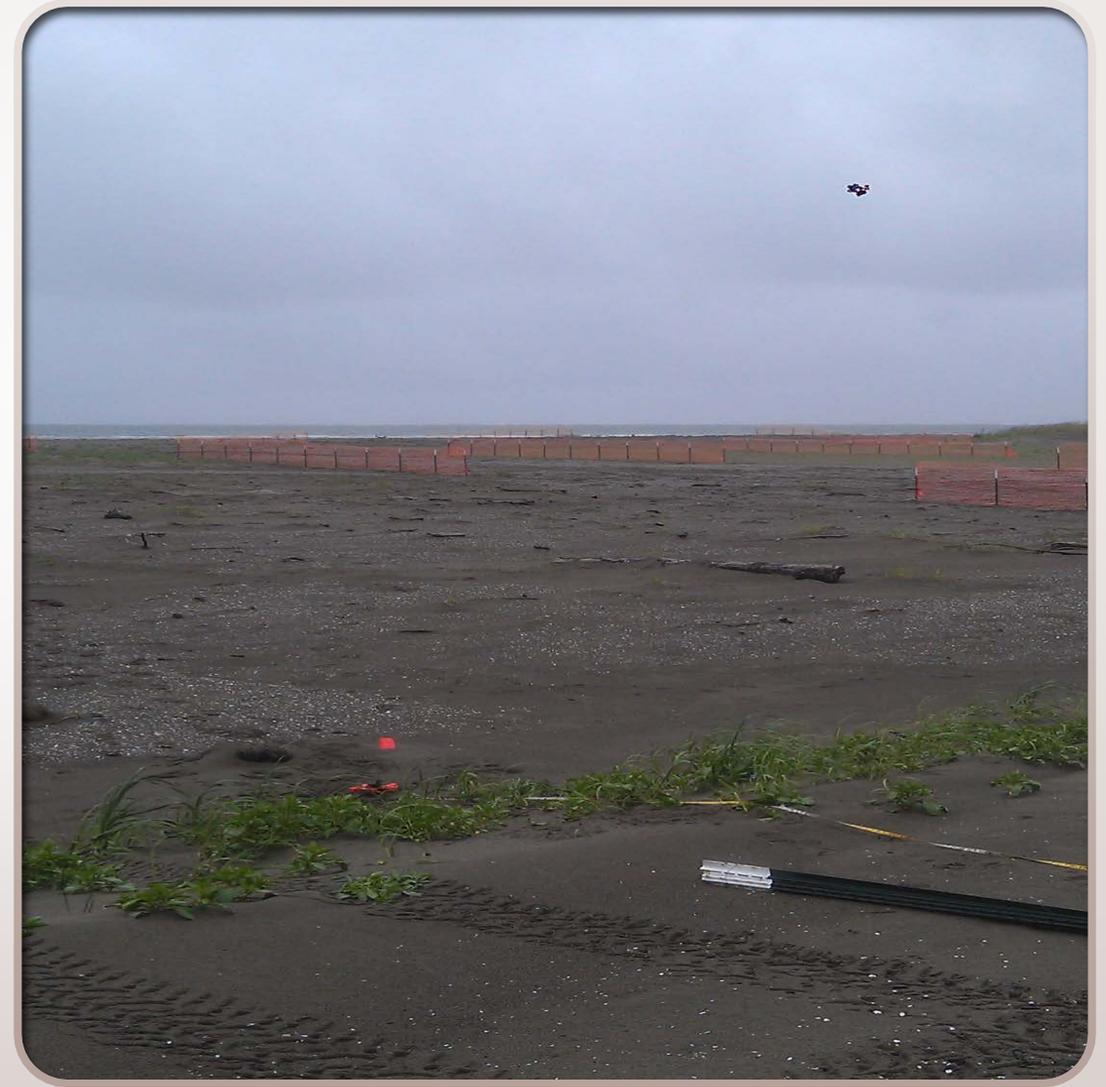
2013 Mobilization & Startup

- Plovers Nested to North
- Re-Commencement of Dredging 7/11/13
- Dredged Completion of Original Breach Berm
- Dredge Placement Advance North to Limits of Plover Buffer by 8/19/13
- Dredging & Placement Advance Up to 300 linear Feet Per Day.
- Dune Constructed Hydraulically, with Minimal Mechanical Grading to Top +25 Elevation

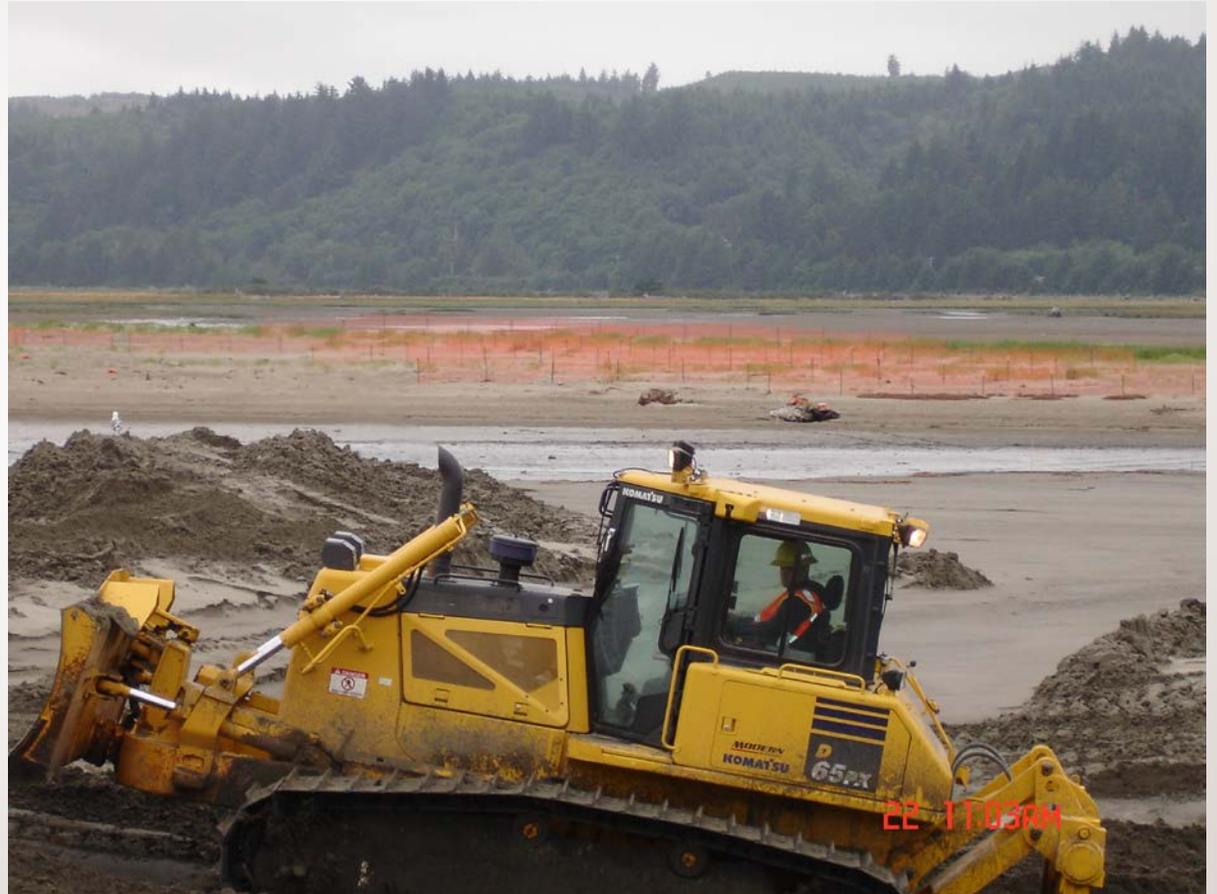
Complete the North Dune Terminous

- North Berms Routed Around Critical Habitat
- Equipment & Personnel Transit Via Crest of Constructed Dune
- North Terminus Widening
 - Berm Shortened 1,200' But Widened to 200' Wide Bench for a 1,400' Thickened Terminus

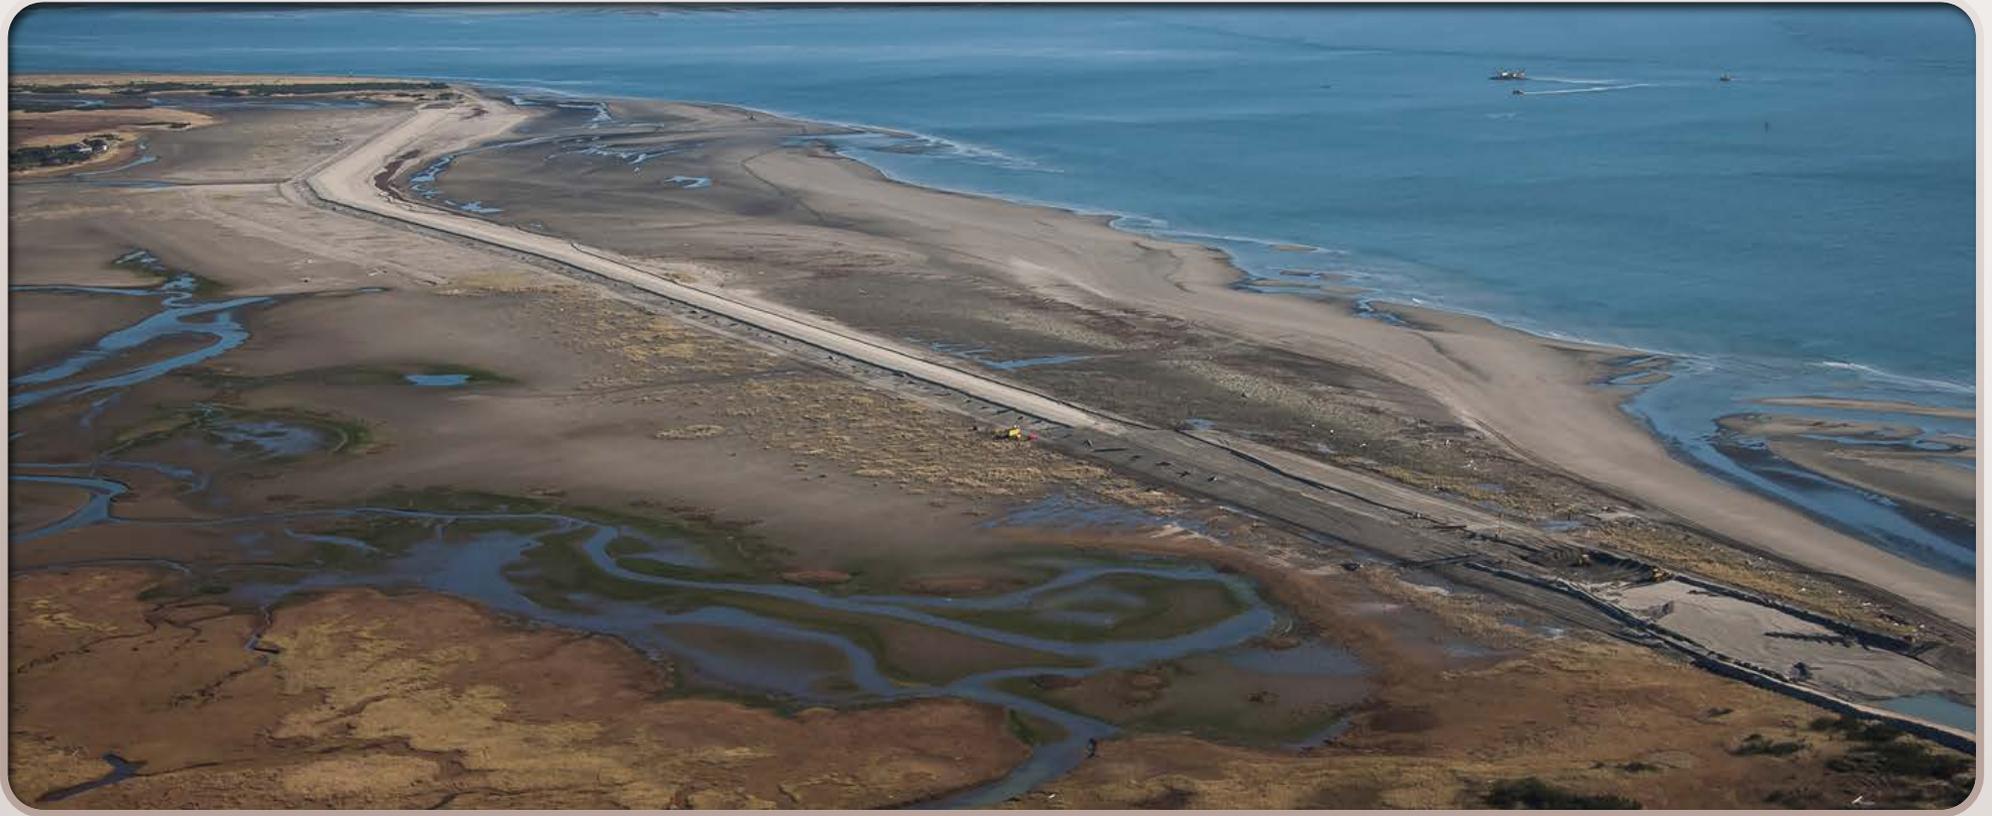
North Dune Completed Late-October 2013

Only 50,000 Cubic Yards Remain At the South Terminus

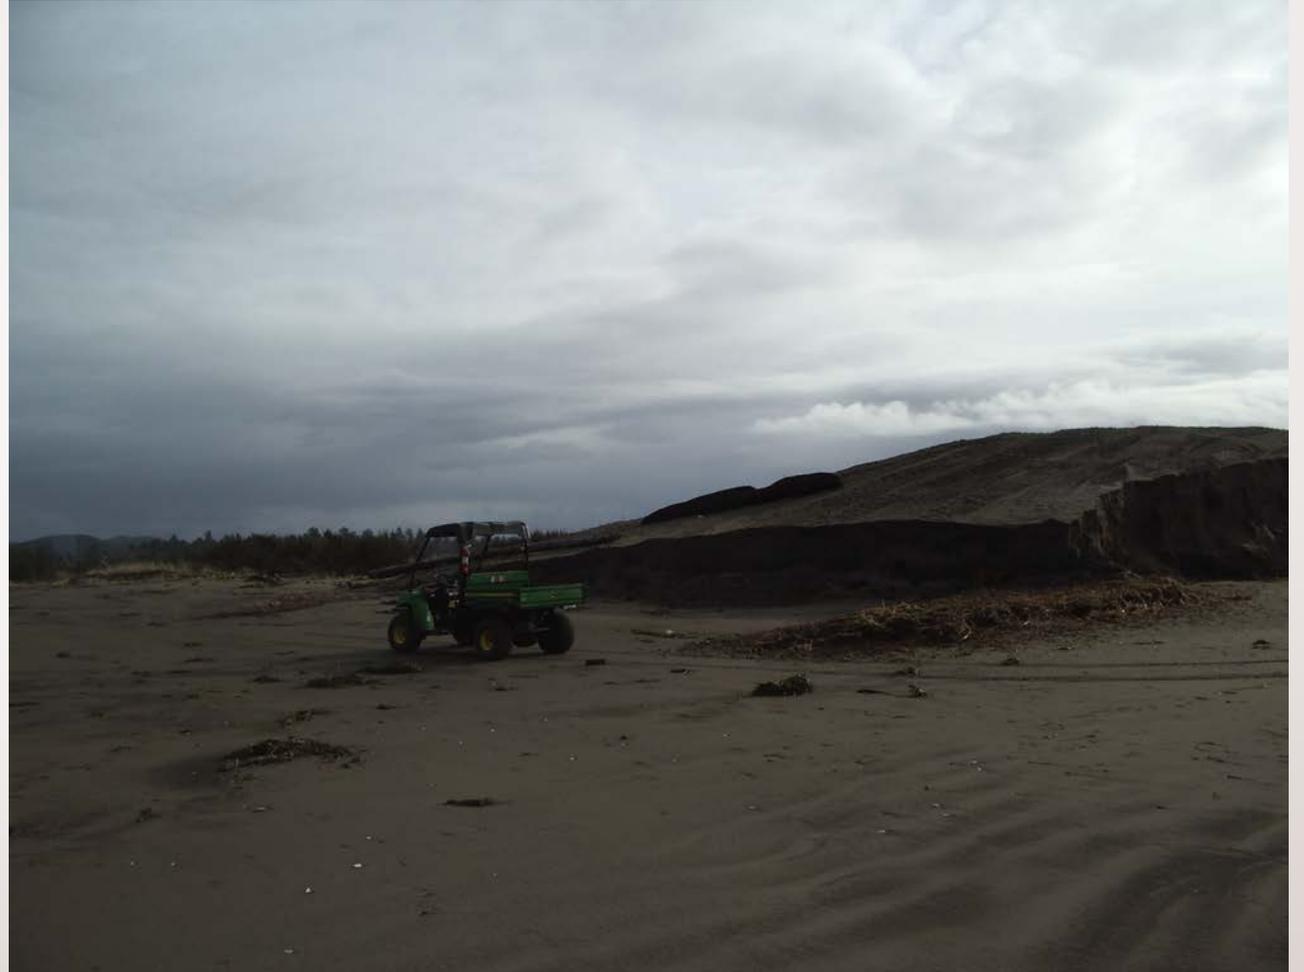
- Dangerous Swells and Seas Linger through November 22
- Weather Broke for 5 Days!
- Dredging Completed Thursday November 28, 2013
A Happy Thanksgiving Indeed
- Significant Storm Erosion Had Already Occurred By End of Dredging

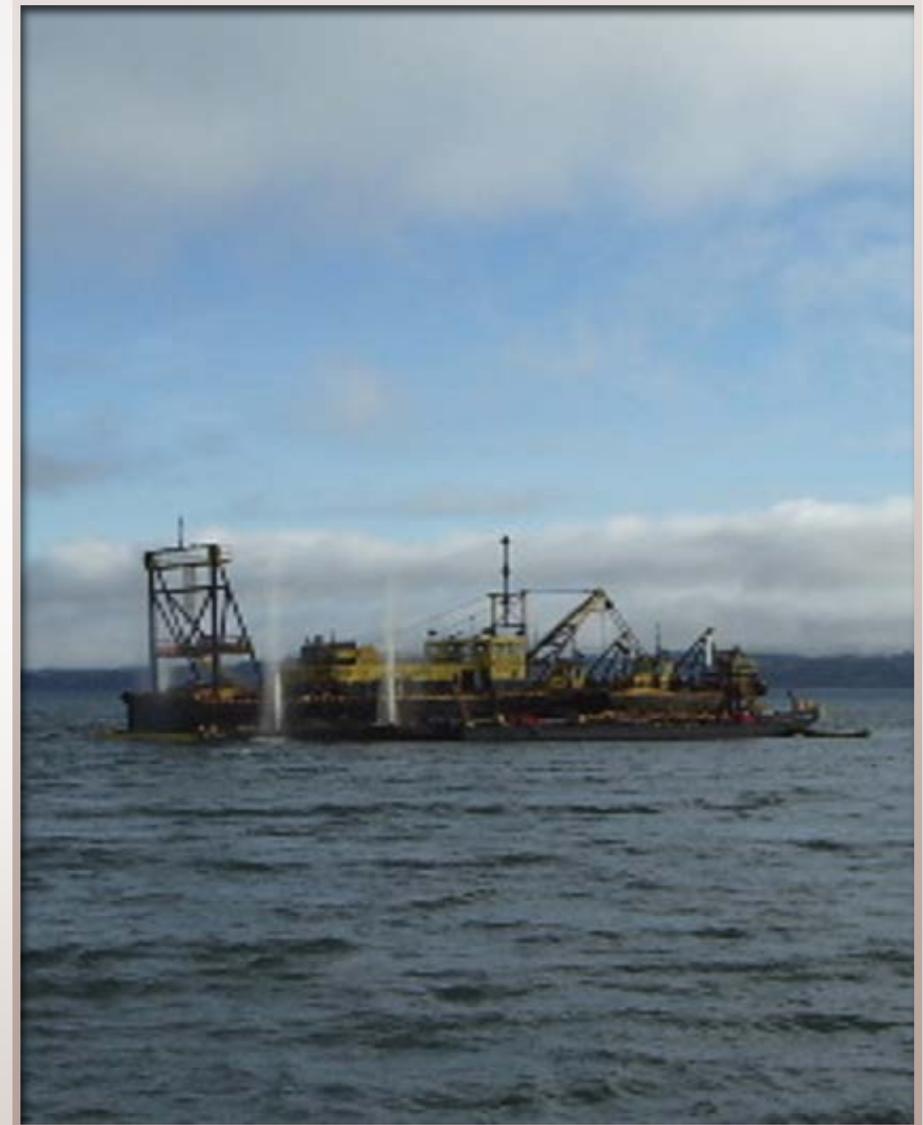
Follow-Up Activities

- Contract Funded Capacity Remained Before Close-Out
- LIDAR Aerial Topo Survey Performed by RIS&G and Supplied to Corps in Mid-June 2014
- Dune Generally Held Up To a Relatively Mild Winter, Other Than North & South Termini
- Wind Erosion Significant in Places +/- 3 Feet Scour From Top of Dune
 - Sand Generally Relocated Immediately In-Shore of Dune
