River Raisin Area of Concern – NAPL Area – Sediment Remediation

Mike Roberts, P.E., CCM, Anchor QEA

WEDA Dredging Summit and Expo 2017
June 26 – 29, 2017

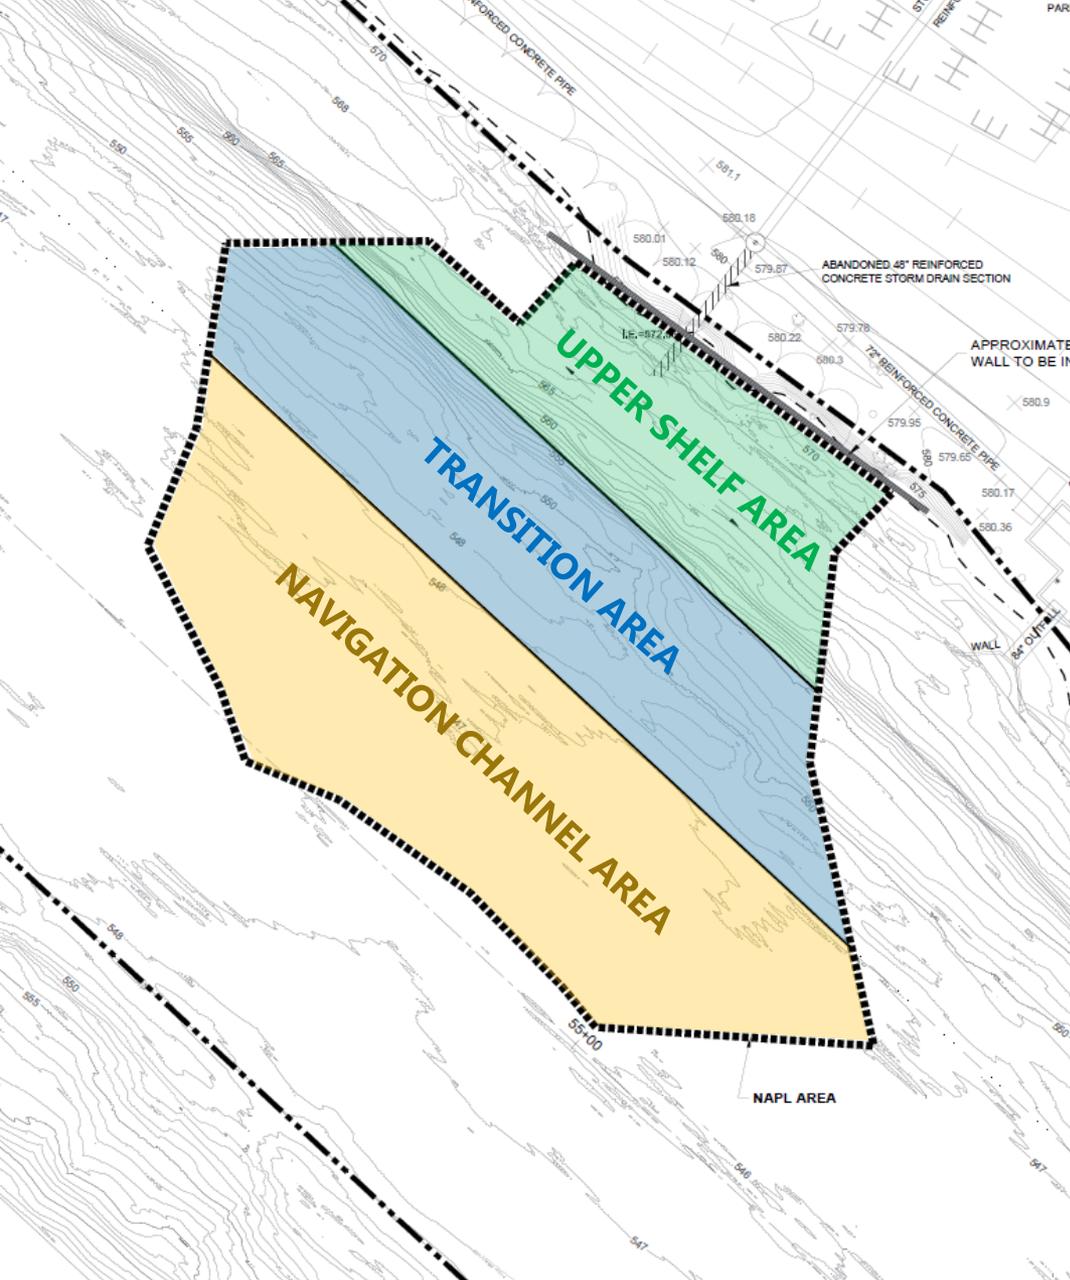
Remedial Design

1. PCBs above 50 parts per million (ppm) and NAPL observed up to 25+ feet below mudline
2. Dredging 8 feet in upper shelf area to remove PCBs above 1 ppm
3. Dredging 10 feet in transition and navigation channel
4. Engineered cap installed in transition and navigation channel after dredging (>10,000 ppm PCBs remain)

- Permanent sheetpile wall along shoreline to facilitate nearshore sediment removal
- Planned dredging of 28,100 cy of sediment
- Upper shelf area includes:
 - Target removal depth of 8.2 feet of material
 - 6-inch residual cover (graded gravel)
- Transition area and navigation channel includes:
 - Target removal depth of 10.0 feet
 - 5-foot cap in transition area
 - 3.75-foot cap in navigation channel

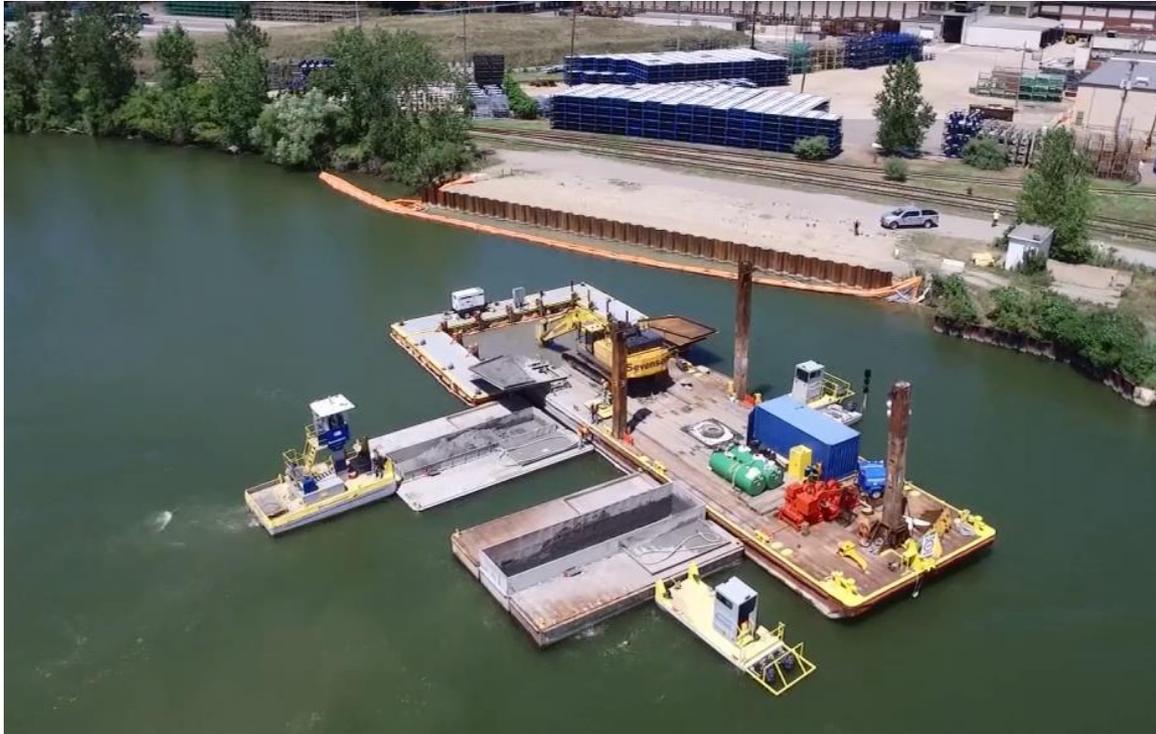
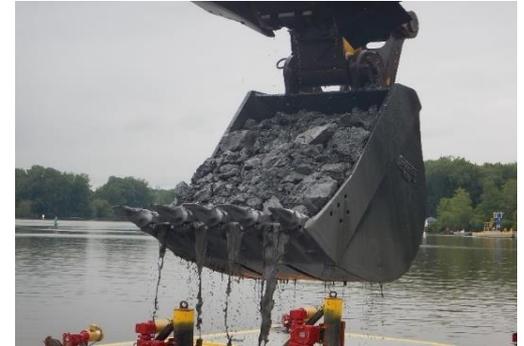
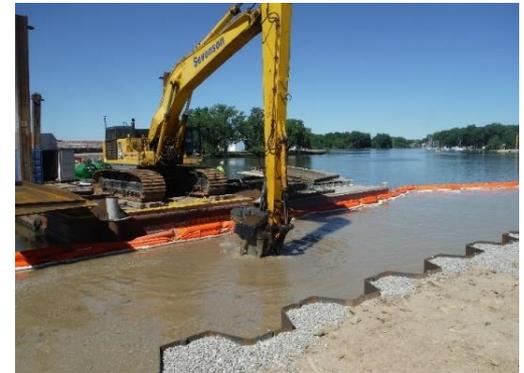
Construction – Dredging

2016 Sediment Remediation at River Raisin¹

- Actual removal was 29,465 cy
- On average, 324 cy dredged per day
- Water depths greater than 35 feet in navigation channel (post dredging)
- Glacial till or weathered bedrock
- Challenging dredging resulted in switching to two 12-hour work shifts 7 days per week

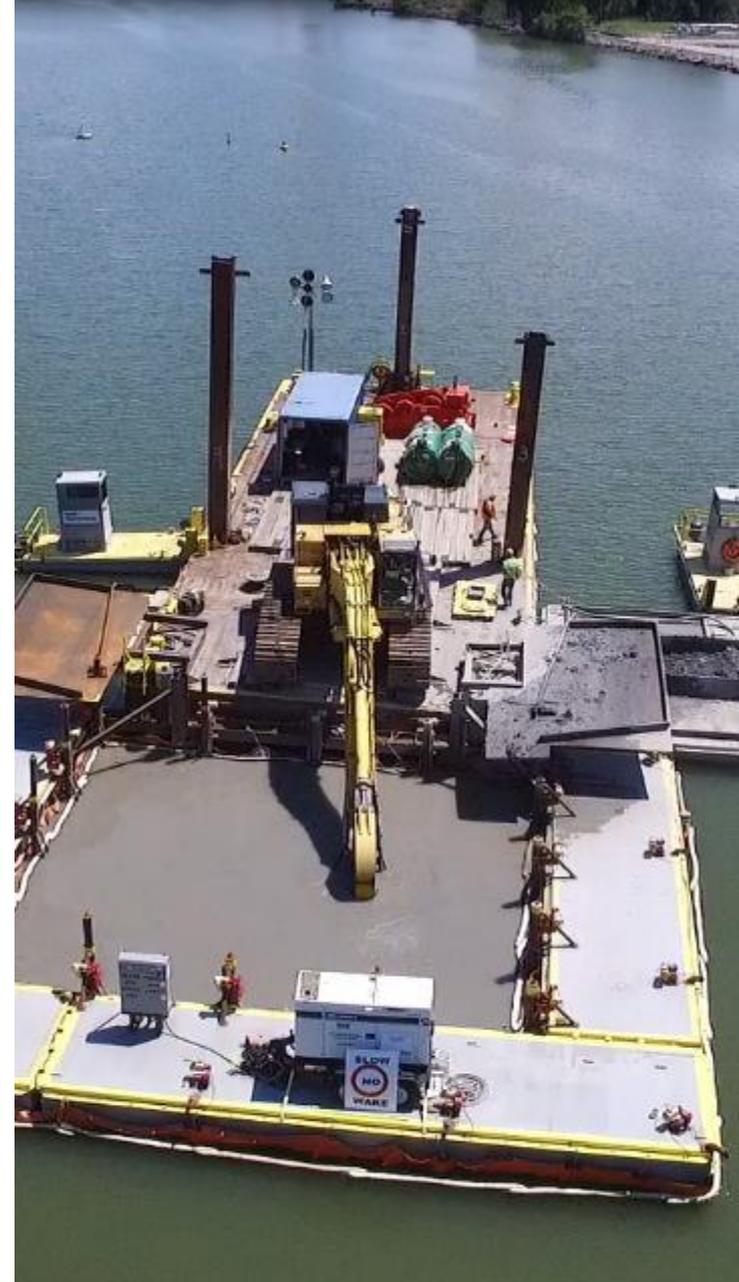
Construction – Environmental Controls

- Dual-curtain system
 - Moon pool
 - Permeable outer curtain
 - Impermeable inner curtain
- Real-time turbidity monitoring
 - Upstream and downstream sensors take readings every 10 minutes, averaged every hour
 - 1 hour average not to exceed 50 Nephelometric Turbidity Units above upstream, or 1.5 times greater than upstream, whichever is greater
 - No project exceedances attributable to dredging or capping

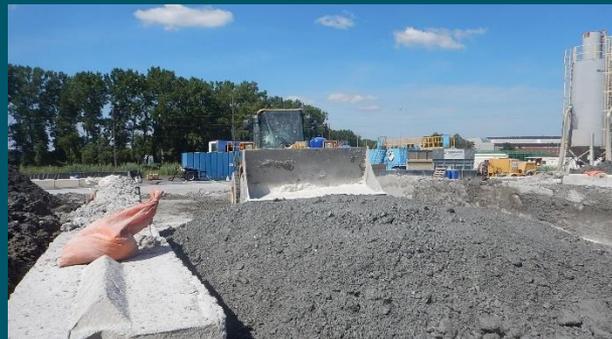
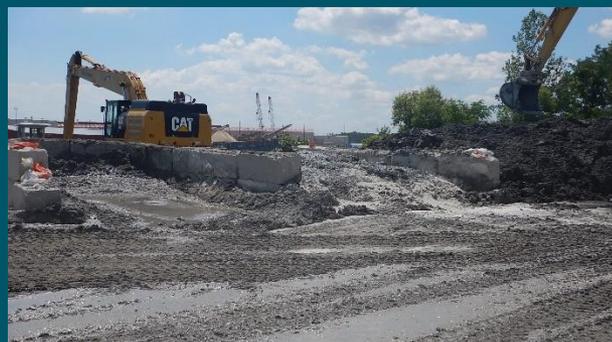
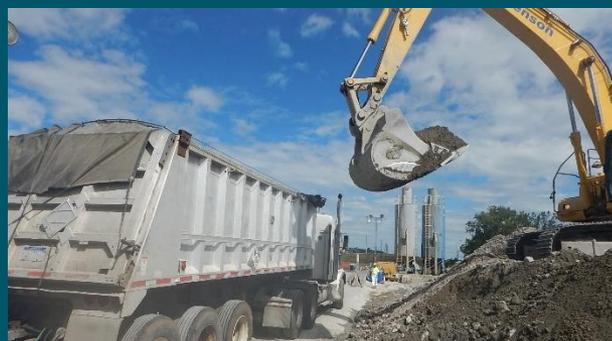
Construction – Stabilization and Disposal

- 62,293 tons of stabilized sediment hauled off site as TSCA waste (1,353 truckloads)
- Calciment® and Type II Portland cement
- Average dosage rate of 6%
- Processed an average 776 tons of sediment each day on a 28,900-square-foot pad

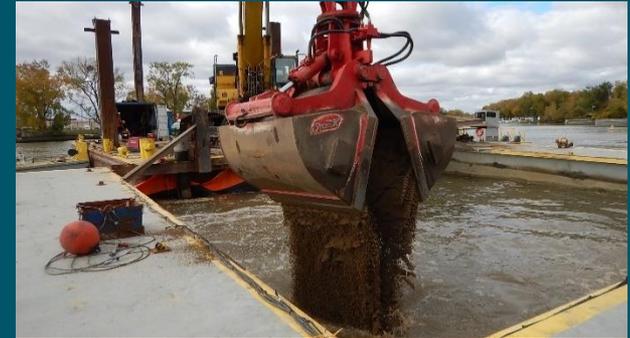
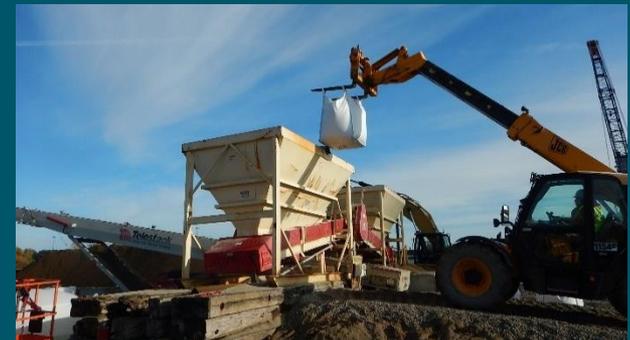
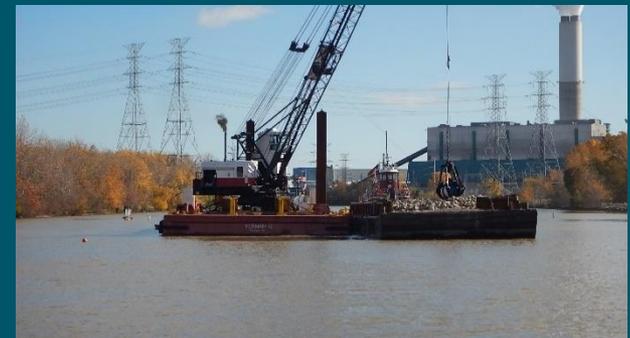
Construction – Capping

- Sand and organoclay blended onshore using series of hoppers, conveyors, and mixing augers
- Heavy liquid separation method used to determine percentage of organoclay in chemical containment layer
- Subcontractor utilized to accelerate cap installation

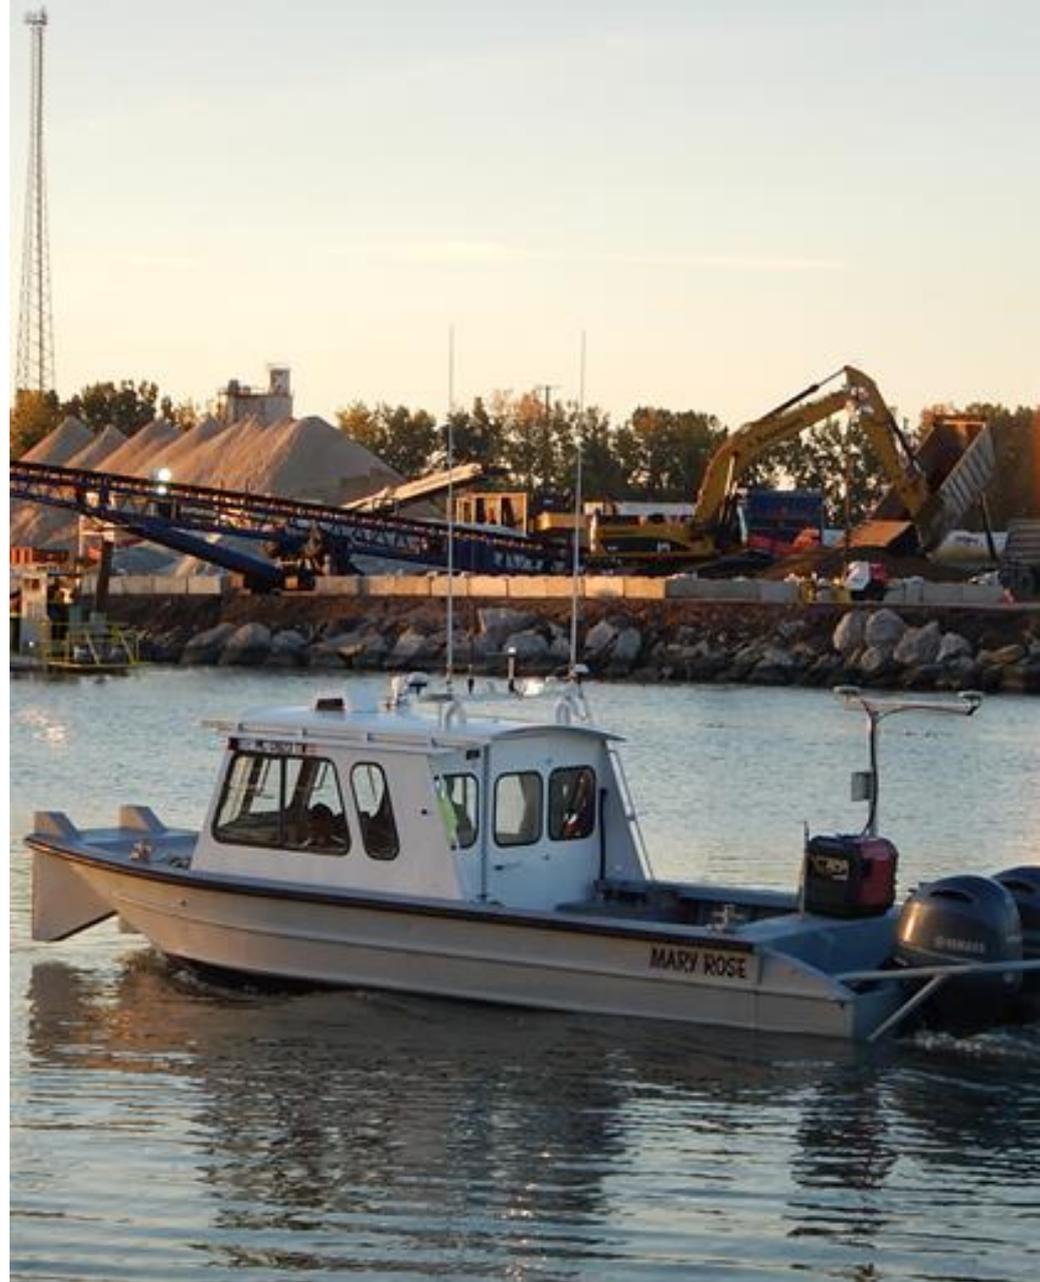
Quality Assurance

- Daily coordination
- Full-time oversight
- GPS control
 - Dredgepack®
 - ClamVision®
- Capping
 - Sand leveling
 - Depth of placement
 - Organoclay content
- Bathymetric survey
