# CHALLENGES ASSOCIATED WITH DREDGING SMALL WATERWAYS IN URBAN SETTINGS

**Jim Hutchens**, Jeanne Tarvin, Victor Magar, WEDA Conference –  
Chicago, IL

June 06, 2019

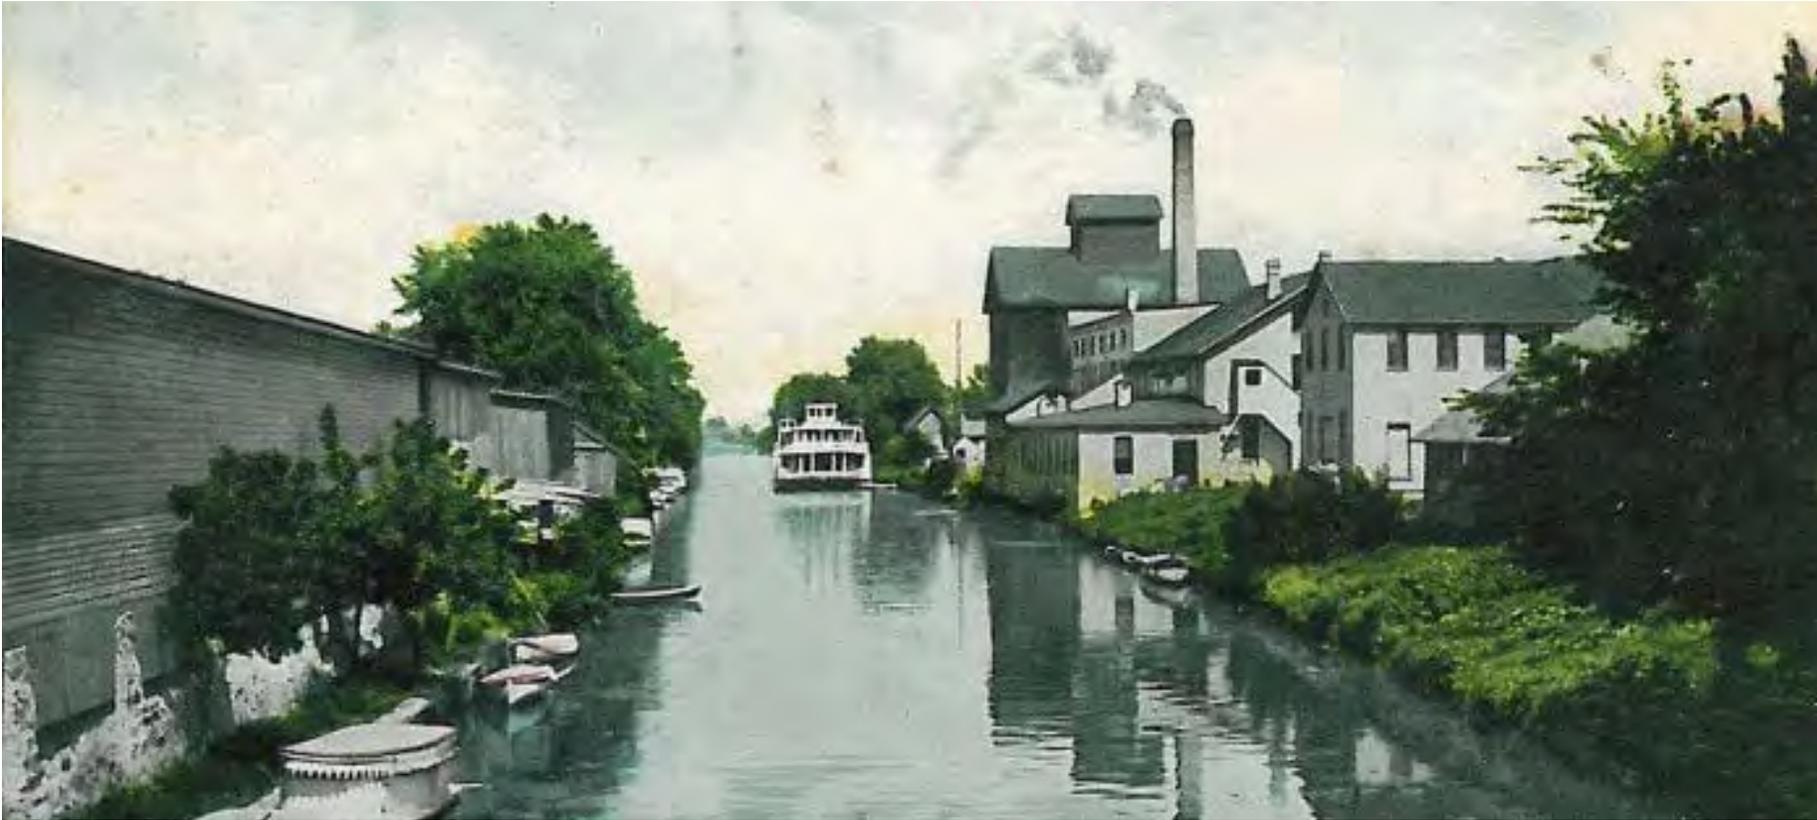
Canal was constructed in mid 1800s as a portage between the Fox and Wisconsin Rivers which allowed access from Great Lakes to the Mississippi River.

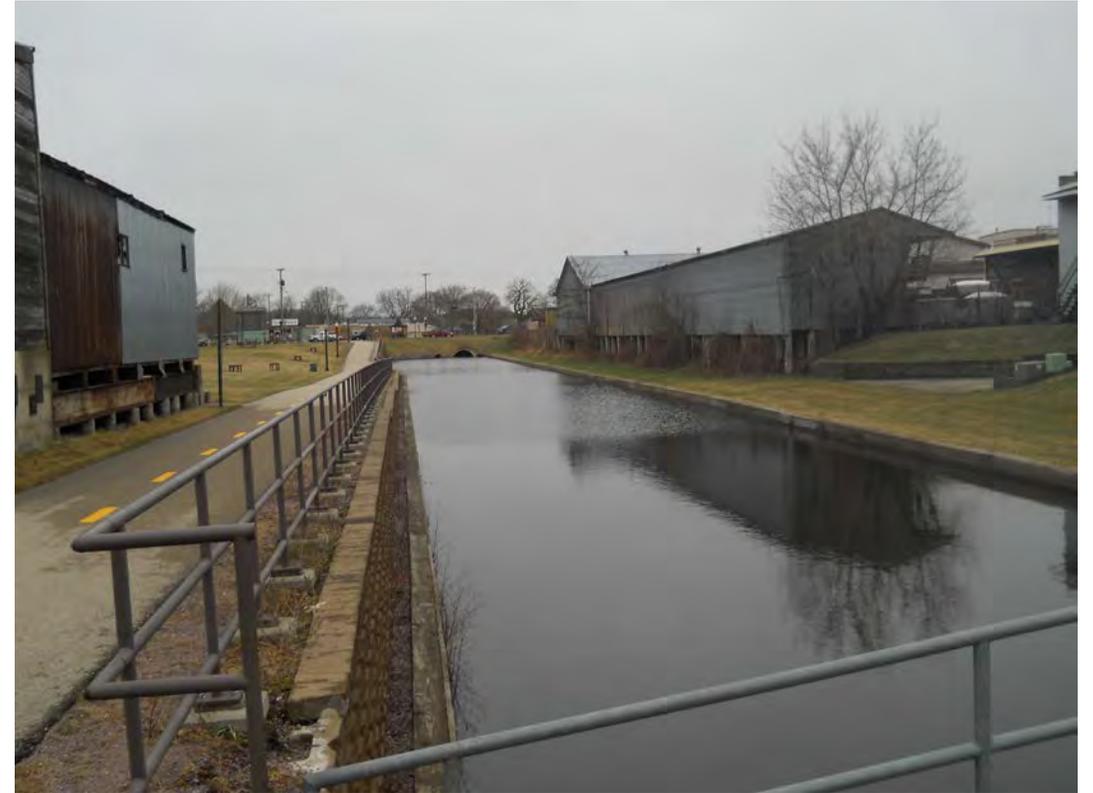
- Contamination including heavy metals, petroleum constituents and PCBs identified during upgrades to the canal in 2002.
- The upgrades performed along segment 1 included new revetment walls and adjacent bike/pedestrian path. Initial dredging closer to Wisconsin River.
- Sediment removal in this area could not be performed during the upgrades due to budget constraints.
- Plans initially projected performing remedial action throughout the remainder of the canal in one project.
- However, due to plans for construction of County office buildings on each side of canal with two walkways across the canal, WDNR made a push to remediate this area on a compressed schedule.

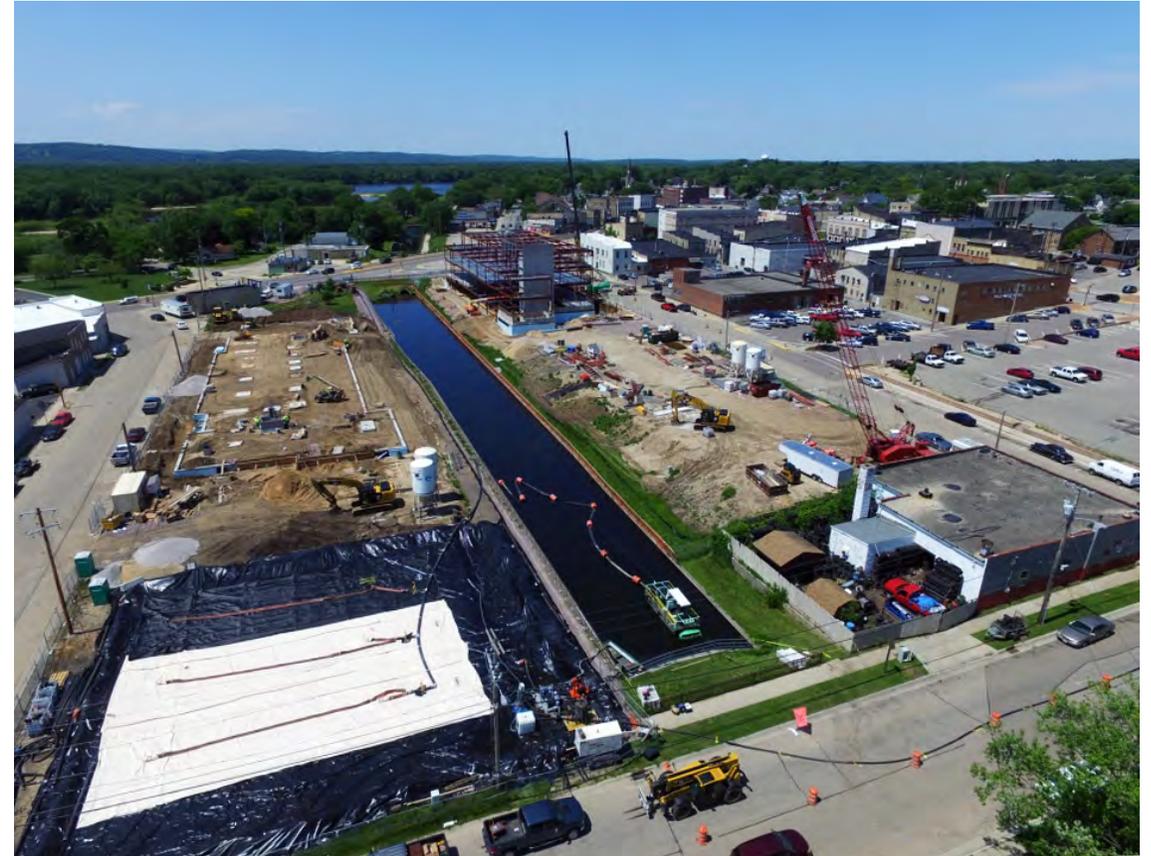
# LIMITED WORK SPACE/TRAFFIC CONTROL

- Project site surrounded by roadways- City required some access on all roads during construction. Single lane access allowed.
- Sanitary discharge location at middle of intersection northeast of property.
- Construction of County buildings limited dredging footprint to eastern end of property.
- IAI was able to install geotubes for dewatering along with water treatment in minimal area.

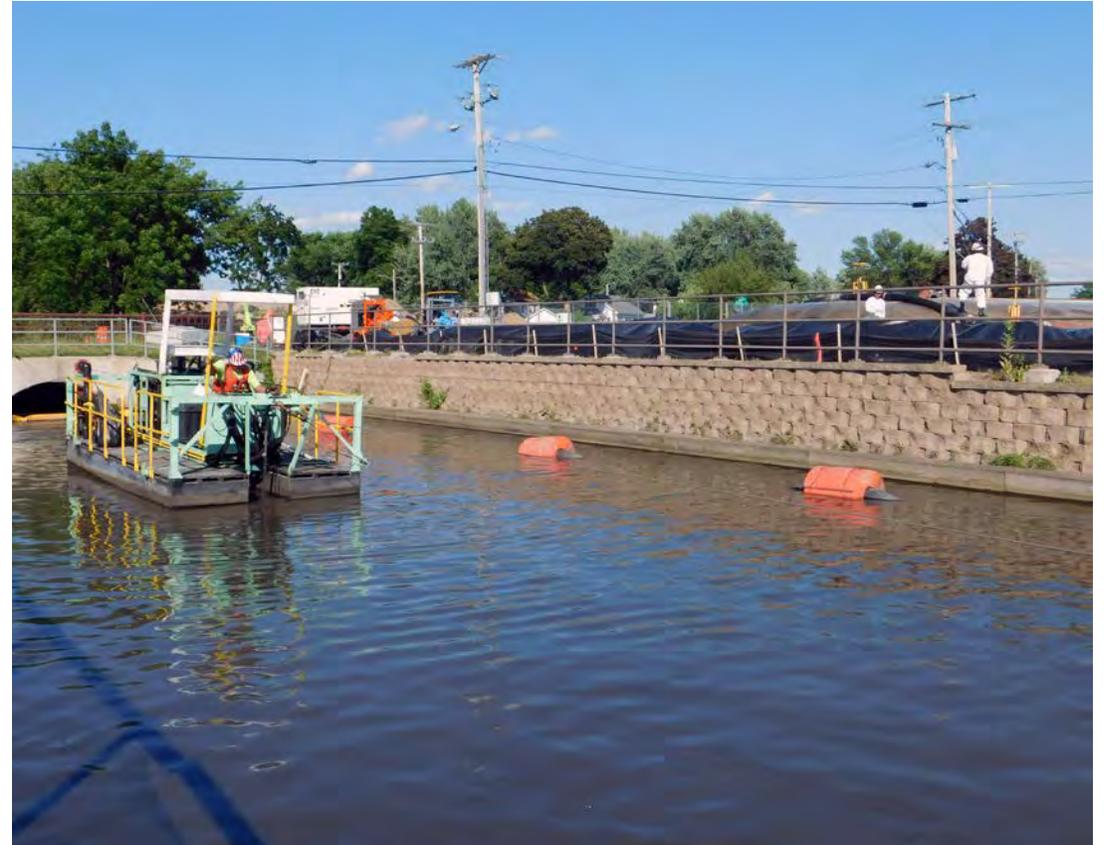
# DREDGING EQUIPMENT

- The canal in this segment is only 50ft wide and water depths of 2-3 feet. Depth of sediment removed up to 4 feet.
- Walls were not constructed to allow heavy equipment or dewatering of canal.
- IAI supplied small horizontal auger hydraulic dredge which allowed site crane to set equipment while maintaining safe distance from walls.
- Dredge moved with drive cables installed along canal

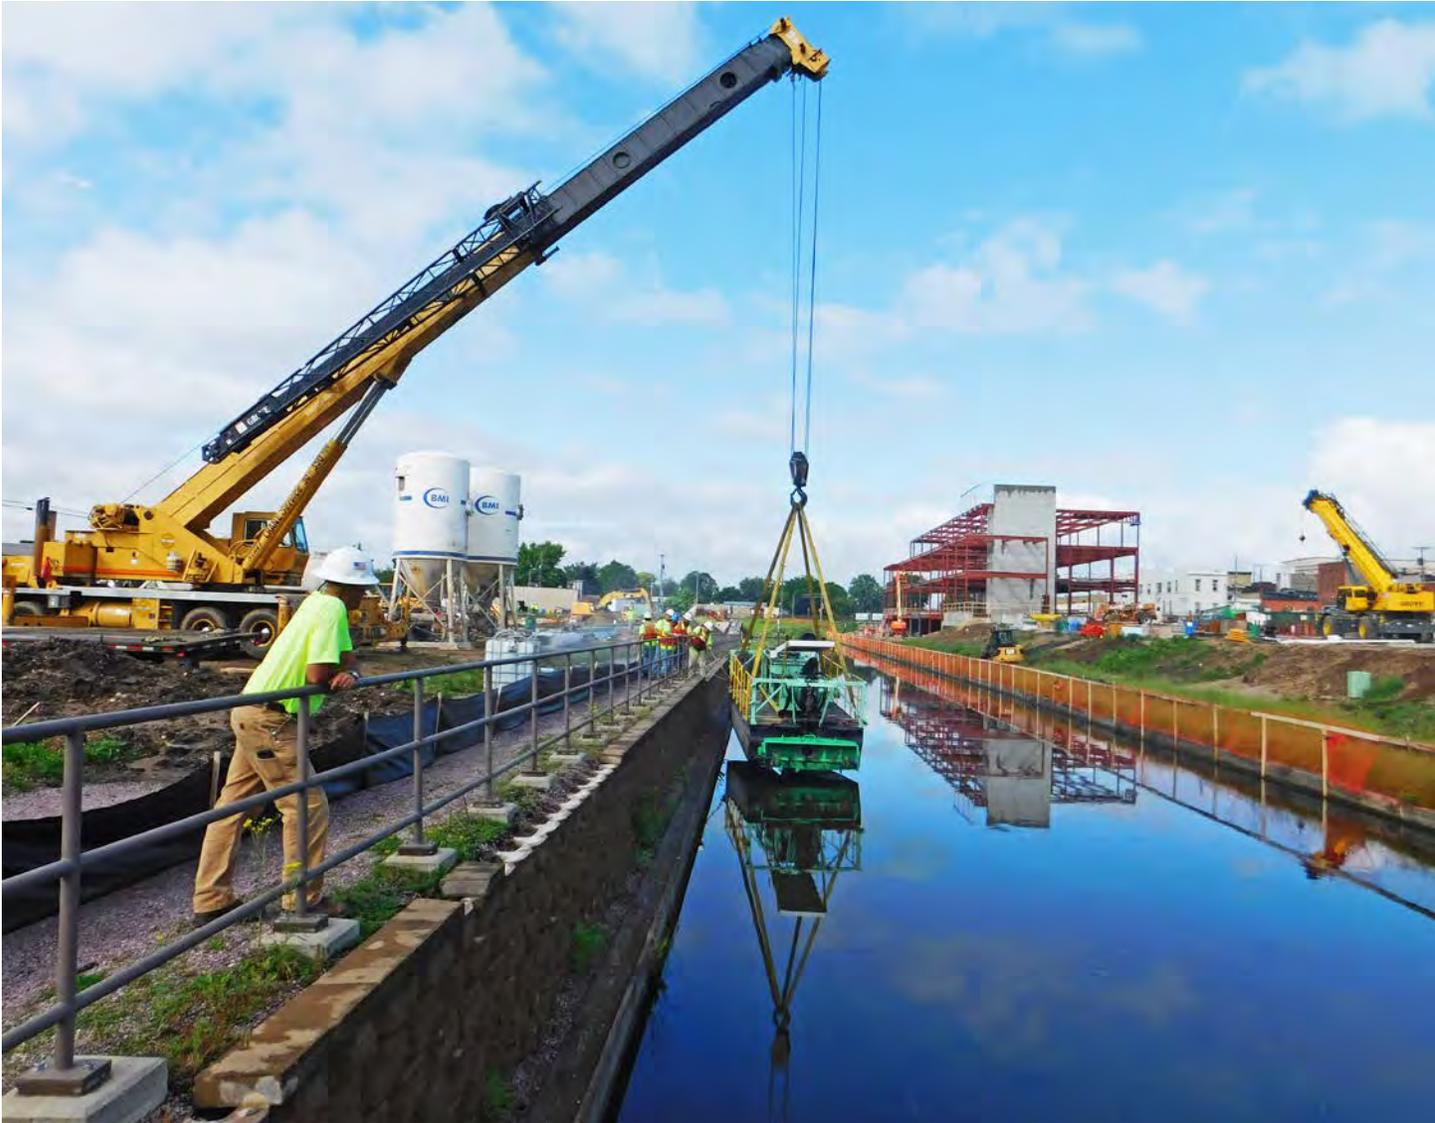
# SETTING DREDGE INTO CANAL

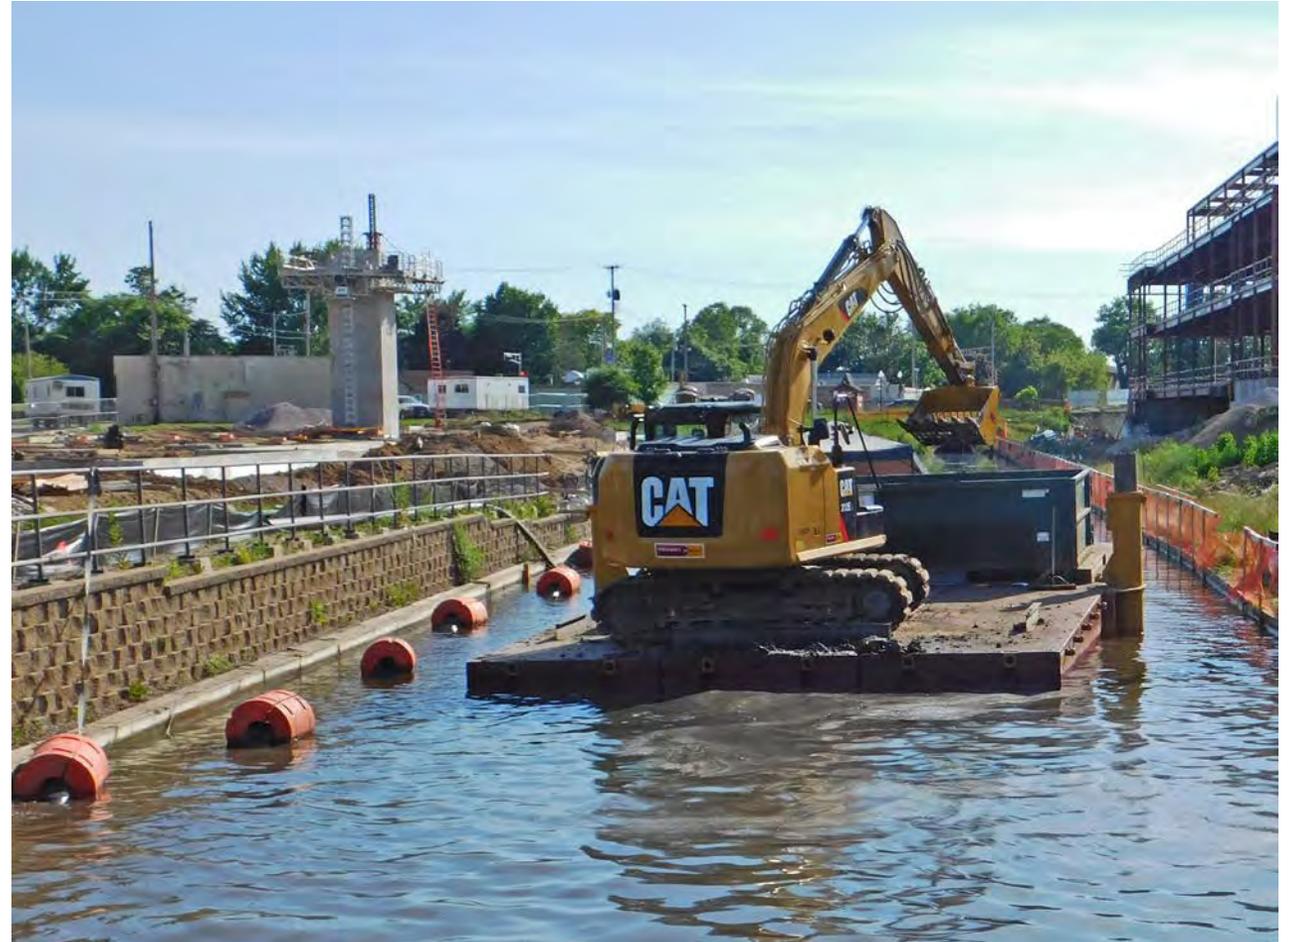
# BURIED DEBRIS

- Based on visual observation and previous sampling minimal debris anticipated.
- Due to the actual amount of debris encountered, dredging stopped and a raking operation brought in by IAI.
- Debris encountered included bicycles, bottles, cables, concrete, deer antlers, brake pads, wood, garbage bags, retaining wall bricks, scooters, shoes, socks, tires and traffic cones.
- Debris raking operation from modular barges throughout canal also allowed loosening compacted material for easier dredging.

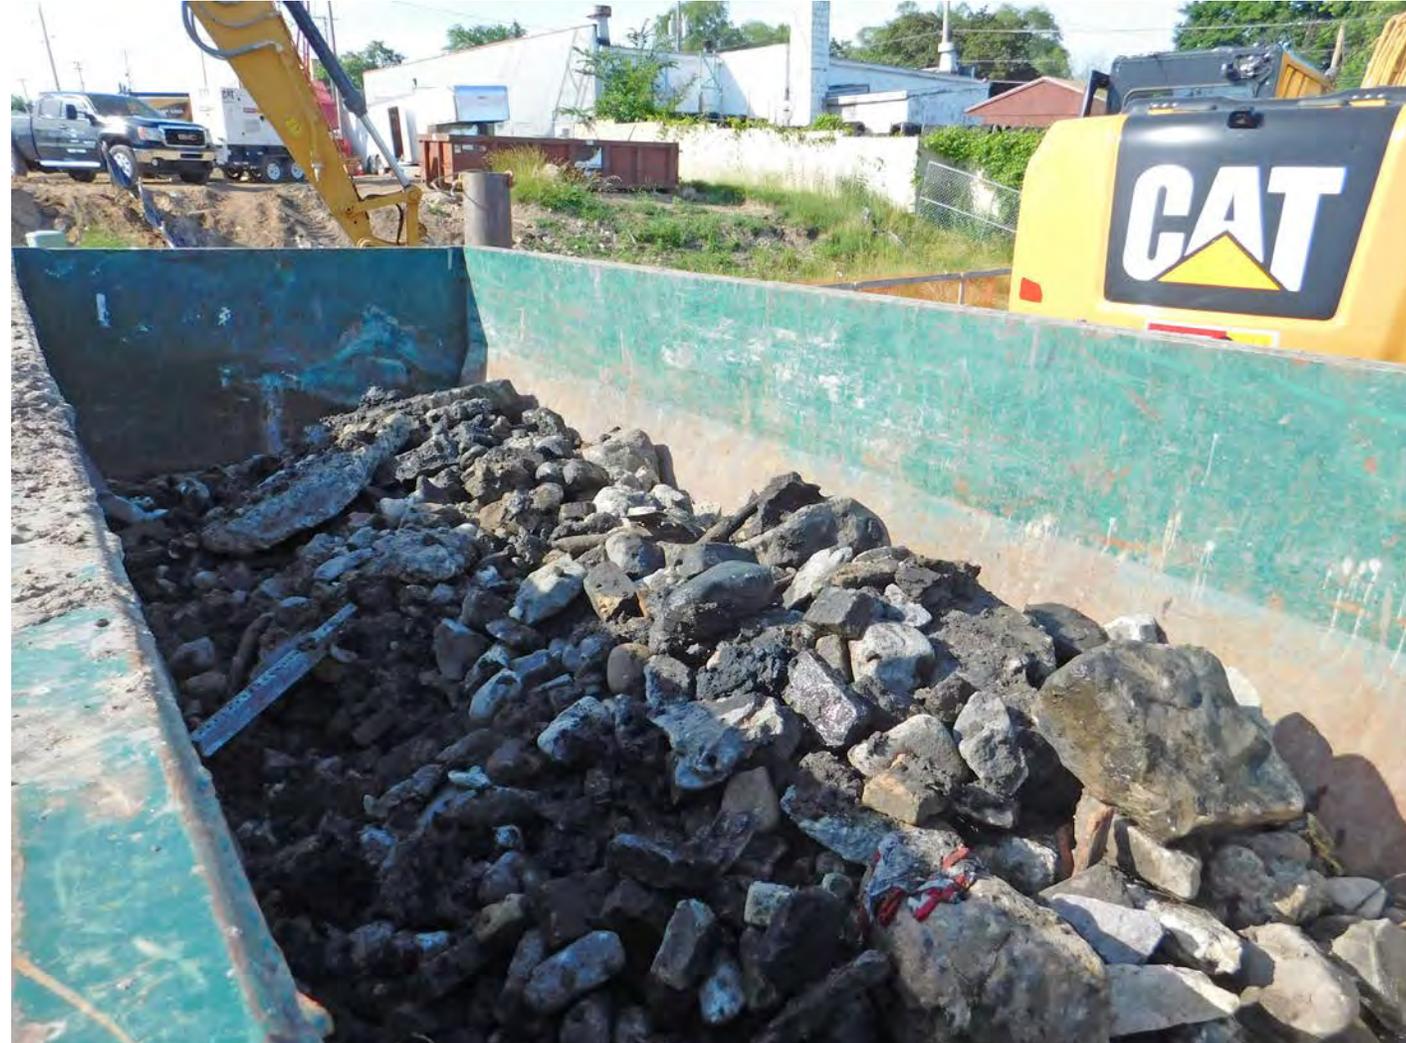
- Five roll off boxes of debris removed from site.

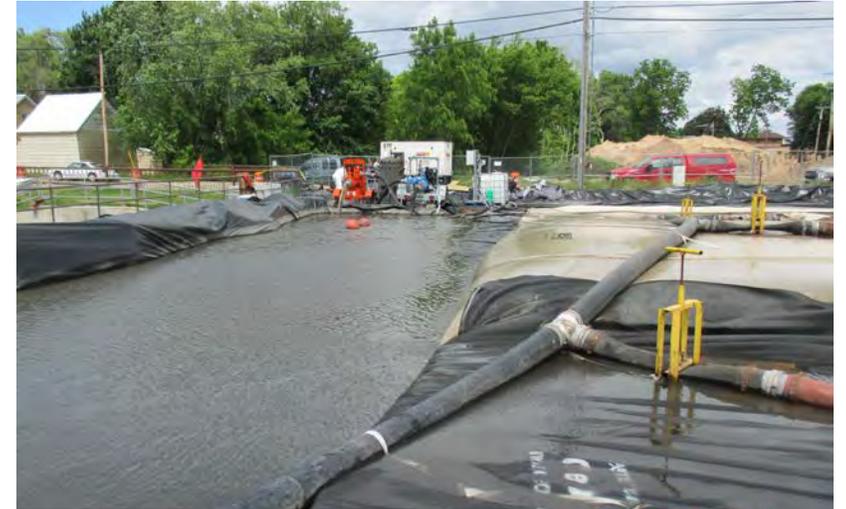
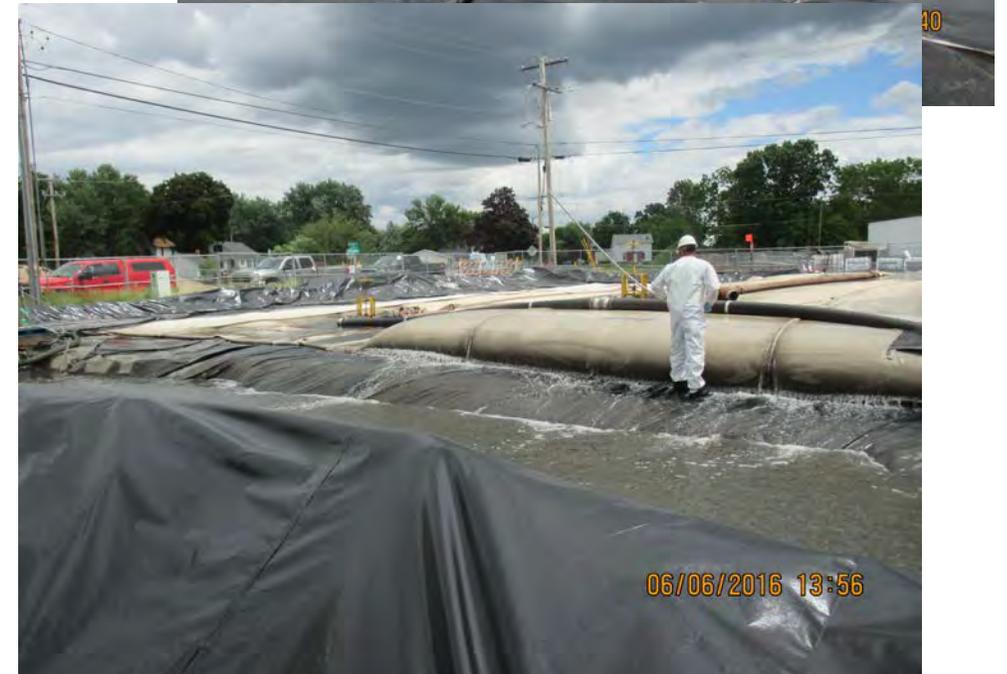
# SEDIMENT DEWATERING

- Based on site location sediment required on site dewatering.
- Dewatering pad scheduled for dismantling and redevelopment within two weeks of completion of dredging.
- Dewatering included
  - Construction of dewatering pad limited to 15,000 sf. Filter tubes constructed to fit within dewatering pad.
  - Dredge slurry pumped into bags through polymer injection system.
  - Excess water from filter tubes collected within sump in lined pad
  - Water pumped from sump to sanitary manhole and to City treatment plant

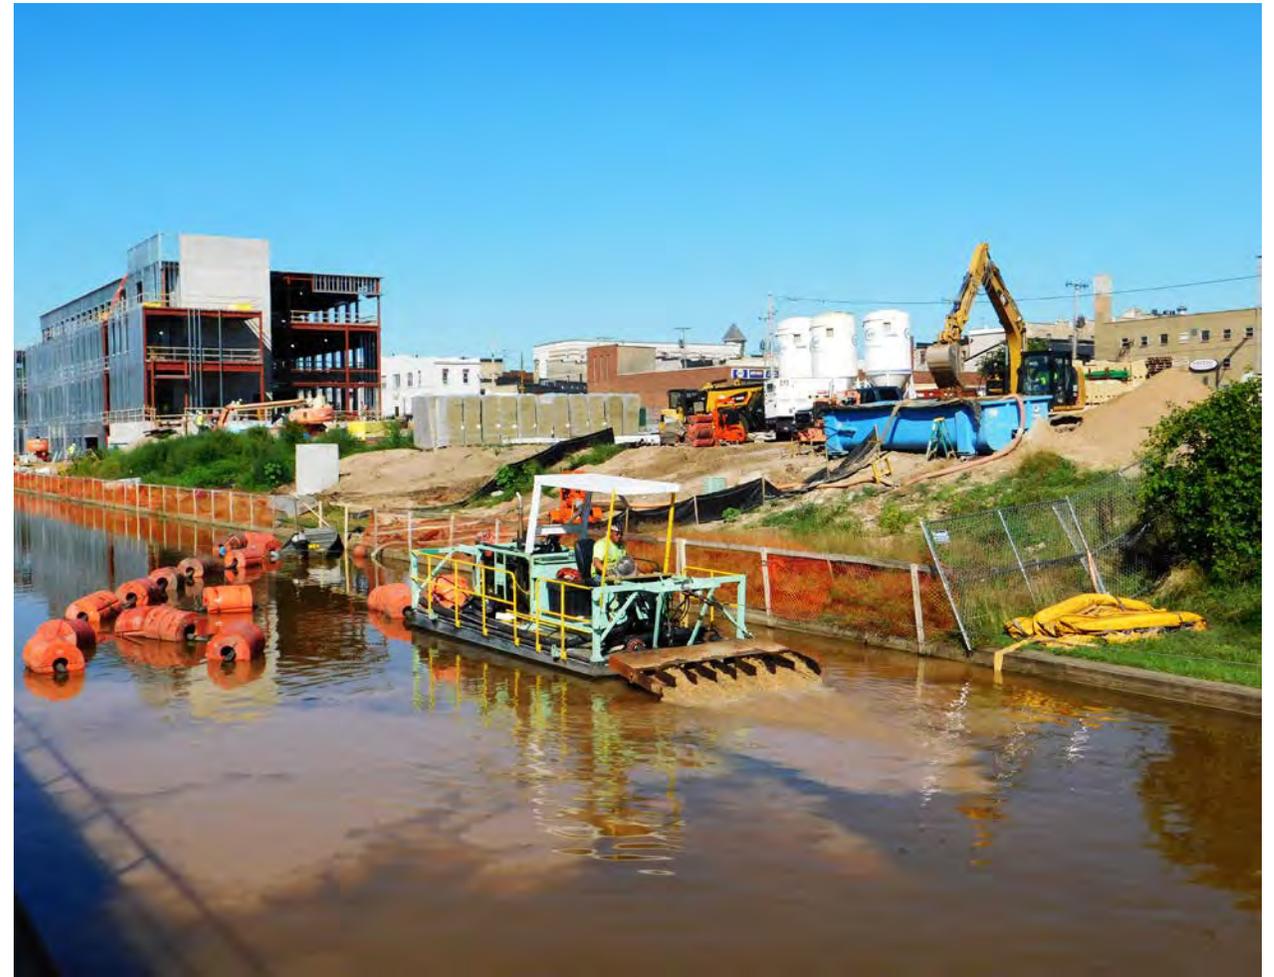
# CAPPING CONSTRAINTS

- Initial sand supplied by City had a large amount of debris and clay clumps
- Had to switch to quarry run material.
- Due to construction activities and wall weight restrictions had to be placed from water.
- Able to utilize same dredge barge equipped with pan for even placement
- Sand put into slurry and pumped to dredge
