MAINTENANCE DREDGING IN A SENSITIVE ENVIRONMENT CASE STUDY: MANCHESTER ENTRANCE CHANNEL

Carlos G. Peña, P.E.¹

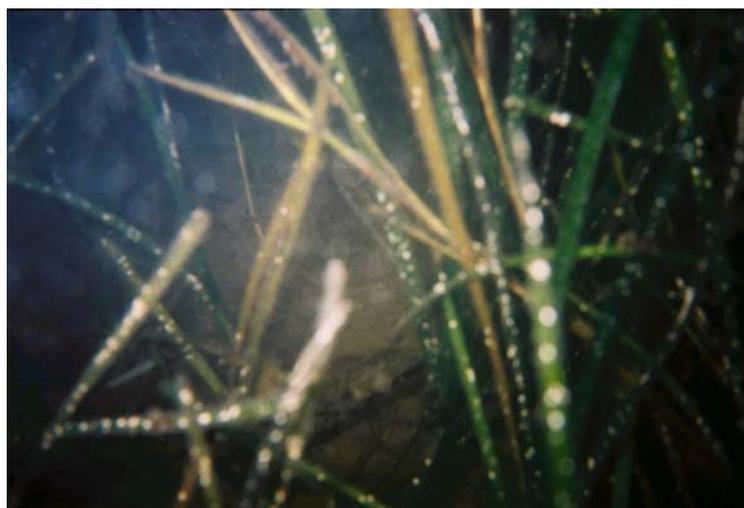
Figure 1: Typical Eelgrass Bed in New England

In New England an eel grass habitat is usually found along protected bays and harbors in water depths ranging from -1.0' below Mean Low Water to a depth exceeding 18' in the coastal regions in Manchester Harbor. According to Burkholder and Doheny (1968) eelgrass flourish when water temperatures range from 10°C to 20°C and a salinity range from 26 ppt to 42 ppt. Eelgrass is a deciduous marine plant commonly referred to seagrass, crabgrass and grass wrack. The plant produces roots, stems, leaves, flowers and seeds. The leaves typically grow from 12" to 48" depending on the habitat characteristics and photosynthesize carbon dioxide in seawater into oxygen. Eelgrass populations grow by reproduction and vegetative growth. Reproduction growth includes the maturation of pollen grains and ovaries, shedding of pollen into the water, pollination, fertilization and the formation of mature fruits with seeds (Burkholder & Doheny 1968). The vegetative growth includes the development from seed, turion and lateral bud formation, up to and including the production of flowering shoots with buds (Burkholder & Doheny 1968). The development cycle of a plant is typically three (3) years, beginning with the seedling and the formation of a terminal bud the first year, the growth of a flowering shoots and the lateral vegetative shoots the second year and the sprouting of rhizomes and geometrically expansion the third year. The plant is perennial and lives for many years.

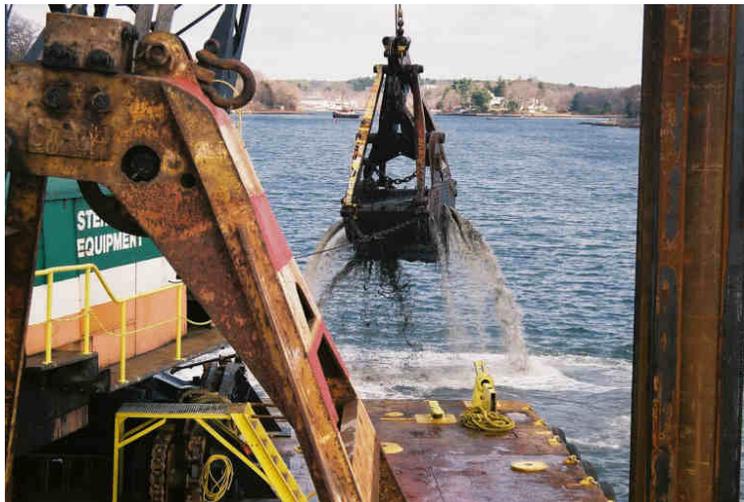
Figure 2: Clamshell dredge in the channel

The dredging project was completed in the winter of 2001 by the contractor Jay Cashman, Inc. utilizing an eight (8) yard clamshell dredge and a 2000 cy dump scow (Figure 2) with offshore disposal. The dredge area was limited to only specific areas and no dredging of the channel side-slopes. Additional restrictions included a no-spud zone within 25' of the buried sewer outfall line. The specifications also include the contractor to use a DGPS system with HYPACK software to provide positioning for the dredge and log dredge production activities. The contractor completed the work ahead of schedule and was very diligent in abiding by the permit conditions for the project.

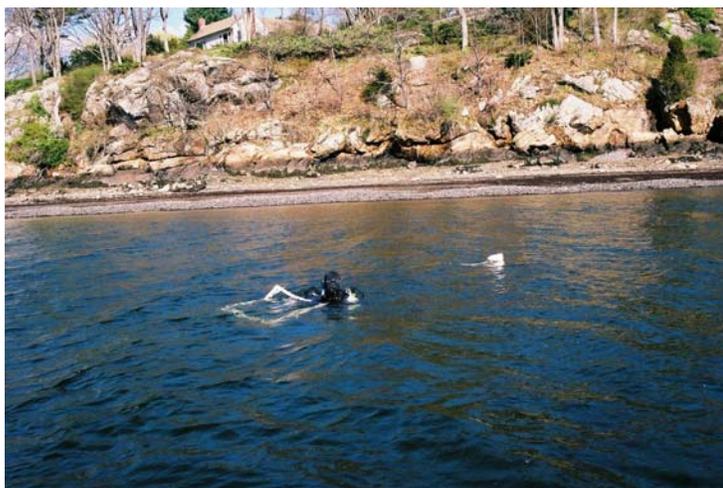
Figure 4: Diver Performing Eelgrass Inspection at Buoyed Location

The August 16, 2001 CLE's pre-dredge survey confirmed eelgrass populations at target locations C-1, S-8, S-7, S-6, S-4 and near S-3 & S-1. The underwater eelgrass assessment was conducted by a P.E. diver utilizing scuba equipment with an underwater camera from our survey vessel (Figure 4). The eelgrass studies are performed at ten (10) specific locations ranging in water depths from 10' to 18', eight (8) in the channel and two (2) control locations outside the channel area. The CLE team deploys ten (10) buoys at the locations using the DGPS system and then dives to each site and records the number, length and vitality of each representative eelgrass community. The assessment targets were located using DGPS positioned survey vessel and a buoy was placed at each location prior to diving activities. The diver dove at each assessment location, placed a one (1) meter grid on the seabed, photographed each referenced location and noted the density, length and color of eelgrass populations and a topside engineer recorded all data for this report. Presently we have completed three (3) studies and already trends are developing as the eelgrass community recovers from the dredging activity and repopulates the dredge area. Evidence prior to the dredging activity indicated the channel area made a complete recovery following past dredging projects and the installation of the said sewer outfall pipe. The preliminary results of the data so far show the eelgrass repopulating the channel areas. Equally spaced rhizome shoots sprouting and becoming denser once the initial plants establish themselves in a specific location characterize the migration of eelgrass plants across the channel.
