WISCONSIN RIVER AND PFIFFNER PIONEER PARK POND REMEDIATION

Western Dredging Association (WEDA)
Environmental Excellence Award Submittal

Wisconsin River and Pfiffner Pioneer Park Pond Remediation

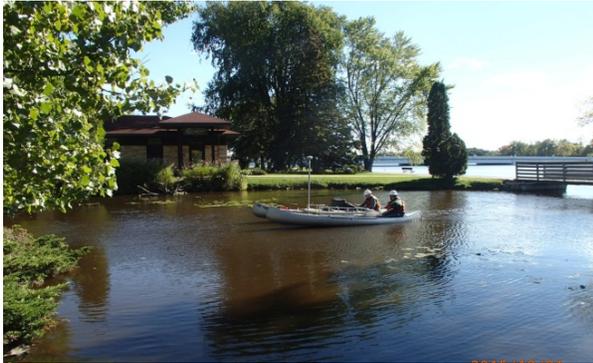
Photo 1: Baseline survey of the Pond

Bathymetric surveying was performed to document the dredge surface and develop elevation contours for comparison to the design dredge prism. Bathymetric surveys were performed using a 200 kHz single-beam echo sounder and a laptop PC with Hypack® Hydrographic Survey software was used for data acquisition and boat navigation.

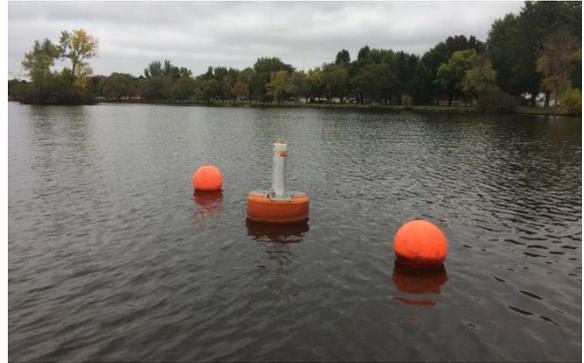
Photo 2: Solar powered remote monitoring buoy

Solar powered remote monitoring buoys with nephelometer sondes were located upstream and downstream of the work area to ensure potential sediment disturbance during dredging and capping activities did not exceed the site-specific criteria of 70 NTU above upstream conditions. Site-specific turbidity was correlated to TSS concentrations through sampling and laboratory analysis. Upstream turbidity and downstream turbidity readings were continuously collected on 30-minute intervals throughout the duration of the project. Turbidity monitoring showed the remedial construction activities were performed to prevent significant impairment to the water quality.

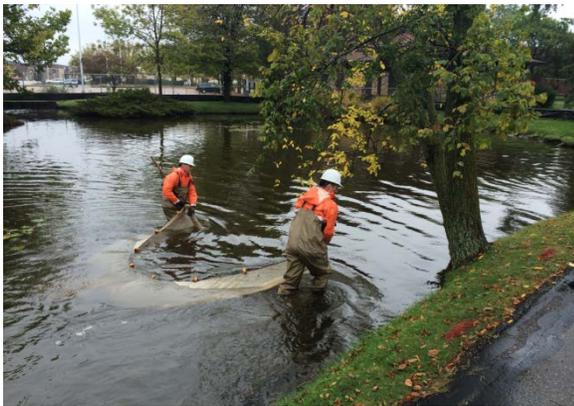
Photo 3: Checking Pond for turtles or other aquatic animals

in collection of turtles and no evidence of turtles or other aquatic animals in the Pond were observed during dredging. Several logs in the Pond near an adjacent public arts center building were removed prior to dredging and replaced after cap installation to accommodate the fish and turtle habitat.

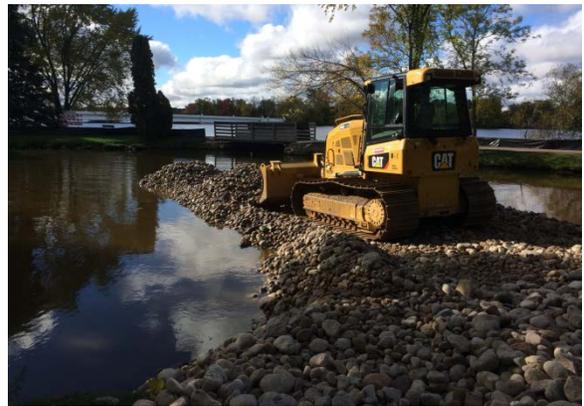
Photo 4: Construction of temporary causeway in the Pond

Pond access was restricted by trees, landscaping, pedestrian walkways, and an art center building. Therefore, a temporary causeway was constructed in the Pond for heavy equipment to access and to mechanically dredge the Pond. The causeway was removed as Pond dredging was confirmed to achieve the design depth required for cap installation without reducing the Pond depth. Following dredging a minimum 15-inch thick adsorptive cap was installed in the Pond.

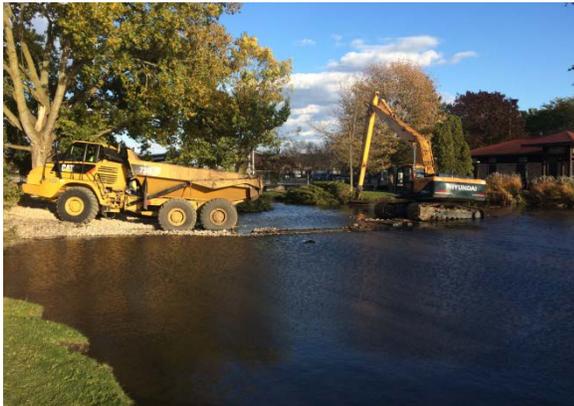
Photo 5: Pond dredging

Mechanical dredging was performed with an excavator with environmental bucket outfitted with state-of-the-art RTK-GPS positioning equipment, locational sensors, and Hypack Dredgepack®. The excavator completed Pond dredging from the ground surface or from a temporary causeway. Dredging the River required barge-mounted equipment.

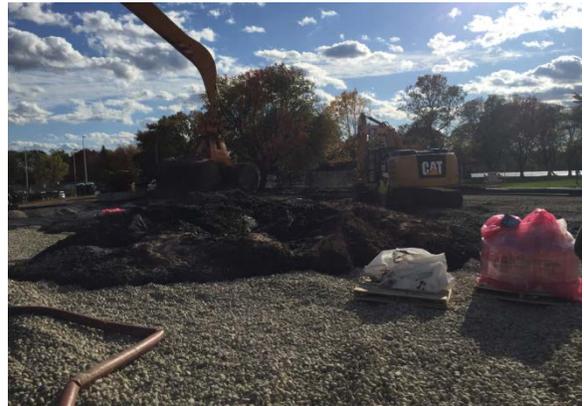
Photo 6: Sediment stabilization using Calciment

Dredge material was transported to the upland contact water management pad and stabilized prior to transportation to the landfill for disposal. Debris encountered during dredging was also landfilled. Dredge material contact water collected from the contact water management pad was batch-treated by Infrastructure Alternatives Inc. (IAI) with a mobile on-site treatment system to meet permit requirements prior to discharge to the Wisconsin River.

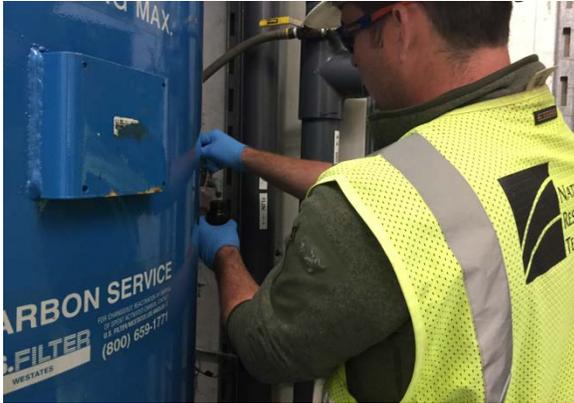
Photo 7: Collecting treated water sample for laboratory analysis

The onsite portable mobile WTP was enclosed in two semi tractor-trailers and capable of 150 gallons per minute (gpm) capacity. The mobile WTP included an inclined plate separator, sand filters, bag filters, and granular activated carbon (GAC) vessels, pumps, hoses, and ancillary tanks. Effluent water was batch treated and held in a tank until laboratory analysis confirmed constituents were below the discharge limits. The onsite mobile water treatment system consistently treated water to well below the discharge limits.

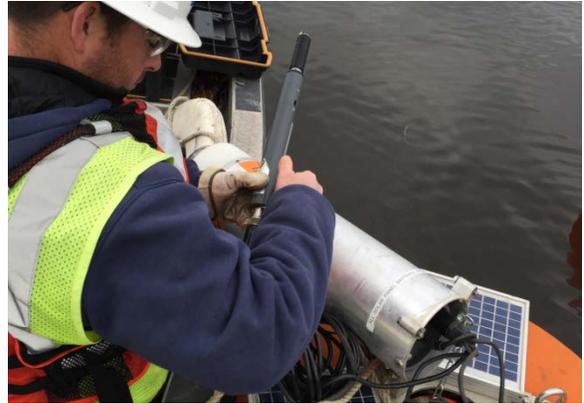
Photo 8: Calibrating turbidity buoy

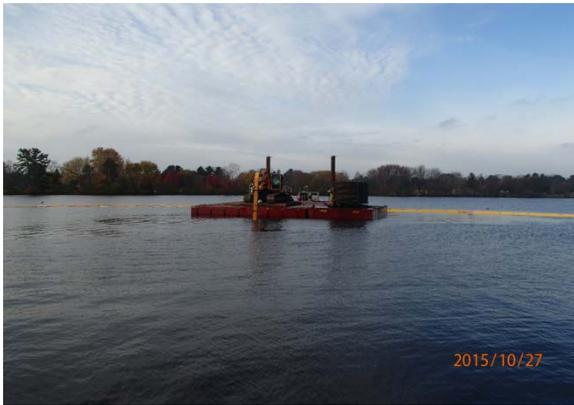
Photo 9: River dredging

River dredging encountered unanticipated non-aqueous phase liquid (NAPL) in a small area below the design dredge prism. Additional dredging was not possible due to the proximity to the shoreline and possibility of destabilizing

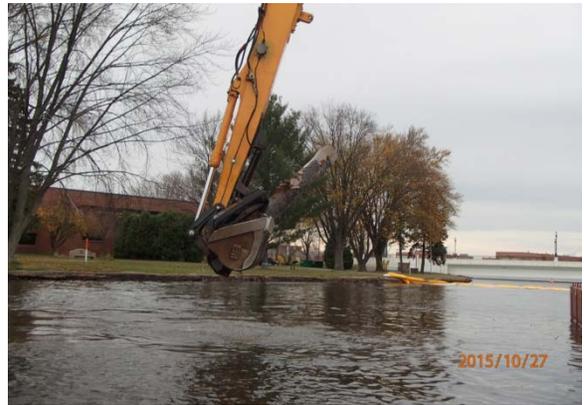
Photo 10: Debris removal from River

Mechanical dredge positioning equipment minimized over-dredging while ensuring removal of target material. Mechanical dredging optimized production due to the numerous debris encountered and the size of debris (e.g., large rocks and logs from previous forestry practices).

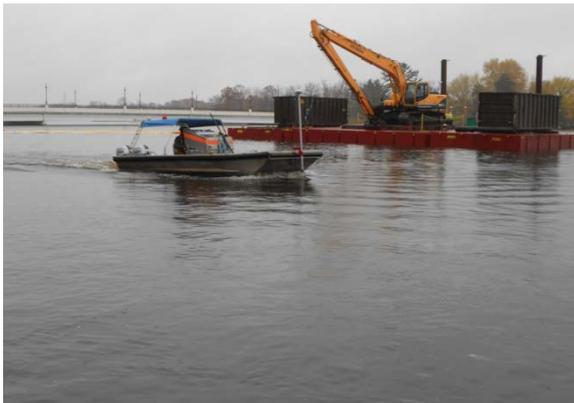
Photo 11: Hydrographic surveying River dredge area

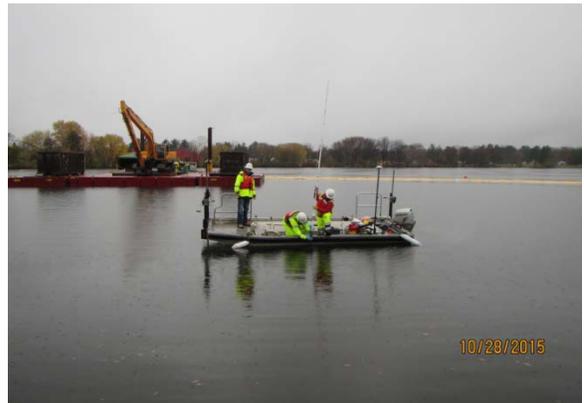
Photo 12: Collection of dredge confirmation sampled for laboratory analysis

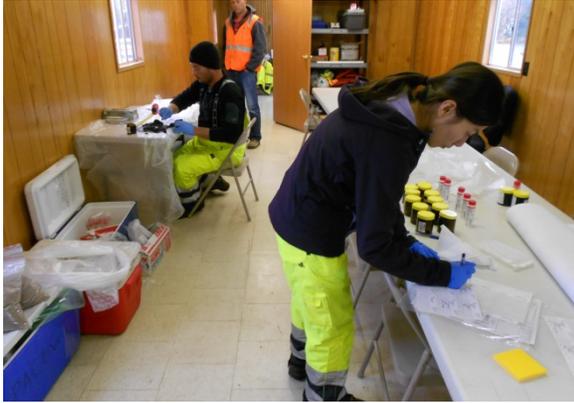
Photo 13: Sediment confirmation sample processing

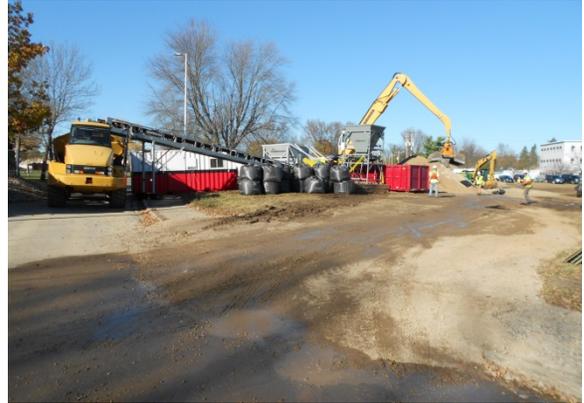
Photo 14: Adsorptive cap (GAC and sand) mixing system

In preparation for cap installation, the carbon was soaked approximately 24 hours to fill the void space and decrease buoyancy. The target carbon-sand ratio was 7% on a dry weight basis (e.g., 7 pounds of dry carbon per 100 pounds of dry sand). Sand and carbon were loaded into separate hoppers that dumped onto conveyor belts with scales. The hopper scales were setup with a leader/follower PLC, which continually controlled the mixing rate of the activated carbon and sand. Based on the individual weights of the carbon and sand, the belt speeds were adjusted to convey the proper carbon and sand volume to achieve the 7% carbon-sand ratio. The carbon-sand ratio was also verified based on the quantity of sand and carbon used. Finally, uniform mixing was visually observed during cap thickness checks.

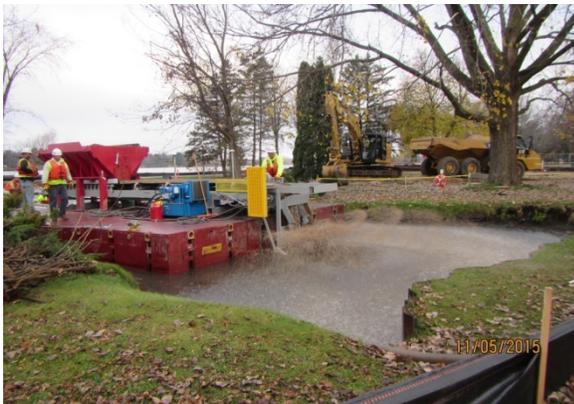
Photo 15: Adsorptive cap placement in the Pond using the BCS™

Brennan's Broadcast Spreader System (BCS™) was used in the Pond and River to uniformly place a minimum 15-inch thick cap with an over placement allowance of 3 inches.

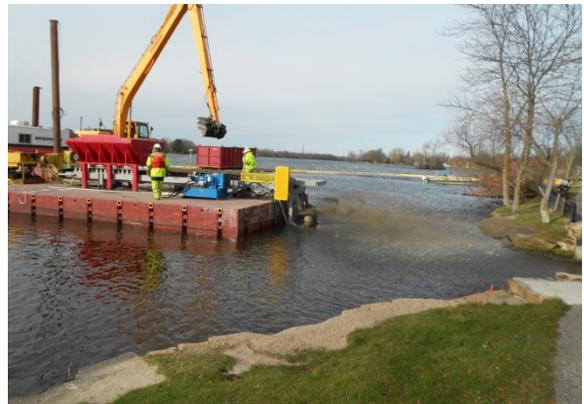
Photo 16: Adsorptive cap placement in the River using the BCS™

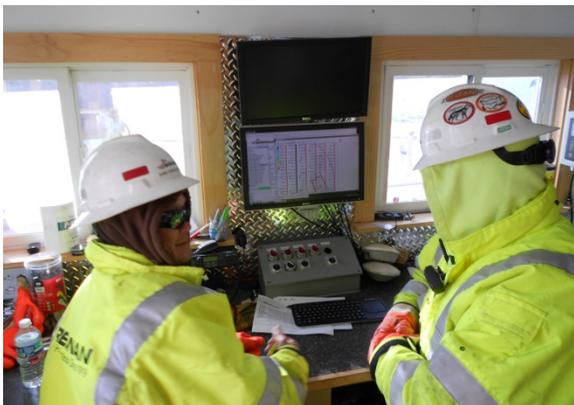
Photo 17: BCS™ control room

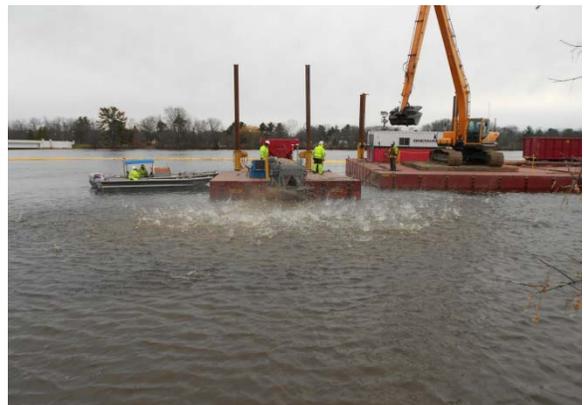
Photo 18: Armor layer placement in the River

The River Remedial Action encompassed approximately 0.4 acres. River sediment dredging was performed to remove contaminated sediment followed by placement of a residual sand layer. A minimum 15-inch thick subaqueous cap consisting of sand mixed with activated carbon was placed in the River where sediment concentrations were above the remedial action level and slope stability limited further dredging. The River cap was overlain with armor stone.
