CHALLENGING DREDGE OPERATION OVER ACTIVE UTILITIES IN NEW YORK HARBOR

ABSTRACT

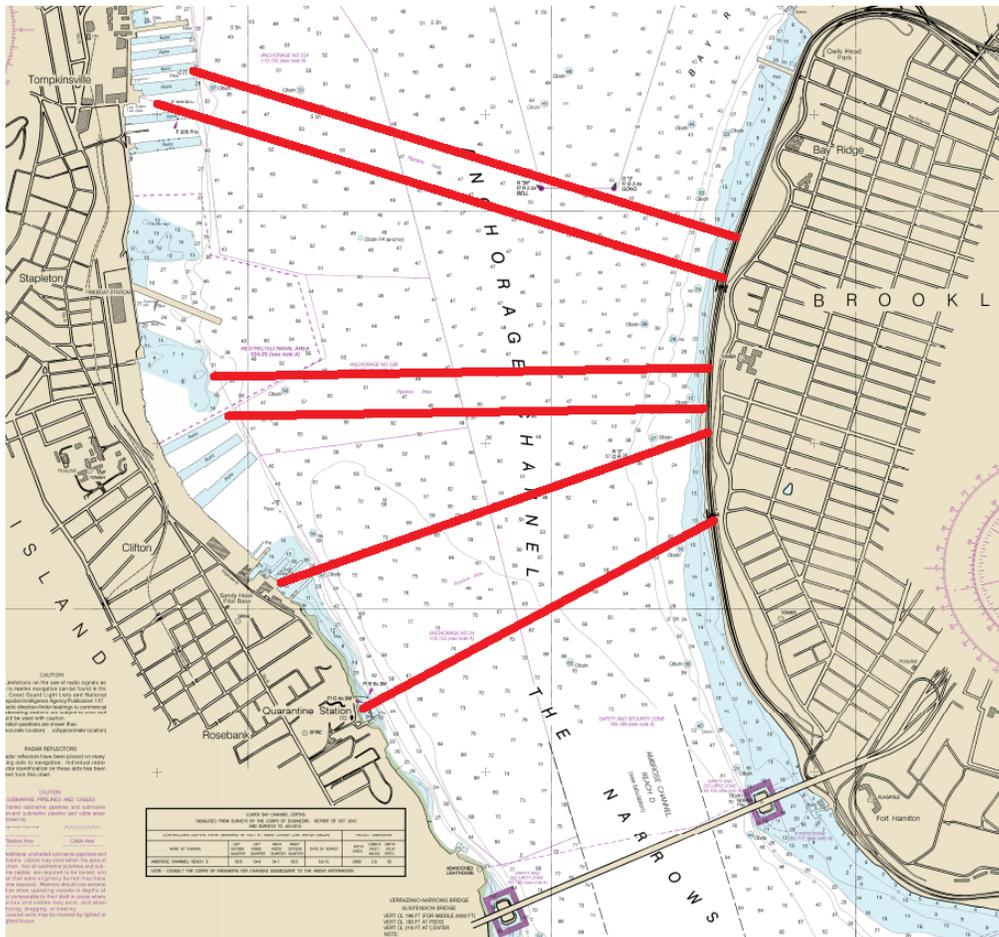
Figure 1. Some of the Designated Utility Crossings (red lines) at New York Harbor Navigation Channel

Prior to the dredging project, controlling water depth at the navigation channel leading to PONYNJ terminals was 13.7m (45ft) at Mean Low Water (MLW). The US Army Corps of Engineers (USACE), the Federal organization tasked with maintaining the navigable waterways of the country, started the channel deepening project in 2004 to increase the navigable water depth to 15.2m (50ft). The project, referred to as the “Harbor Deepening Program”, included 21 individual dredging contracts and several additional contracts for the beneficial use of approximately 40 million cubic meters (52 million cubic yards) of dredged material in marshland restoration projects (USACE, 2016). The last and final dredging contract in the Harbor Deepening Program was completed in 2016 and required dredging over three utility corridors close to the navigation channel entrance, as marked on the National Oceanic and Atmospheric Administration (NOAA) chart in Figure 1 (NOAA, 2017a). Two cast iron water mains, electric cables, gas pipelines, and oil pipelines are currently active in these utility corridors. Millions of customers rely on these utilities for their basic everyday needs, and any damage to them would result in extended periods of service interruption and put millions of people in jeopardy.

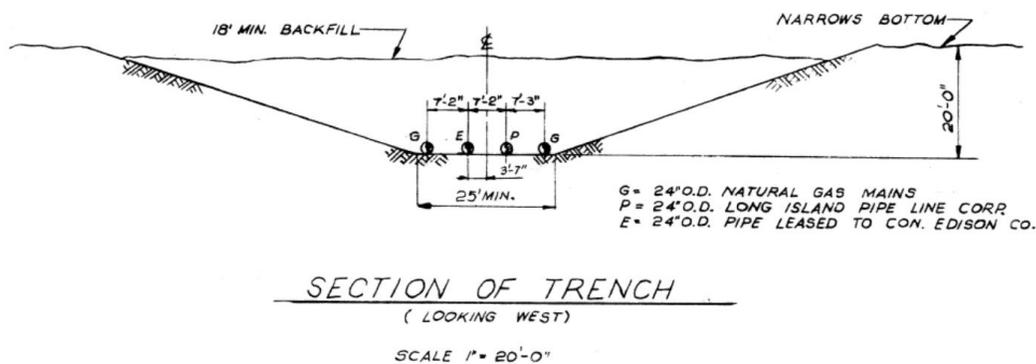
The utility corridor passing through the dredging area, where the oil and gas pipelines are located, was constructed in the 1960s by traditional trench-and-cover methods (Figure 2). A trench was excavated at the seabed to a minimum depth of 6.1m (20ft) below the existing mudline, with side slopes sufficient for temporary stability during construction based upon the in-situ sediment natural angle of repose. After the pipelines were placed in the trench, they were covered with a minimum cover thickness of 5.5m (18ft) backfill. The limited available construction drawings do not provide the specification of the backfill material. However, it was observed later during the dredging that the backfill material was actually different in color than the native material. This color difference was used as a telltale sign of cutting in to the trench.

Figure 2. Typical Cross-section of Utilities

Although the existing utility trench construction drawings provided some information about the cross-section of the trench, they were far from adequate in providing precise elevations of the pipelines along the trench. Thus, additional surveys were needed to approximately locate the vertical positions (i.e. depth) of the pipelines within the dredging prism. Existing historical design drawings indicated that the utility pipelines rise in elevation on the eastern boundary of the navigation channel to tie in to pipelines on the shore.

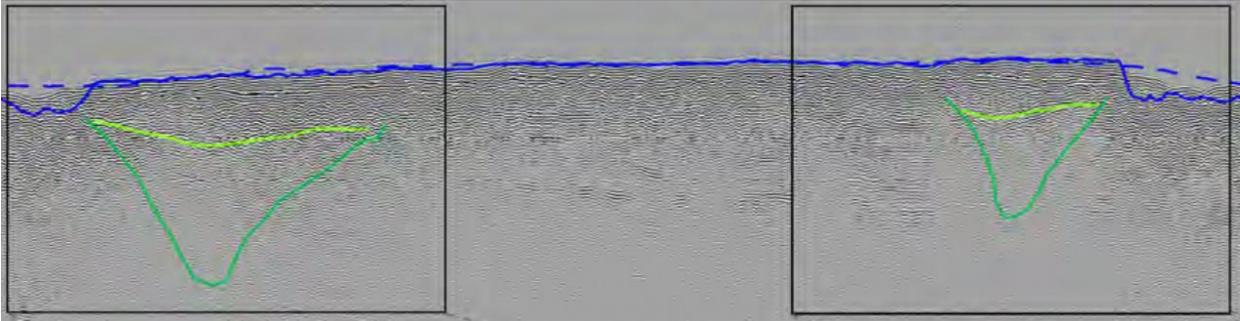
Several subsea profiler surveys had previously been conducted at the project site to locate the pipelines. Unfortunately, subsea profiler surveys are not precise by their nature and the results are highly operator-dependent. Figure 3 shows a subsea cross-section profile obtained from such a survey, where green lines indicate the approximate trench boundaries interpreted from the subsea profiler data and the blue lines indicate mudline elevations obtained from multi-beam bathymetric survey. As can be seen in the figure, only a trained individual can distinguish the trench boundaries by interpretation of the data.

Figure 3. Imagery Indicating Utility Trench Location

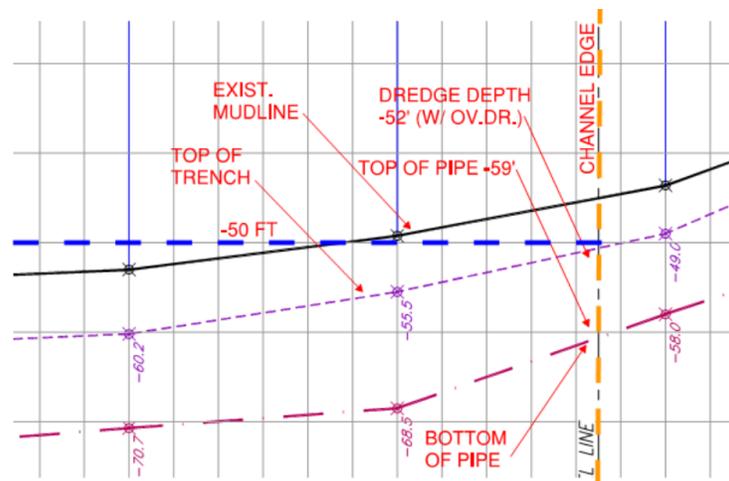
Based on the subsea profile obtained from magnetometer surveys, the mudline profile obtained from multi-beam bathymetry surveys, the navigation channel profile from official navigation charts, and a target dredge depth of 15.2m (50ft), Figure 4 was developed for locations where the proximity of dredging to existing pipes was being investigated. It can be seen in the figure that, with an over-dredge tolerance of 0.6m (2ft), a common tolerance benchmark for dredging projects, the dredged seabed profile comes within 2.1m (7ft) of the pipelines, making the dredging operation over the utilities a high-risk operation by industry standards.

Figure 4. Assessed Location of Utility

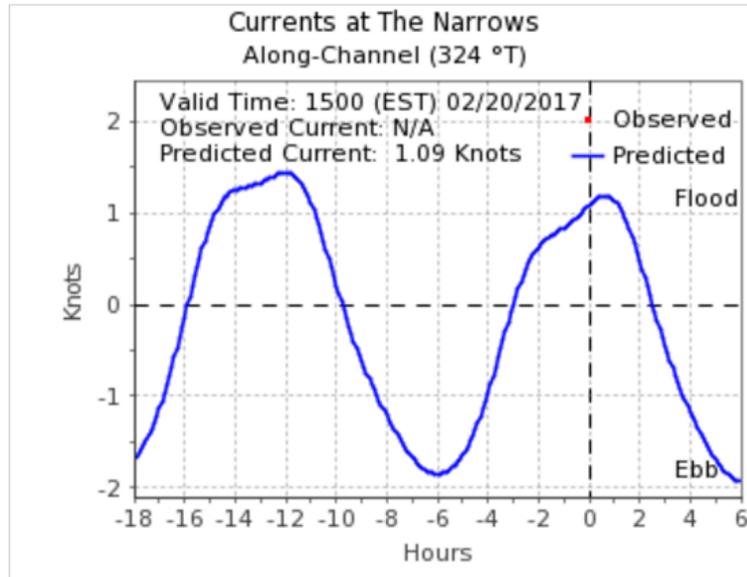
To add to the complexity of the project, the dredge site was located near the exit point of New York Harbor, where currents, especially ebb currents, are known to be very strong. Ebb currents at the project site routinely reach 2 knots (1 m/s), as depicted in Figure 5 (NOAA, 2017b). Once the dredge bucket is in the water, it will be subject to lateral forces from the currents acting on it. For a water depth of 15.2m (50ft), even a small bucket inclination angle of 5 degrees would result in an offset of 1.3m (4.3ft).

Figure 5. Typical Current Speeds at Project Site

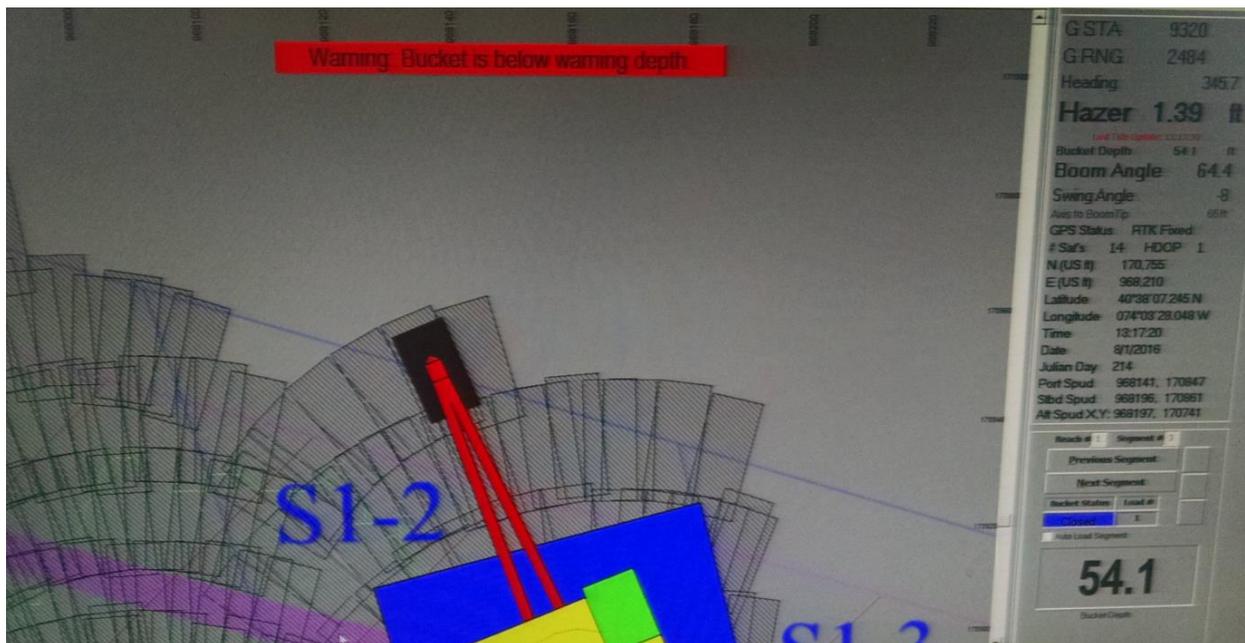
The dredge plant was equipped with a high-precision differential global positioning system (DGPS) receiver constantly updating the plant coordinates and tide levels. Knowing the precise location of the GPS antenna on the plant, overall dimensions of the barge, coordinates of the center of rotation of crane ringer on the barge, crane boom length and angle, and bucket size (open and closed footprints and height of the bucket) enabled the operator to precisely locate the dredge plant over the utility corridors and the dredge bucket over the pipelines. Once positioned at the desired location, the dredge plant was held in place by three spud piles lowered into the mudline. To avoid damage to the pipelines, spudding was not permitted inside the utility corridor. Coordinates of the spud pile locations were measured relative to the DGPS antenna location. This information was entered in to the dredge contractor's propriety software and displayed on dual screens, one in the operator's cabin and one in the engineer's room (Figure 6 and 7). All readings were refreshed in-real time, approximately once per second.

Figure 6. Screen Shot of Contractor's Proprietary Dredge Control Software

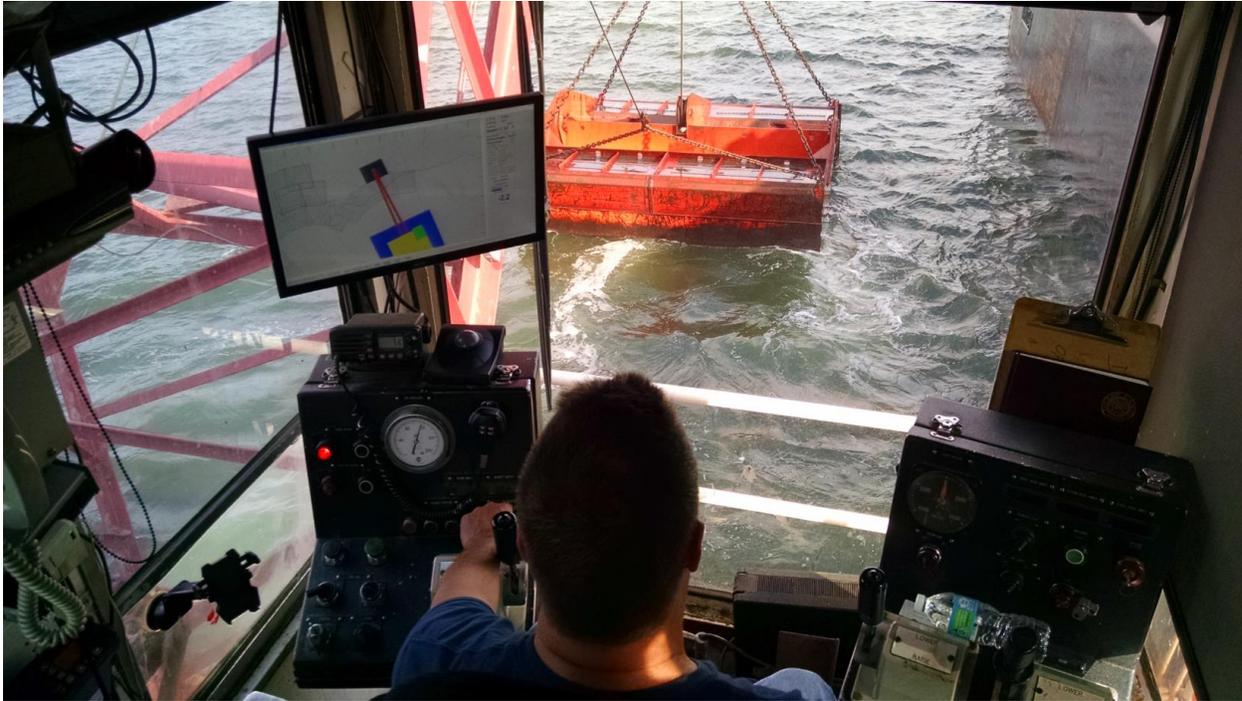
Figure 7. Dredging Operation – View from Operator Cabin

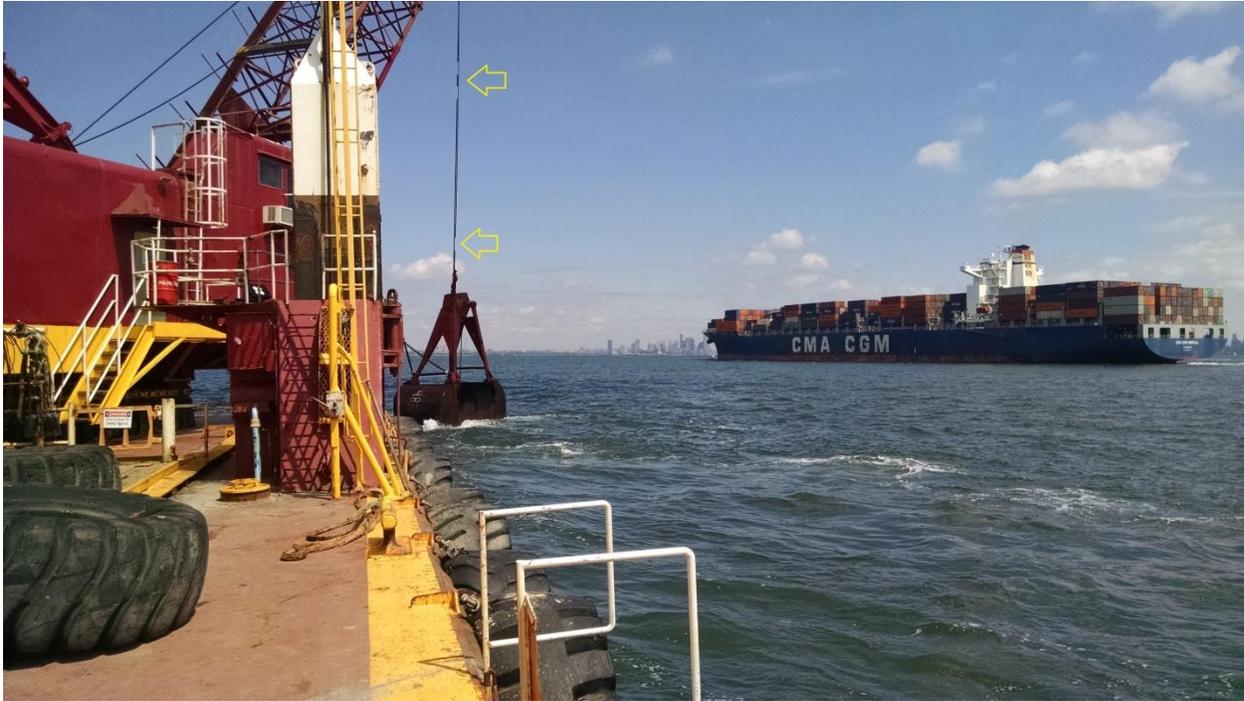
Visual redundancy was provided to the dredger operator by marking the steel cables holding the dredge bucket with white paint (refer to Figure 8). These markings indicated bucket open and closed position as well as mudline depth elevation. An electronic tide gage and a tide board were installed at a nearby dock to visually check the digital tide readings. Additionally, a Real Time Kinematic (RTK) tide gage was installed on the side of the dredge plant. The dredged area was surveyed by a survey boat immediately after the dredger moved out, to ensure the target depths were reached and over-dredge depth was within the target tolerance (Figure 9).

Figure 8. Dredging Operation in Progress (yellow arrows indicate cable markings for depth control and dredge bucket open/close check)

Control of the bucket depth, and thus the dredge depth, was the most important aspect of the dredging operation, and required higher than normal precision. This, however, was challenging due to the swift currents at the project site. Both electronic and manual depth control measures were implemented. The control software providing the operator tide-adjusted bucket depth in the water was visually calibrated every time a new bucket was taken. This was done by closing the bucket in the air and checking the computer reading when the bucket was lowered just enough to touch the water surface, where the operator zeroed the depth reading. When the bucket was lowered to the mudline, depth readings on the computer screen were relative to the water surface at that specific time, taking tide level into account (Figure 8).

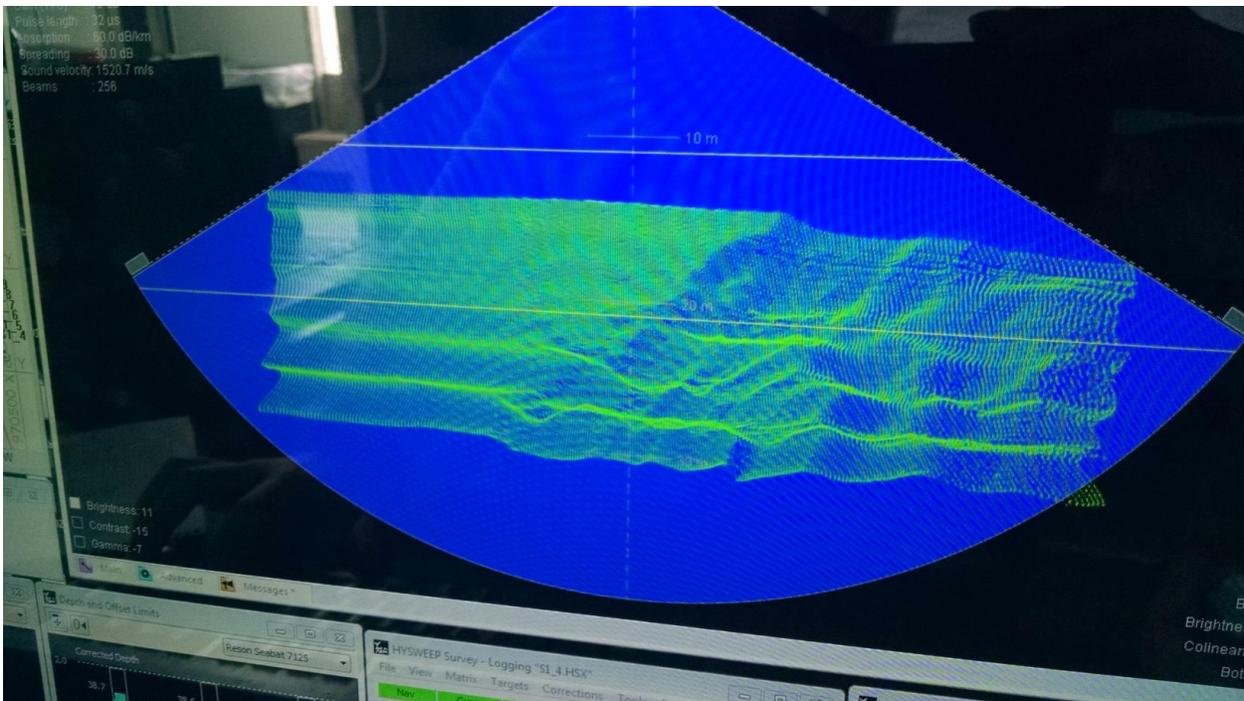
Figure 9. Bathymetry Survey at Site after Dredging
