MILE POINT TRAINING WALL CONFIGURATION

Kirk Foley and Aaron Wright¹

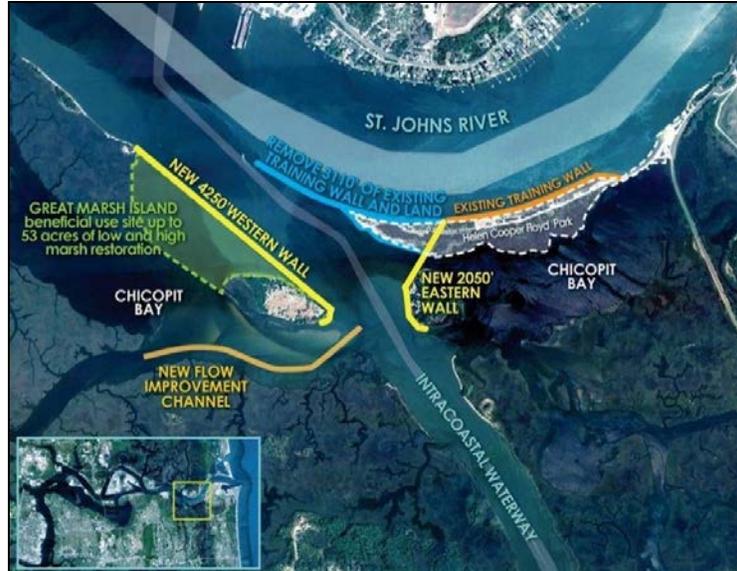
Figure 1. USACE design of the Flow Improvement Channel

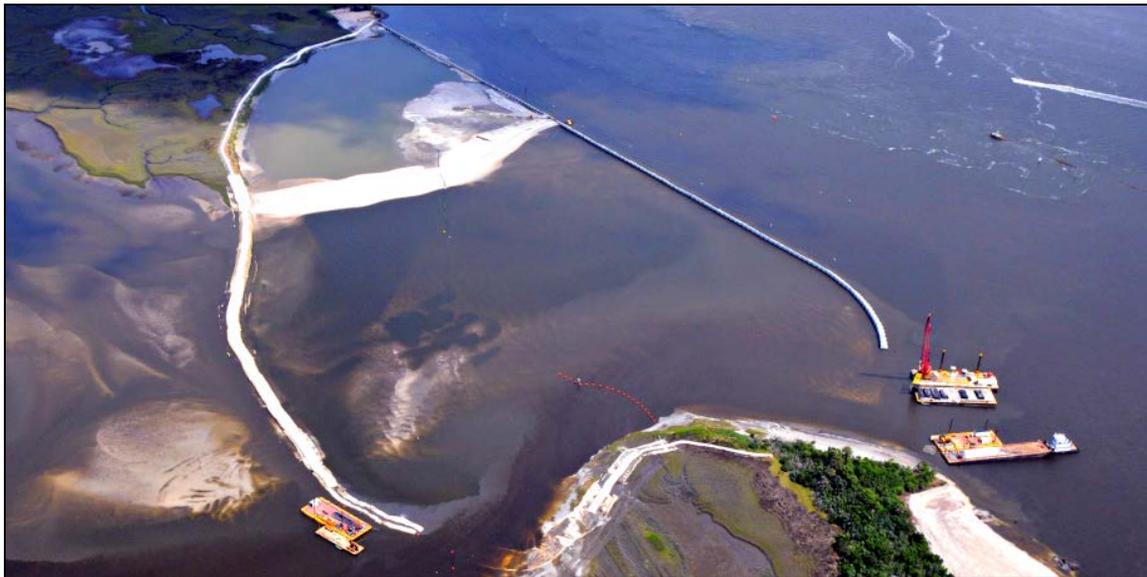
Figure 2. Aerial view of construction of the training wall, including the geotextile tube alignment and installation of precast concrete units.

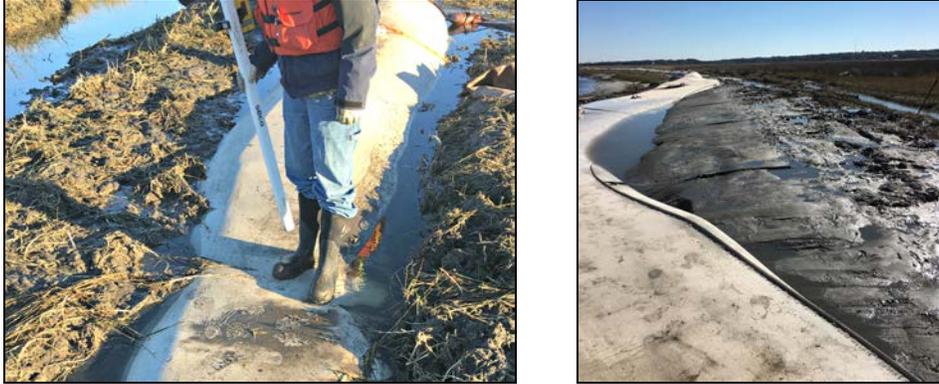
Figures 4 and 5. Filled geotextile tubes, sinking in the marshlands.

On the first day of operations, 121.9-m. (400-lineal ft.) of geotextile tubes were filled to slightly more than the minimum height of 1.5-m. (5-ft.) MLLW, as planned. The next morning, the crew found that the geotextile tubes that had sunk into the marshland, so much that some parts of the top surface of the tube alignment was lower than ground level.

To prevent this from happening again, a process was developed to inspect the remainder of the marshland, and increase stability if needed, before installing any more geotextile tubes in the alignment. In unstable areas, the base was prepared by placing sand in the alignment path and compacting the sand as much as possible. In the least stable area, a 10.4-m. (34-ft.) circumference geotextile tube was placed in the alignment, to achieve the minimum 1.5-m. (5-ft.) MLLW height. That geotextile tube was almost complete when the weight of the tube caused the edge of the marsh to slide toward the water taking the geotextile tube with it.

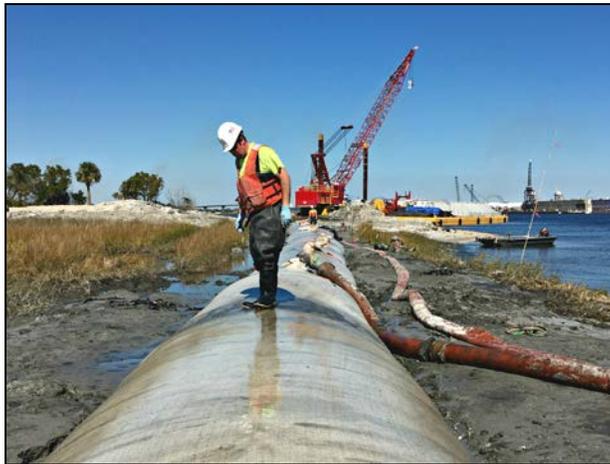
Figure 6. Land side geotextile tubes installed over compacted sand.

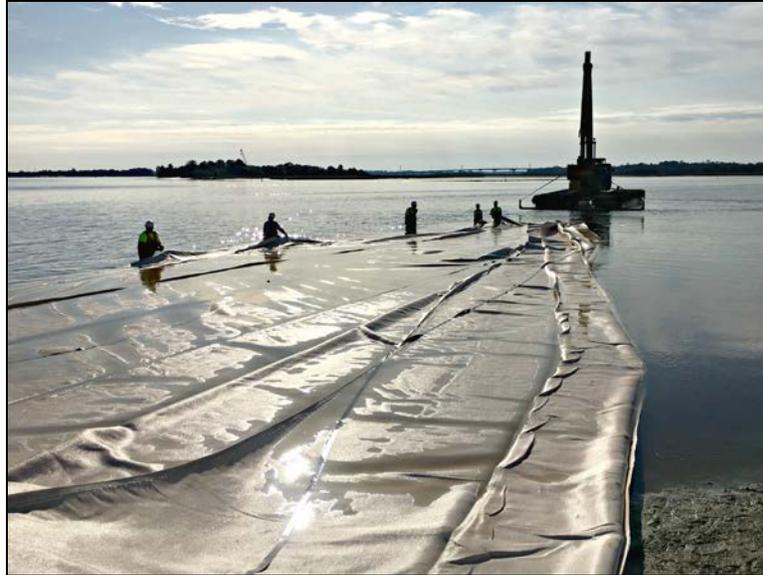
Figure 7. Deploying scour apron with the marsh excavator.

The geotextile tube alignment entered the water at Station 13+75. Beginning at this station, the geotextile tubes were stacked in a 2-1 pyramid configuration of three 5.2-m. (34-ft.) circumference tubes. Scour aprons were installed, extending 15.2-m. (50-ft.) in front of the geotextile tube filling operation. This practice prevented the base from washing out from under the end of the tube as it was filled. The installation process in this section of the alignment proceeded in 121.9-m. (400-lineal ft.) increments, such that two 15.2-cm. (6-in.) diameter pipelines were utilized to fill two geotextile tubes concurrently.

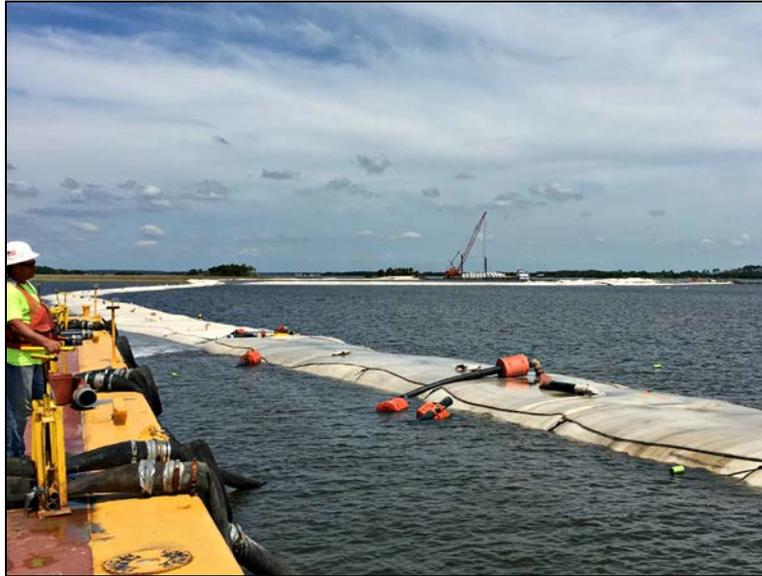
Figure 11. Filling geotextile tubes in the water.

Geotextile tubes were deployed from work boats. When a geotextile tube is placed in water it will float. After the tube was placed in the water, crews had to move the work boat over top of the tube, then insert fill pipes into each fill port, and finally, lay out and attach hoses from the fill pipes to the sand slurry pipeline. If the tide was moving in or out during this operation, it made it increasingly difficult to keep the tube in place long enough to secure the pipelines. The tide could catch the tube and spread it out like a sail; the force needed to bring a fill port to the surface, as the tide rushing against it, it was significant.
