## **RESILIENCE OF UPLAND CONFINED DISPOSAL FACILITIES AND BENEFICIAL RE-USE OF DREDGED MATERIAL FOR COASTAL PROTECTION**

### **ABSTRACT**

### **DAMAGE ASSESSMENTS & RESILIENCE OF UPLAND CONFINED DISPOSAL FACILITIES**

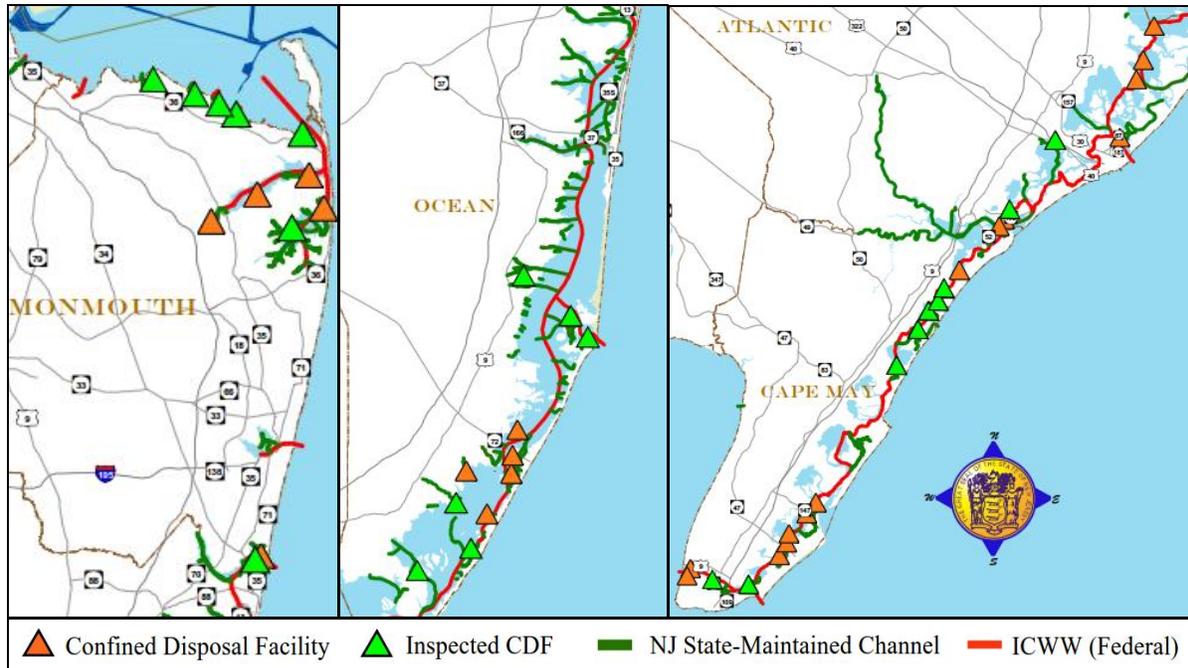
**Figure 1. Locations of Inspected CDFs along Raritan Bay & ICWW: Raritan Bayshore (Left), Ocean County (Center), and Atlantic & Cape May Counties (Right).**

In order to assess damages for FEMA reimbursement, an initial visual assessment of 22 CDFs was performed by boat in February 2013 to identify those CDFs most critically damaged from the storm. This preliminary assessment was followed by a detailed on-the-ground damage assessment and conditions survey performed on 6 of these 22 CDFs between June & September 2013 followed by inspections of 7 other CDFs between September 2013 & March 2014. Further damage assessments were later performed for design & research purposes on 9 additional CDFs in 2014 & 2015 (3 in 2014 & 6 in 2015). Since no major storms struck the NJ coastline during this time and these CDFs were unused and unrepaired, it was assumed that the observed conditions were representative of post-Sandy conditions. Figure 1 shows the locations of the 22 CDFs investigated.

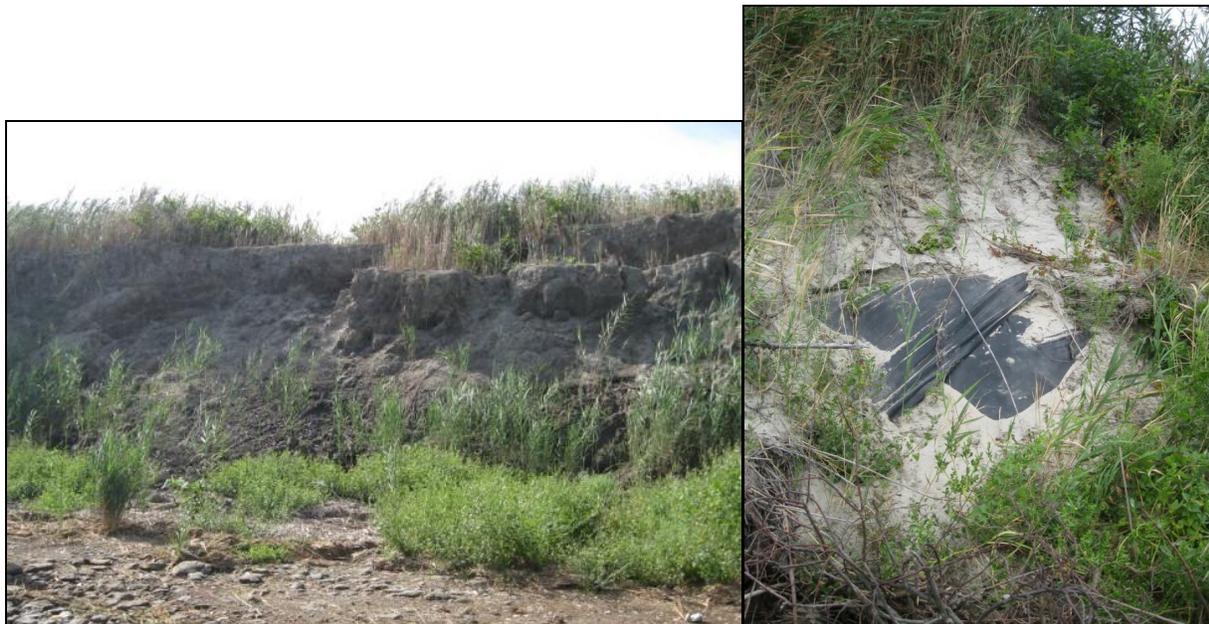
**Figure 2. Damaged Dike at Ludlam Thorofare No. 2 CDF (Left) and Exposed Geosynthetic at Broad Thorofare No. 1 CDF (Right):**

In some cases, geosynthetic was observed within the dikes between the overlying sand and clay core. The original intended purpose of this liner is unknown, as the material appeared to serve as neither a waterproof membrane nor a barrier to soil migration. As shown in Figure 2, this liner provided a sliding surface for the overlying soil resulting in exposure of, and damage to, the geosynthetic. However, though exacerbating erosion of the overlying soils, the geosynthetic did appear to provide limited resistance to further damage by providing confinement to the underlying soil. Despite this, the presence of the geosynthetic is not expected to considerably increase the resilience of the CDF and may have an overall net zero effect. More sites will need to be investigated to expand the data set and assess the overall impact, if any, of similar geosynthetics on CDF resilience.

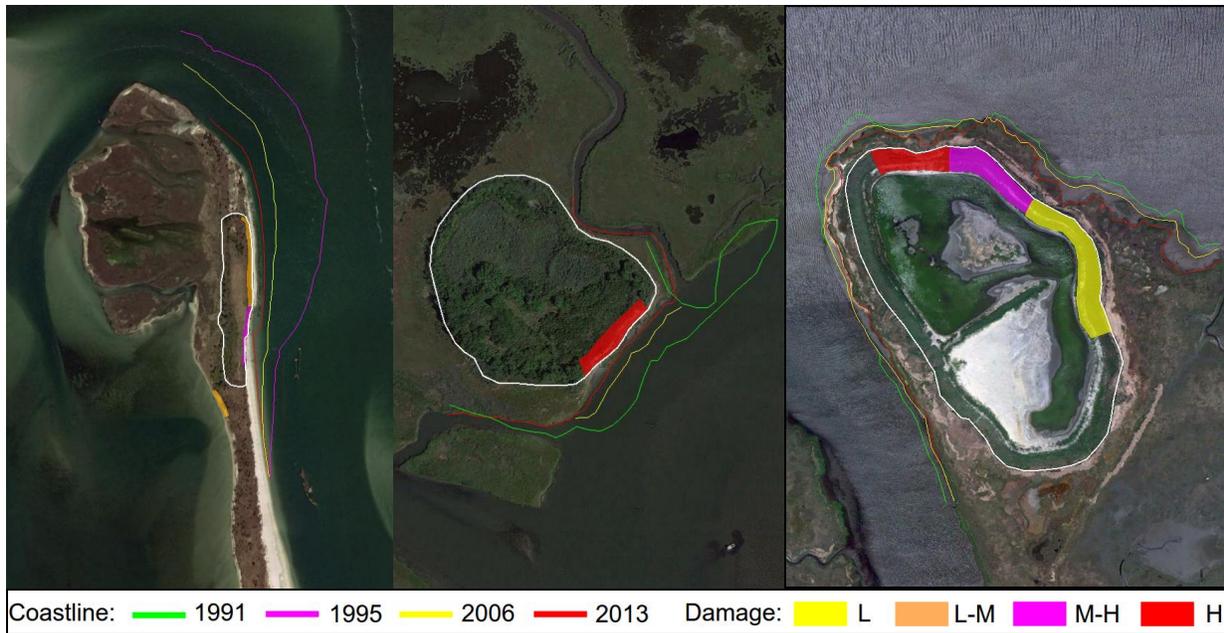
One goal of this investigation was to better understand the relationship between geomorphology and propensity for dike erosion during major storms. Figure 3 clearly shows the relationship between historical coastal erosion or marsh loss and damage to three representative CDFs. Two other CDFs listed in Table 1 showed the same relationship (figures not shown). Unlike those sites with a history of coastal erosion, the Gull Island CDF regularly accumulates sand seaward of the CDF and is protected by over 90 meters (300 feet) of barrier marsh and an old bulkhead on the exposed sides. This CDF showed no signs of damage as a result of Superstorm Sandy, despite its close proximity to the Manasquan Inlet. When marsh and sand bar buffers did not exist on sites proximal to inlets, however, the risk of CDF damage increased, as indicated at the Story Island and High Bar Harbor CDFs. These damage assessments appear to indicate that geomorphology of the CDF site has a direct relationship to its resilience. However, further research would be needed to expand the data set and confirm this correlation.

**Figure 3. History of Erosion from 1991-2016 and Observed Sandy Damage at High Bar Harbor CDF (Left), Broad Thorofare #1 CDF (Center), & Ludlam Thorofare #2 CDF (Right).**

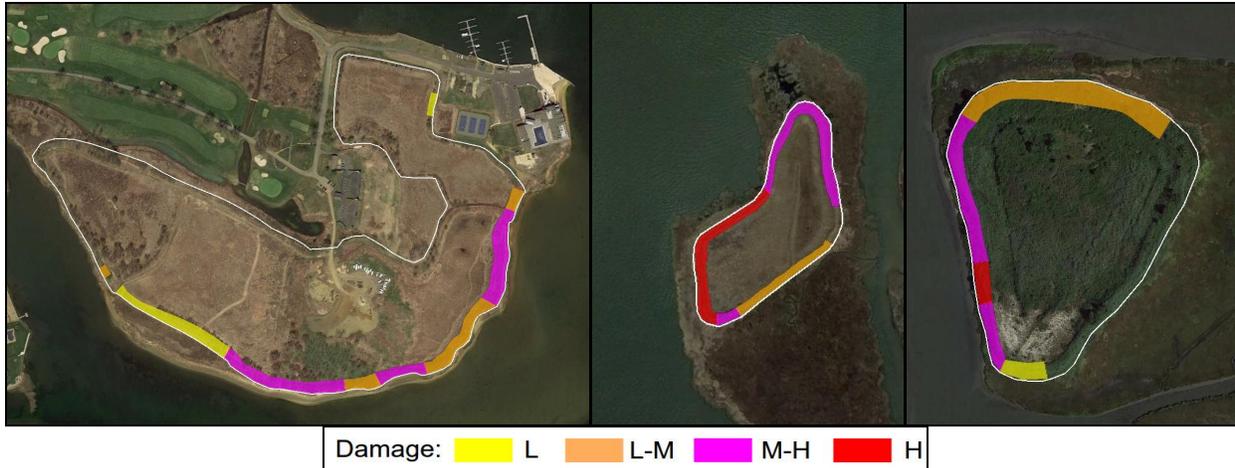
Lastly, the amount of marsh or beach buffer present in front of the CDF dikes clearly affected the amount of CDF damage sustained. From visual inspection and surveyed data, the extent of damage and presence of existing buffer was recorded and categorized around the perimeter of each CDF. This relationship is portrayed in Figure 4, which shows the generalized damaged areas along with the existing marsh for 3 representative CDFs, as does Figure 3.

**Figure 4. Observed Sandy Damage with Marsh Buffer at Long Branch Reach CDF (Left), Story Island CDF (Center), & Devil's Island CDF (Right).**

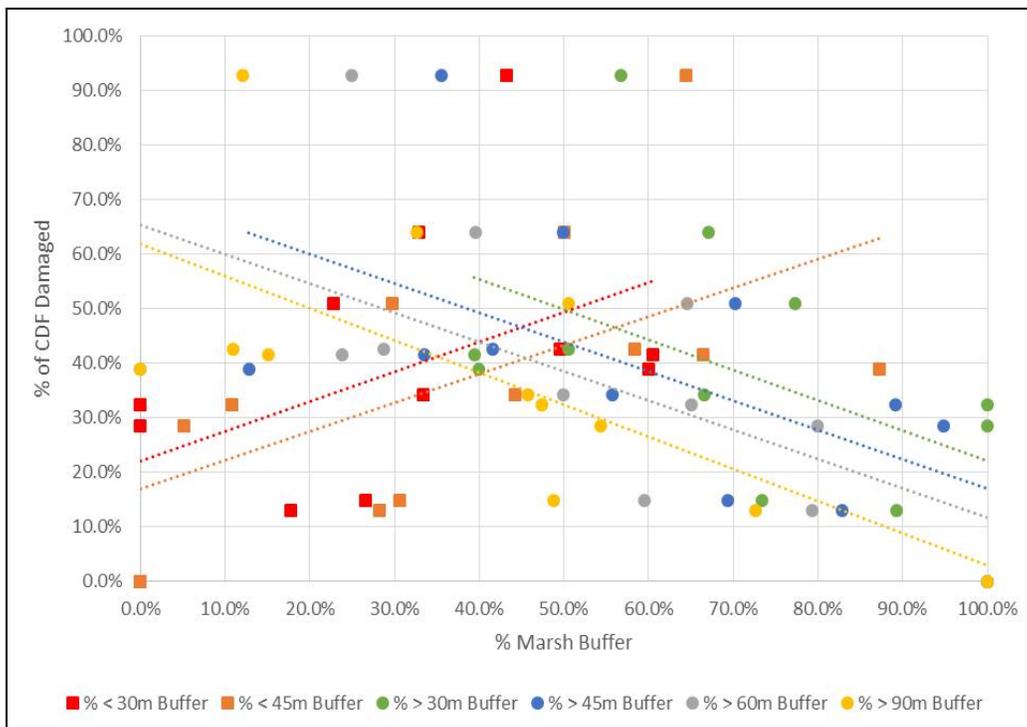
**Figure 5. Percentage of CDF Damaged versus Percentage of CDF with Designated Buffer Width.**

The trendlines in Figure 5 show a general proclivity for increased damage with reducing buffer widths. Likewise, a consistent decrease in damage was observed with increasing marsh buffer distance. More damage to dikes with lesser buffer widths is also confirmed by general comparison across buffer width categories, as increasing percentages of damage occur to dikes with reducing buffer distances (Figure 6).

As indicated in Table 2, the percentage of dike damage significantly increases as the extent of marsh/beach buffer decreases. Comparing the extent of dike damage with width of the buffer yields consistent results at all distances, with decreasing damage (i.e. increased resilience) noted with increasing buffer width. Figure 5 illustrates these trends across all buffer distances.

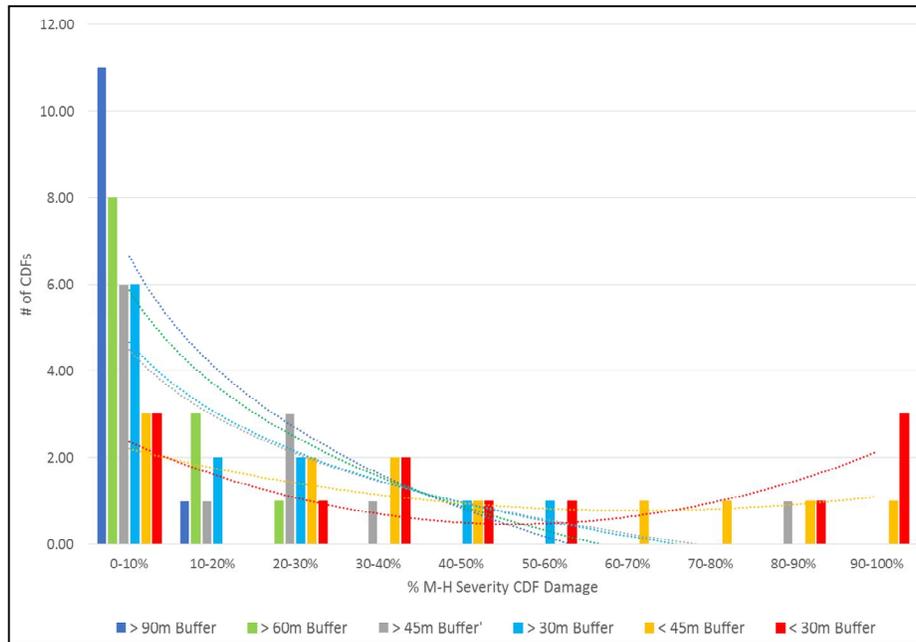
**Figure 6. Comparison of Extent of Moderate to High Severity Damage with Designated Buffer Widths.**

As indicated in Figure 6, the extent of significant damage increases with reducing buffer widths. While there appeared to be an increased tendency for damage of sections with less than a 30-meter buffer compared to those with less than a 45-meter buffer, there was no discernable difference between the trends for sections with greater than a 30-meter buffer and with greater than a 45-meter buffer.

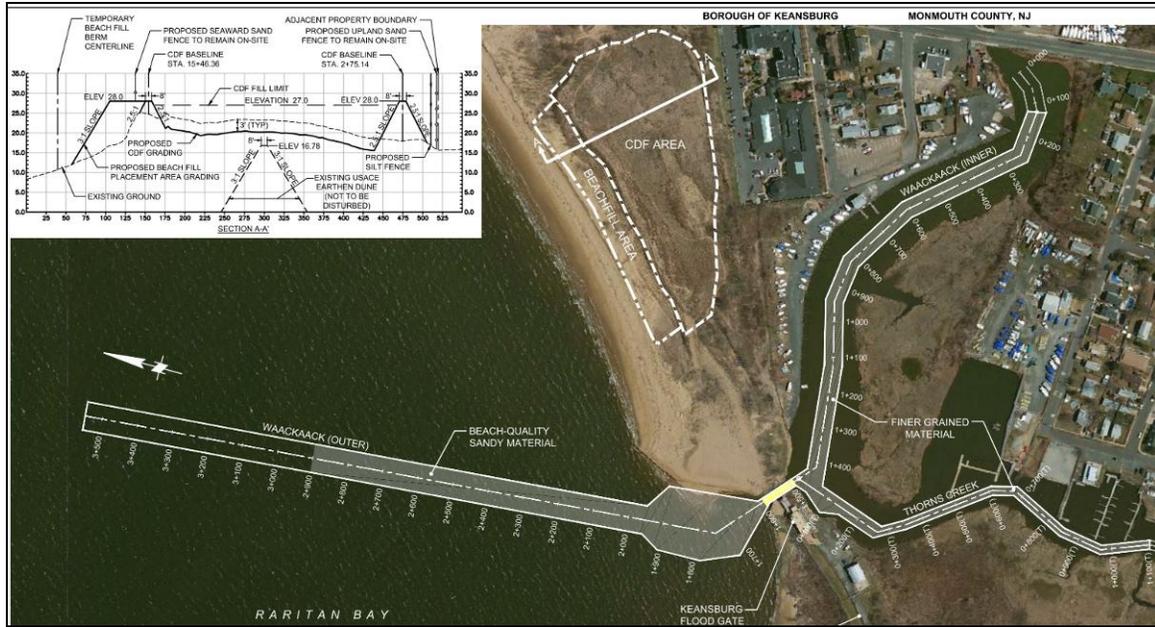
The Keansburg CDF was actually located at the top of a coastal dune, parallel to the coastline (see Figure 7). Contrary to the typical procedure, and due to the limited land available for construction of a CDF, this site had been used for the placement of fine-grained material, followed by capping with clean sand. After placement, the filled CDF would actually be more stable than a dune made solely of sand since fine-grained material has more natural cohesion (see Section A-A on Figure 7).

**Figure 7. Project Map with Section A-A of the Keansburg CDF**

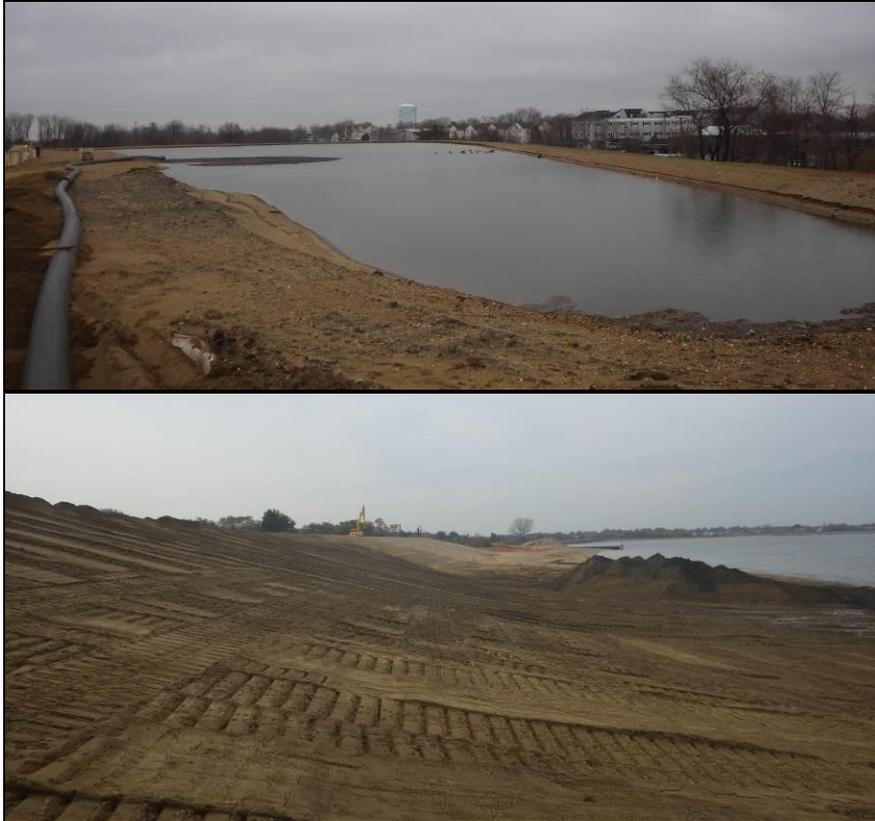
The design team took this idea and ran with it. If the proposed CDF stayed within the original permitted footprint, the team could use some of the material on the inside of the CDF to raise the confining dikes, thereby creating more capacity. This would allow for the placement of the fine-grained material into the raised portion of the CDF and provide the town with an even larger natural barrier to Raritan Bay storm surges. The coarse-grained material from outside the floodgate was designed into a dune-like feature simply by extending the top of the confining dike's elevation waterward for a set distance, and then transitioning down to the existing beach grade at a 3 horizontal to 1 vertical (3H:1V) slope. The slope met the existing beach grade well upland of the mean high water elevation line (Figure 8).

**Figure 8. Keansburg CDF in Use (top) and Construction of Beach Fill (bottom)**

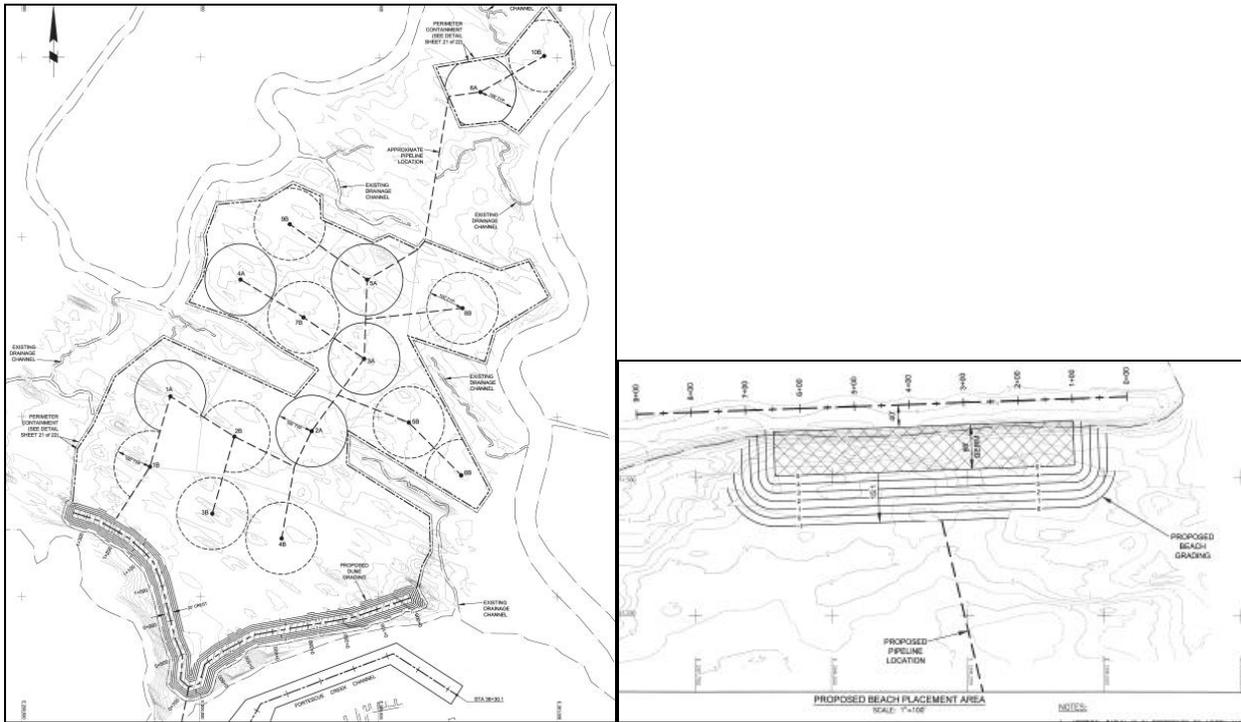
Sediment greater than 90% sand was identified for restoring an eroded dune along the south side of the marsh, while sediment classified as 75% to 90% sand was used in restoring a nearby beach that had been classified as prime habitat for horseshoe crab spawning. For the TLP on the marsh, fine-grained sediments were expected to sheet flow over the marsh and settle out naturally due to gravity. Since it was expected that some coarser-grained material would accumulate closer to the discharge pipe outlets, the outlets were proposed in areas intended for higher elevations, i.e. restoration of high marsh habitat. Based on the sediment characteristics, a complex pipeline and valve network was designed. The network included a number of outlet points to optimize dispersion of dredged material on the marsh, with primary and secondary confinement (compost filled silt socks) placed between and around different marsh zones (Figure 9).

**Figure 9. Plan Views of Marsh Placement Zones (Left) and of Beach Placement Area (Right)**

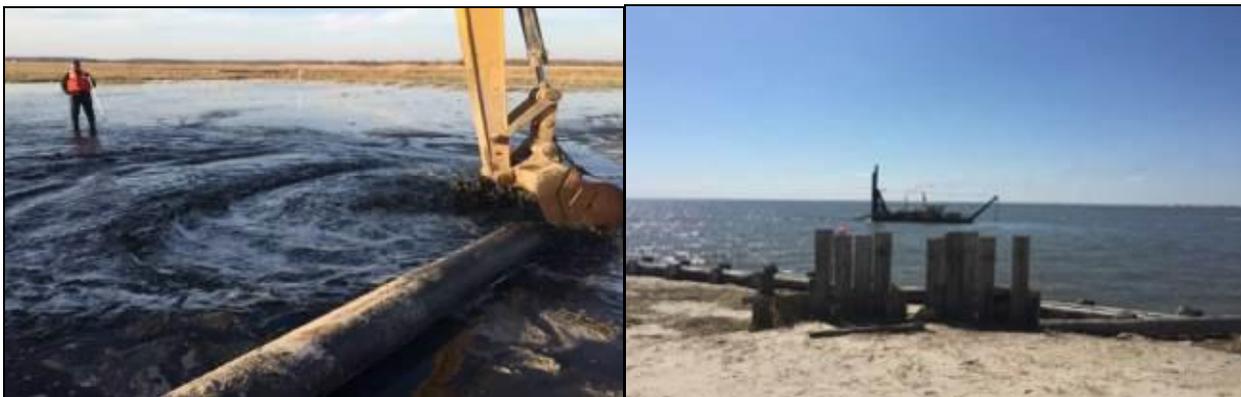
**Figure 10. Excavator Bucket Directing Dredge Slurry Flow to Low-Lying Areas during TLP Operations (Left) and Dredge Barracuda nearing Station 29+00 (Right)**

Construction activities began in January 2016 with the intent of dredging the 27,500 m<sup>3</sup> of sediment from within the Fortescue channel. Due to the TLP techniques being fairly new to the NJ region, a learning curve resulted in a delayed effective start date of dredging and limited the number of cubic meters dredged in the 2016 dredging season. Despite front-end construction delays and a permitted dredging window of only 3.5 months, a total of 10,100 m<sup>3</sup> were successfully dredged and pumped onto the marsh and the horseshoe crab beach. In order to partially restore navigation, half of the channel width was cleared to the project depth for its entire length. The remaining sediment would have to be removed in winter 2017 season.
