ASSESSMENT OF EQUIPMENT PERFORMANCE AND ENVIRONMENTAL EFFECTS DURING THE DEBRIS REMOVAL PILOT STUDY AT GOWANUS CANAL

J.M. Gasser¹, J.M. Fears², G.D. Nicholas P.E.³

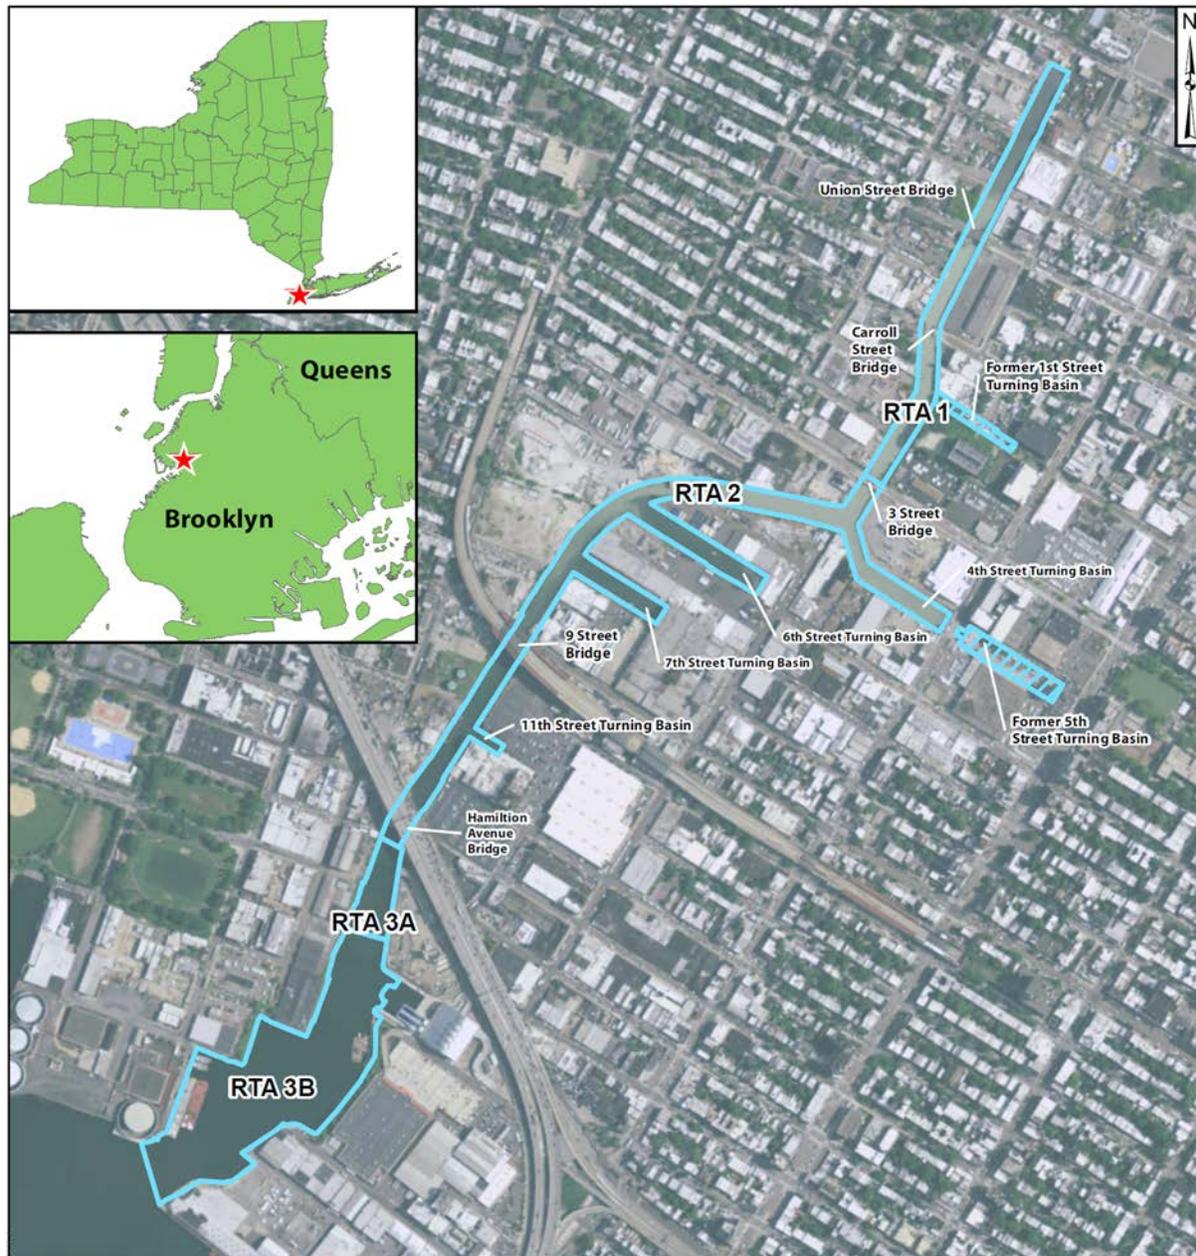
Figure 1. Gowanus Canal, Brooklyn, NY

The Gowanus Canal (Canal) is a 2.9 kilometer (km) man-made canal constructed within the former Gowanus Creek in Brooklyn, New York (Figure 1). While development of the Canal began as early as 1767, the Canal was officially authorized in 1848 by the State of New York for the dual purposes of draining the wetlands of South Brooklyn and opening the area to development (Hunter Research, Inc., et al., 2004). Constructed between 1853 and 1869, the Canal was designed as a conveyance channel for barges (NYC Department of City Planning, 1985). It consists of the main portion of the Canal along with six turning basins, some of which have since been abandoned. The Canal was the primary mode of transportation for bulk materials such as coal, petroleum, asphalt, and lumber to support the rapid growth of industry in Brooklyn and surrounding areas. During its peak period of operation in the 1920s, there were an estimated 23,000 to 25,000 vessel trips per year through the waterway to 60 dock facilities (WFB Engineering, 2016). Use of the Canal started to decline by the early 1960s due to relocation of many industries. By 2000, there were only five active dock facilities along the waterway, with current estimates of only 400 to 500 vessel trips annually (WFB Engineering, 2016).

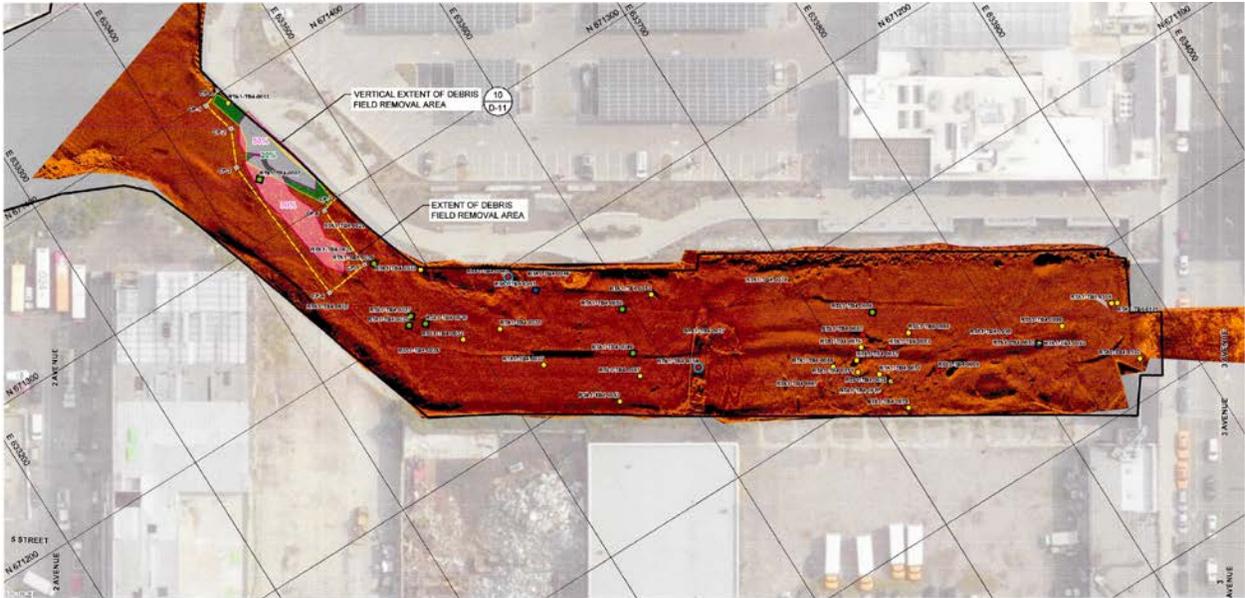
Figure 2. Observed Debris Locations in the 4th Street Turning Basin – Prior to Debris Removal Operations

Sidescan sonar surveys performed by SeaVision Underwater Solutions in 2015 and 2016 identified various forms of debris present throughout the Canal. Specifically, the 4th Street Turning Basin (Figure 2) had 36 large debris (greater than 1.5 meters (m) in any direction), 10 tires, and a debris field (area with excess coverage of smaller debris). Debris in the Canal obstructs planned remedial operations; therefore, efficient debris removal and management is critical to ensuring the success of Phase III remedial activities. The key objectives of the 4th Street Turning Basin Debris Removal Pilot Study included:

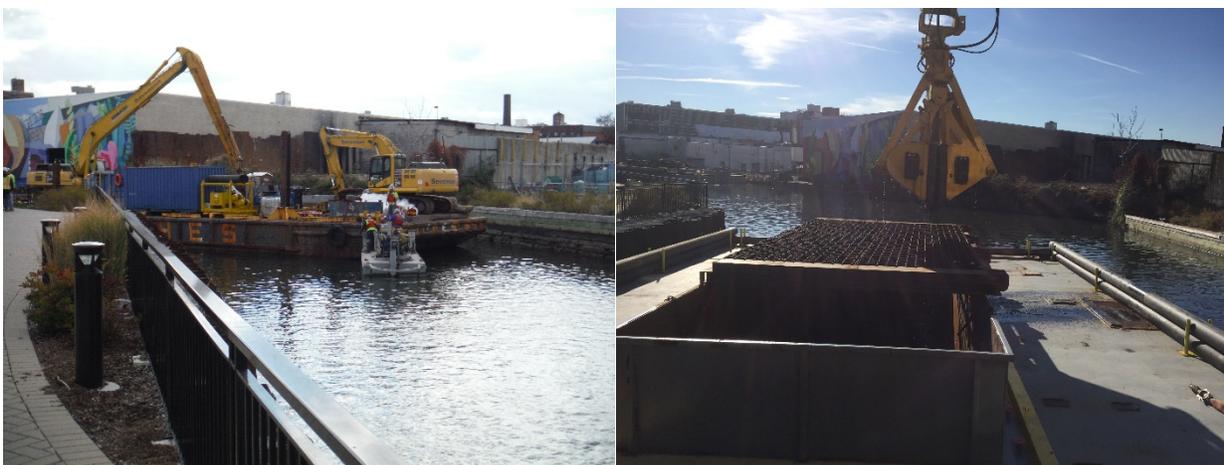
Sevenson furnished the following equipment (Figure 3) to conduct the work: 30.5 m x 9.1 m deck barge (equipped with a Komatsu PC450 long reach excavator on the front, Komatsu PC240 excavator placed on the back, a water tank, office/storage trailer, environmental clamshell bucket, conventional clamshell bucket, conventional excavator bucket, rake, and 5-tined grapple), another 30.5 m x 9.1 m deck barge to collect large debris, four pocket scows for sediment, one water scow, a push boat, a work boat, turbidity/air curtains, and a front end loader for use at the staging site area.

Figure 3. 4th Street Turning Basin Debris Removal Pilot Study Equipment

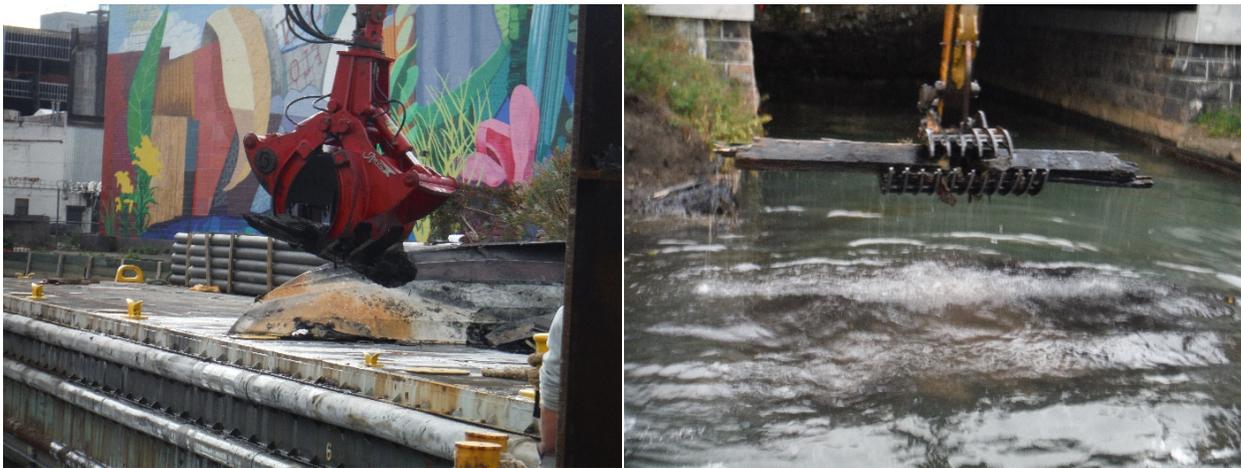
Removal operations began with the 36 large debris targets (greater than 1.5 m in any dimension) and 10 tires identified by sidescan sonar survey within the 4th Street Turning Basin. Two different attachments (a five-tine grapple and a rake) were used during the large debris removal operation (both shown in Figure 4). The advantage of the grapple is that it could rotate more easily to gather debris from the Canal. However, while working to remove an Aircraft Rescue boat, submerged debris severed one of the small exposed hydraulic lines at the fitting to the cylinder, rendering the grapple nonoperational. Thus, the grapple had to be replaced with the rake, resulting in lost time. The rake was larger and more durable than the grapple, but could not provide the same rotational movement. Additionally, the rake retrieved more sediment with the debris than the grapple. Debris covered in excess sediment was held over the Canal and was washed with Canal water using a fire hose prior to placement on the debris barge. Due to concerns with pathogens in the Canal water, this method was used sparingly. Some washing with the fire hose was also conducted once the material was placed on the debris barge, and a switch was made from Canal water to potable water for later stages of the project.

Figure 4. Large Debris Removal Attachments: Five-Tined Grapple (Left) and Rake (Right)

Grapple and rake attachments were tested to evaluate which attachment was more effective for large debris removal. An advantage of using the grapple was that the tines could be rotated to easily remove debris. One disadvantage was the number of small hydraulic lines that could be severed while trying to remove submerged debris. This happened on the first full day using the grapple causing a minor hydraulic leak and forcing an attachment change to the rake. Grapples did not seem effective in removing tires from Canal. The rake attachment was more durable than the grapple, but could not rotate as easily to retrieve debris. There were still hydraulic lines on the rake, but they were fewer and more protected. The rake was less precise than the grapple and picked up more sediment with debris than the grapple which adds to processing time. Additionally, a shear attachment was onsite for the pilot study, but was not needed as the timber and bulkhead pieces were easily picked and placed on the debris barge. While the grapple and rake each have advantages and disadvantages, they showed similar effectiveness during the short duration of the pilot study. Thus, the future Contractor will most likely be allowed to specify which attachment they prefer to use in their means and methods.

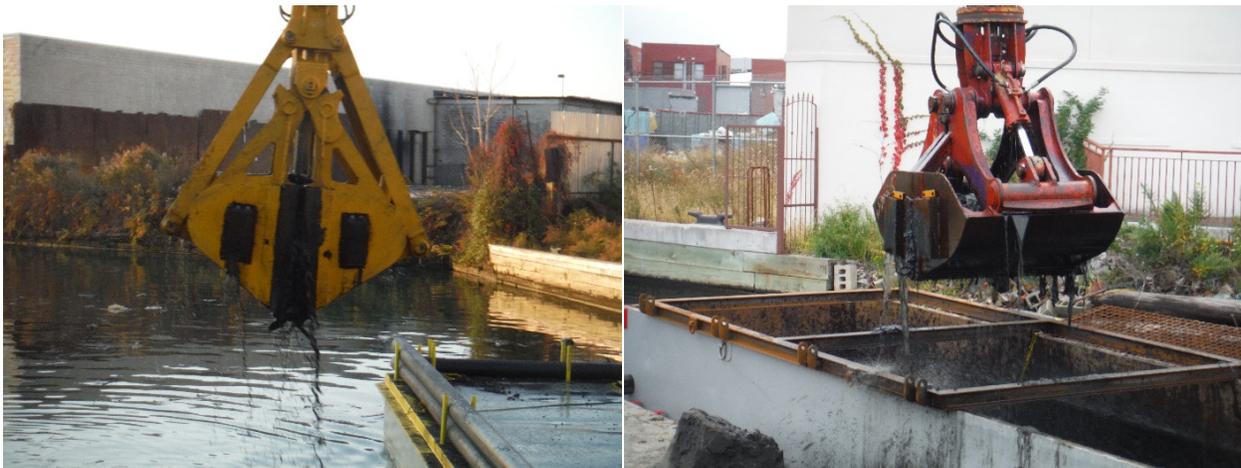
Figure 5. Debris Field Removal Attachments: 1.5 CY Environmental Bucket (Left) and 2.5 CY Conventional Clamshell Bucket (Right)

Noticeable differences between the two bucket types was observed during the debris field removal. Due to the size and quantity of debris, typically the environmental bucket did not completely close allowing for spillage of dredged material. Since the conventional bucket was not fully enclosed, it allowed for heaping buckets of sediment. The operator drained all buckets prior to emptying the contents to reduce water in the scow. Production numbers for each of the four scows are presented in Table 4. Bucket size and scow loading techniques were as follows:

Both a 1.1 CM environmental and 1.9 CM conventional clamshell bucket were evaluated. The environmental bucket did not completely close, usually due to debris, and drained water. The conventional bucket drained as much water as the environmental bucket, closed sometimes, and allowed for heaping buckets. For future work, it is recommended that an environmental clamshell bucket be used for dredging initially. If the environmental clamshell bucket is deemed ineffective, then a switch could be made to a conventional clamshell. A conventional excavator or backhoe bucket was not tested in this study and is not planned for use during full scale operations.

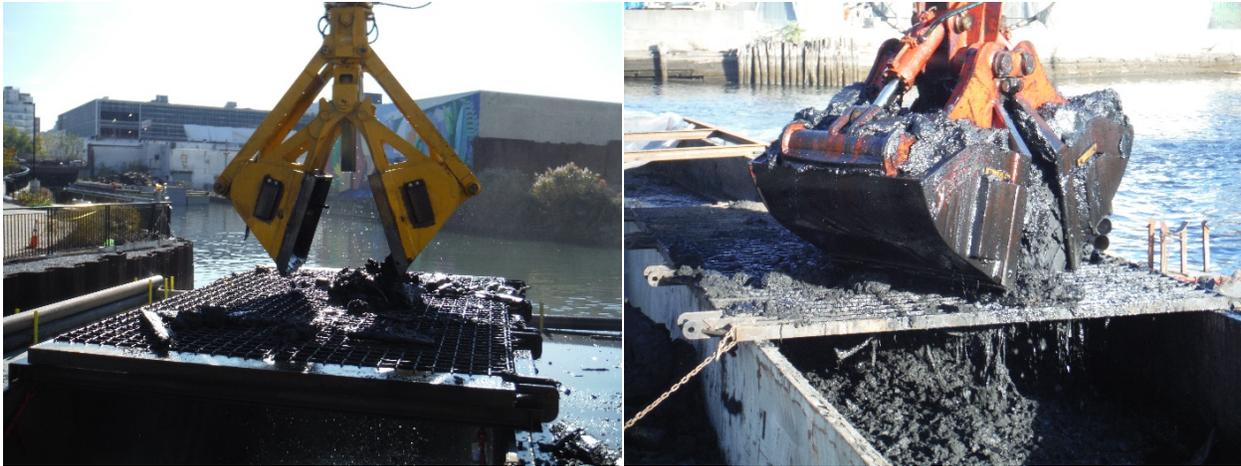
Following completion of large debris removal, Severson conducted the debris field removal. Approximately 250 CM of material were removed and loaded into four pocket scows. Two different bucket types and three different loading techniques were used during the debris field removal, as shown in Figures 5 and 6. The first two scows were loaded with a 1.1 CM environmental bucket and the second two with a 1.9 CM conventional clamshell bucket. One scow was loaded using the first loading technique in which buckets of commingled sediment and debris were emptied directly onto a 10-centimeter (cm) screen. To improve efficiency, a second loading technique was evaluated in which buckets were loaded directly into a scow and subsequently transferred to another scow through grizzly bars with 10-cm spacing. The final scow was loaded using the third loading technique in which buckets were emptied directly through the 10-cm grizzly bars into the scow.

Figure 6. Debris Field Removal Scows: Screen (Left) and Grizzly Bars (Right)

Since both Scows 1 and 4 were loaded through a screen and grizzly bars, respectively, lost time refers to the time required to push material through and remove material from on top of the screen or bars. Not accounted for in the table is the time required to rehandle the material in scows 2 and 3. This material was removed from the loaded scow and passed through the 10-cm grizzly bars into a new scow. It took the long reach excavator just over 1 hr to rehandle both scows. Accounting for this time, total scow load times are as follows: 4.45 hrs for Scow 1, 3.29 hrs for Scow 2, 3.18 hrs for Scow 3, and 3.63 hrs for Scow 4. Load times show that a 10-cm screen significantly impacts debris field removal production. Similar load times were observed when comparing loading directly into a scow with rehandling through 10-cm grizzly bars or loading directly through 10-cm grizzly bars.

As shown by the scow loading durations, the 10-cm screen over the scow significantly impacts dredge production and is not planned to be used in the future. Similar load times were observed when comparing loading directly into a scow with rehandling through 10-cm grizzly bars or loading directly through 10-cm grizzly bars. Similar to the attachment for large debris removal, for future work, the Contractor will be able to determine which one of these loading techniques they will use in their means and methods. To further reduce the impact of debris sorting, while still preserving archeological artifacts and not sending debris to sediment stabilization, it is recommended that the grizzly bar spacing be increased to 15 cm for future work.

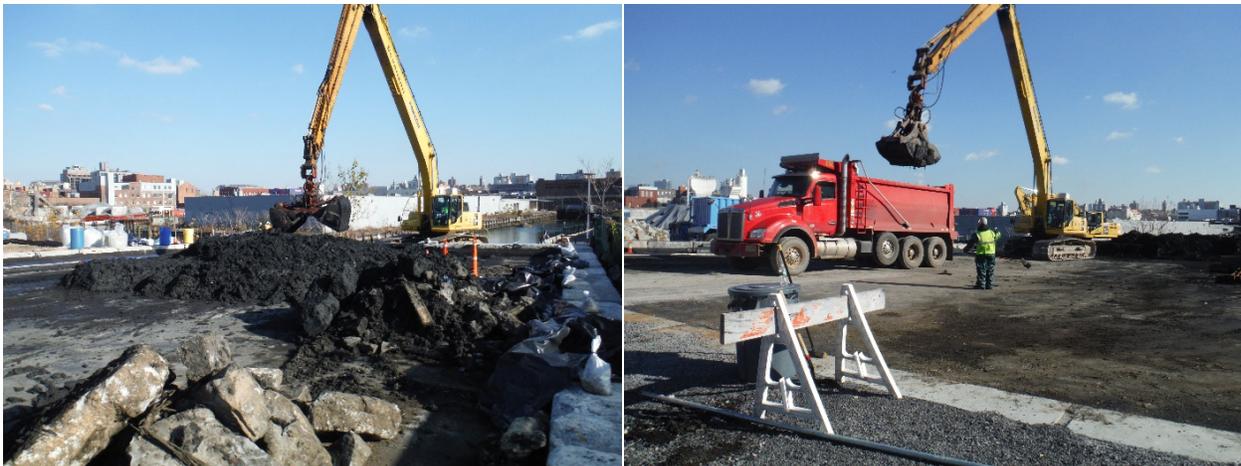
Following large debris and debris field removal, debris and sediment were transported to the site staging area for sorting and disposal. The long reach excavator removed the debris and sediment from the barges, while the excavator sorted the material on the asphalt pad with the rake. Separate debris piles were made for rocks, wood, tires, metal, and general debris. Dredged sediment was stabilized in each scow with Portland cement (approximately 5% by weight). Following stabilization to pass the paint filter test, the sediment was offloaded to the asphalt pad at the staging area. Water decanted from the sediment scows was pumped to a frac tank on the staging site for later disposal. Photos of the debris and sediment offload are presented in Figure 7.

Figure 7. Debris and Sediment Offload to Pad (Left) and Loading of Debris and Sediment to Trucks for Disposal at Permitted Landfill (Right)

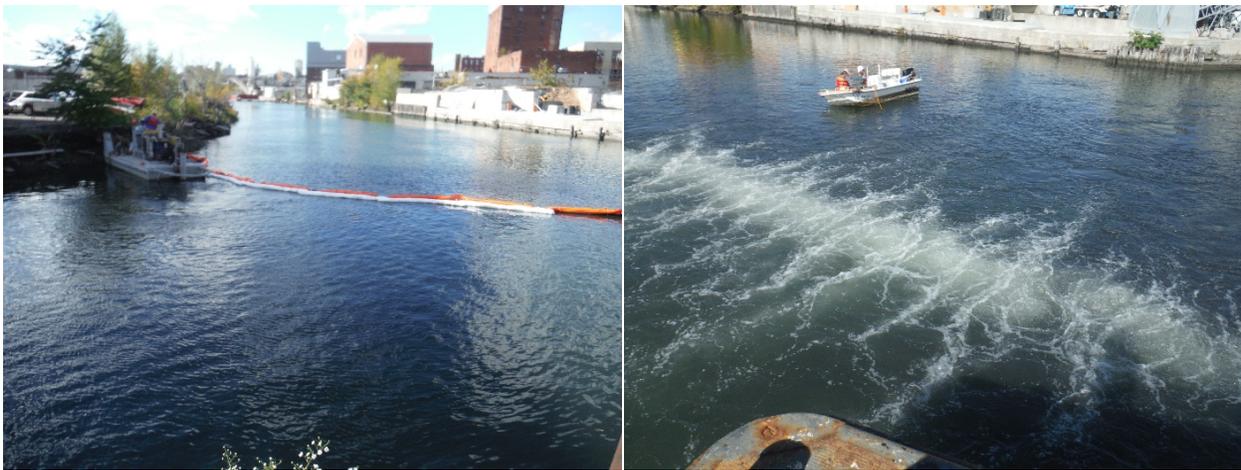
Over the course of the debris removal pilot study, both a turbidity curtain and air curtain were tested for sediment and floatable containment during dredging (Figure 8). The turbidity curtain was deployed upon mobilization and during large debris removal. The air curtain was installed prior to debris field removal. During debris field removal, the air curtain was operated and the turbidity curtain was tied to the bank. At night, the air curtain was shut off and the turbidity curtain was redeployed. This saved costs by reducing fuel and eliminating the need for an air curtain operator overnight. Low fuel and other mechanical issues with the air curtain compressor regularly caused delays, but were usually resolved quickly. While the air curtain was much faster and easier to use compared to the difficulties associated with opening and closing the turbidity curtain, the reliability and added cost of the air compressor and fuel may limit the air curtain as a sole sediment and floatable containment device.

Figure 8. Turbidity Curtain (Left) and Air Curtain (Right)

During the pilot study, both a turbidity and air curtains were deployed. Once the ties holding up the boom on the turbidity curtain were removed to lower the curtain to approximately 30.5 cm from the bottom of the Canal at low tide, the curtain became difficult to open and close. The air curtain was easier to work around than the turbidity curtain as it allowed for vessels to enter and exit the work area without delay. Turbidity data from the water quality monitoring buoys showed a negligible difference between the sentinel and ambient buoys, showing that both the turbidity and air curtains were effective at containing sediment and floatables.

The air curtain was unsuccessful in containing sheen when the dredge barge was straddling the air curtain. The dredge barge should not straddle the air curtain unless additional containment measures are applied such as setting up the turbidity curtain around the barge to contain the sheen. The recommended approach for future work is to deploy an air curtain during dredging or debris removal operations and deploy a turbidity curtain during non-working hours. The turbidity curtain will also provide redundancy in case the air curtain becomes nonoperational.

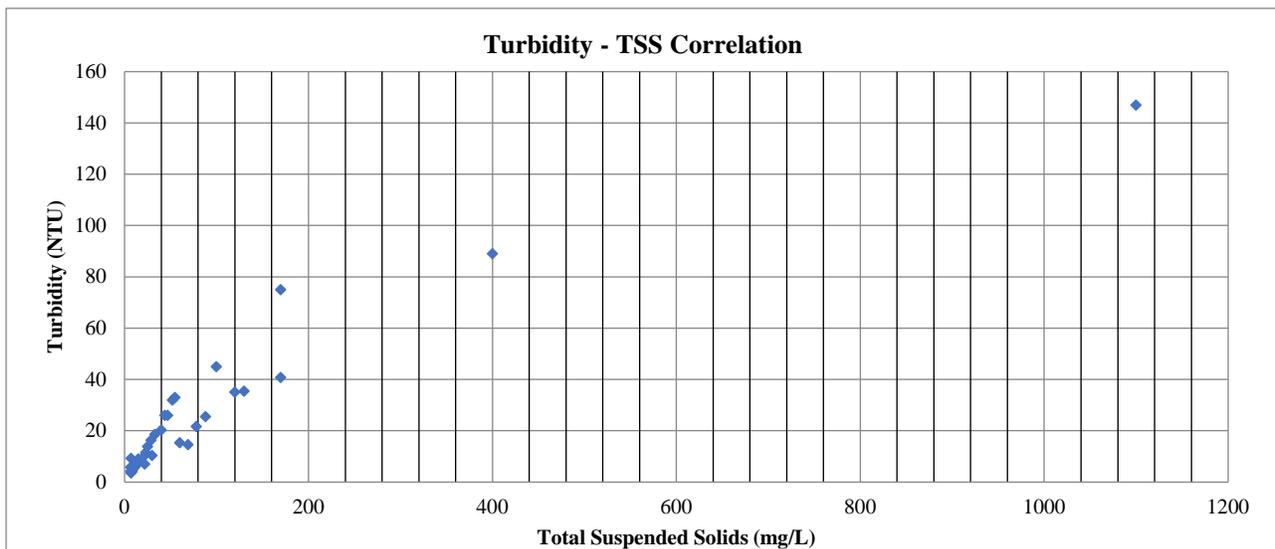
Samples were also collected manually, measured for turbidity, and sent to the laboratory for TSS analysis. Table 6 indicates the turbidity measurements within the plume of turbid water from the debris removal operations. The most turbid plumes were detected not during removal operations, but during movement of barges. The propeller wash was the most impactful due to the shallow depths of the turning basin. A linear correlation between turbidity and TSS was observed (Figure 9).

Figure 9. Turbidity and TSS Correlation
