## ESQUIMALT GRAVING DOCK WATERLOT PHASE 2 SOUTH JETTY REMEDICATION DESIGN AND CONSTRUCTION CHALLENGES

### ABSTRACT

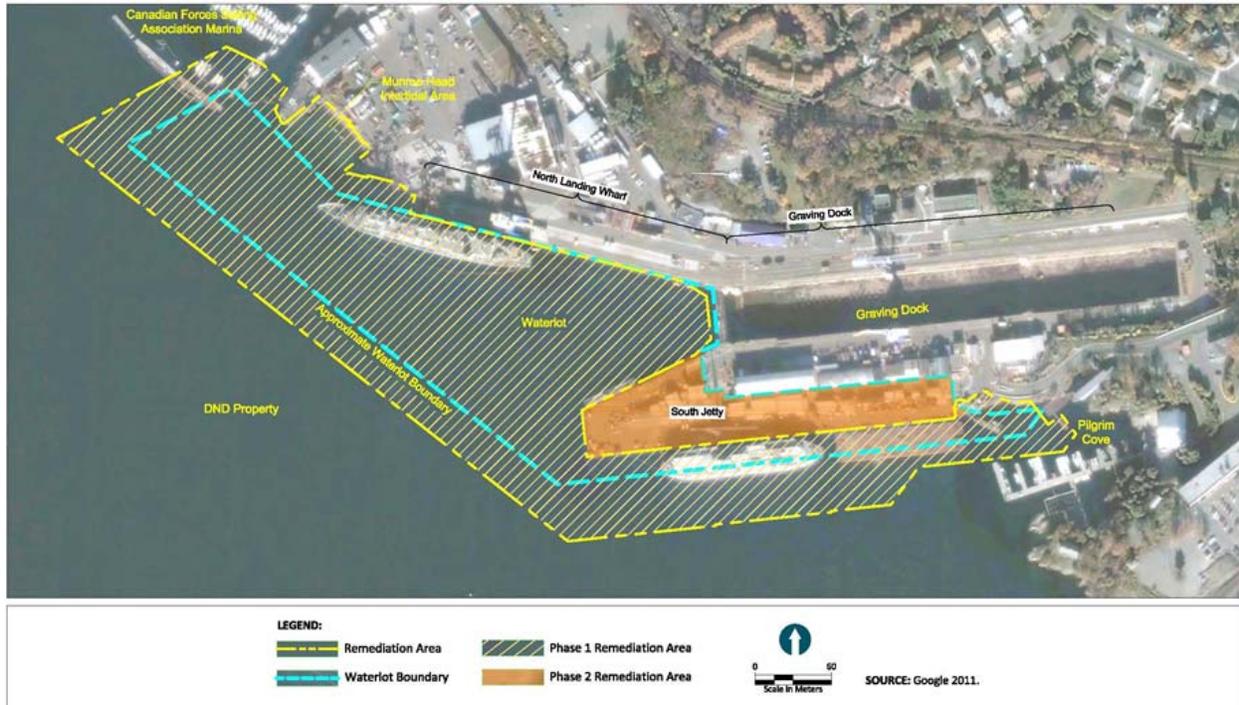
**Figure 2. Project area and boundaries.**

A remedial options assessment was conducted as part of the development of the initial Remedial Action Plan/Risk Management Plan. Various alternatives and technologies were evaluated, and the preferred alternative selected by PWGSC consisted of maximum practicable removal of contaminated sediments through dredging and off-site disposal, to be conducted in two phases to address sediment contamination as soon as possible. Phase 1 consisted of open-water sediment remediation and was completed in March 2014, while Phase 2 addressed remediation of the sediments beneath the South Jetty (Figure 2) and was completed in December 2016.

Phase 1B consisted of remediation of the open-water area of the Waterlot, with maximum practicable removal of approximately 144,000 m<sup>3</sup> of contaminated sediments (Figure 2). The dredge prism design and overall construction sequencing for remedial dredging were established to maximize contaminant removal, minimize potential for dredge residuals and recontamination, and minimize impact to ongoing EGD operations during construction. A post-construction sand layer was placed at the end of Phase 1B to address dredge residuals and provide a clean post-construction surface. Implementation of the Phase 1B open-water dredging effort was conducted by Frasier River Pile and Dredge and occurred from June 2013 to March 2014.

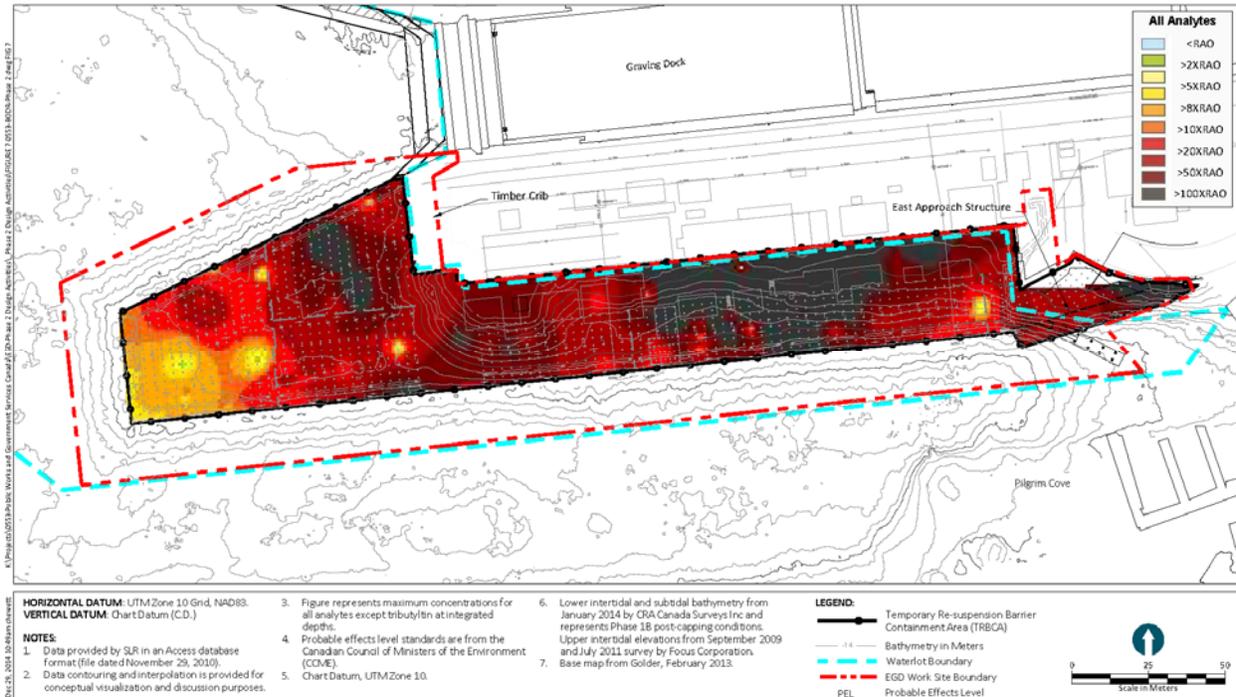
The EGD Project sought to remove the maximum amount of contaminated sediments that exceeded the most stringent numeric criteria for a given contaminant based on the Canadian Council of Ministers of the Environment Probable Effects Level or British Columbia Contaminated Sites Regulation Sediment Quality Criteria for typical contaminated sites. These numeric criteria are referred to as numeric remedial action objectives (NRAOs) and were also used as the basis for cap modeling within the Phase 2 project area and recontamination assessment outside the Phase 2 project area. Figure 3 shows concentrations above NRAOs within the Phase 2 project area prior to remediation.

Figure 3. Maximum contaminant concentration at integrated depths.

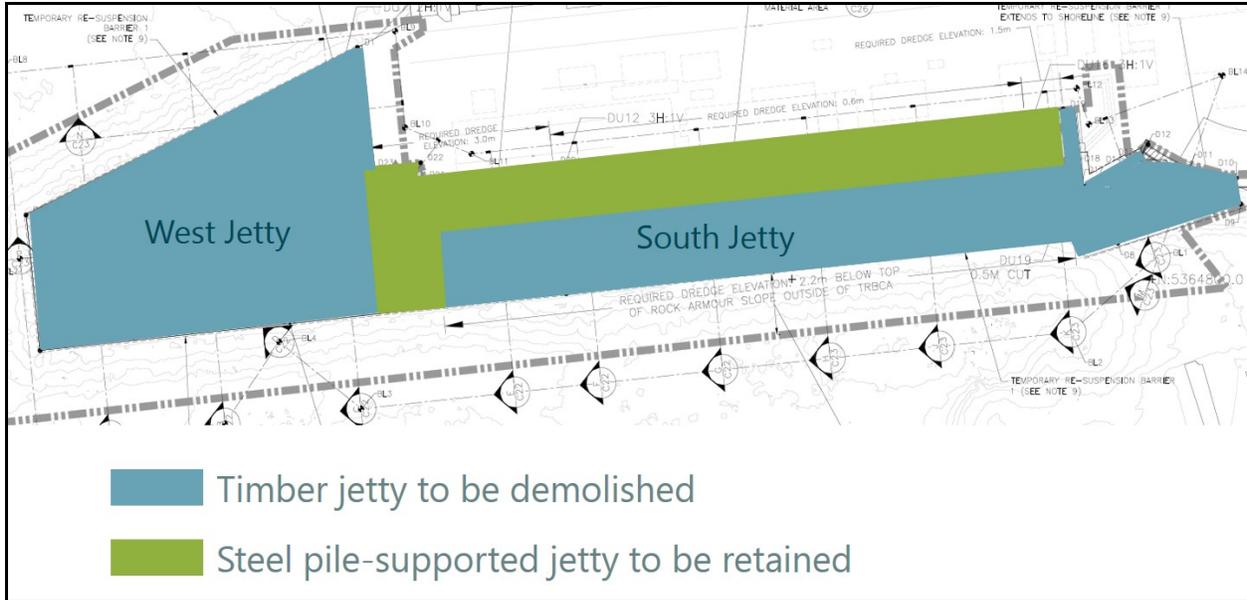
The EGD Phase 2 design documents allowed the contractor flexibility for construction sequencing regarding demolition of the timber jetty structure. The jetty was divided into two areas. The West Jetty area included the section of structure west of the concrete deck and steel-pile-supported crane pad, and the South Jetty area extended to the eastern end of the project area in Pilgrim Cove, as shown in Figure 4.

**Figure 4. West Jetty and South Jetty areas.**

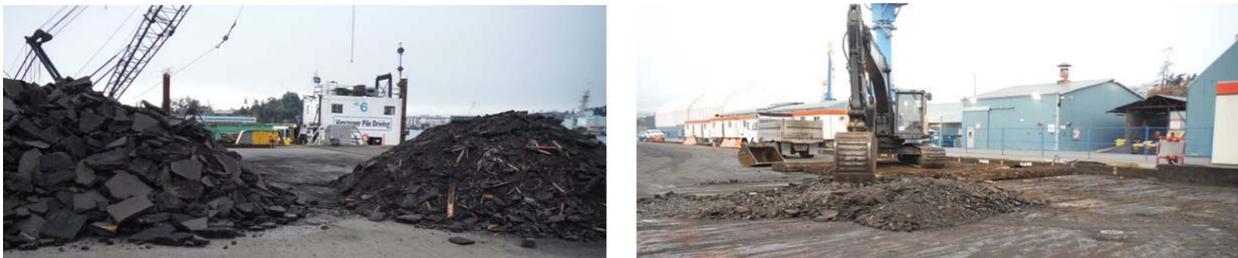
Construction challenges were encountered immediately as the contractor began asphalt section removal in the South Jetty area of the project site. The asphalt section did not peel back from the timber decking easily due to the presence of tack coat material that was applied between the bottom of asphalt and top of the timber jetty deck, and as a result, some treated timber decking was mixed into the asphalt material stockpiles, as shown in Figure 5.

**Figure 5. Asphalt demolition challenges.**

The presence of the tack coat material was not identified in the Reference Drawings provided in the project tender, which resulted in slower production rates and led to the mobilization of specialized equipment to complete removal of the asphalt material. Additionally, the mixing of treated timber debris into the demolished asphalt material resulted in the asphalt not being accepted at the recycling facility for reuse. The demolished asphalt and timber debris needed to be disposed of at a landfill facility, which resulted in the need to utilize contingency funding to cover the added costs for time used to remove and dispose of the demolition debris.

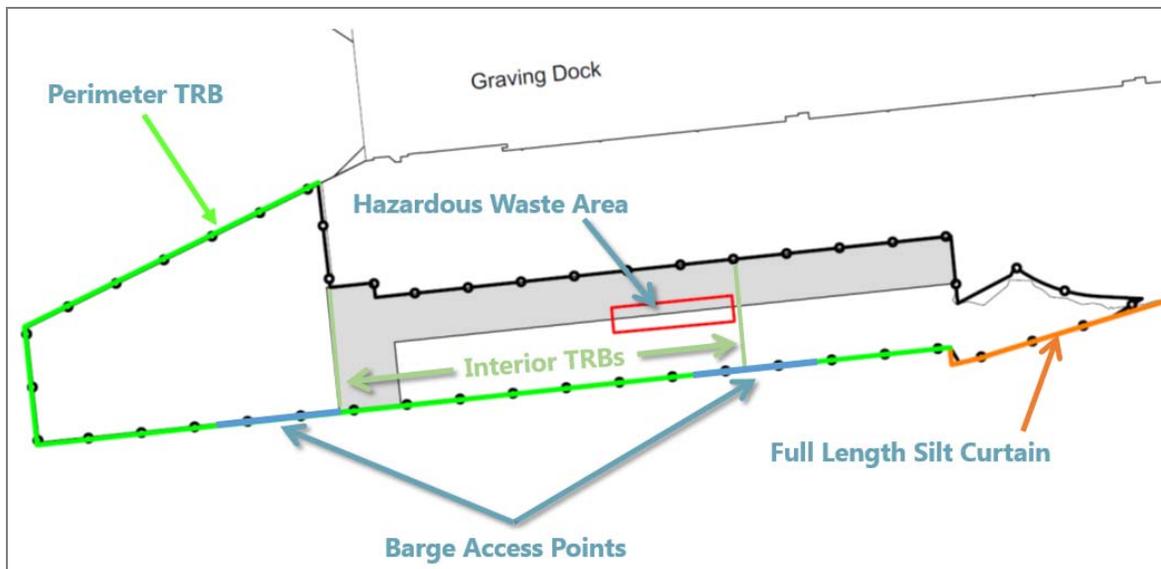
The objective of the TRB was to create a physical barrier around the jetty perimeter (and dredge equipment) to prevent the spread of suspended sediment generated during dredging operations. The TRB extended around the entire Phase 2 work area (Figure 6) and included an area along the eastern side where a full-length silt curtain was necessary because sheetpile could not be installed during Phase 1A due to the presence of shallow bedrock (Figure 7). The contractor partitioned the work area using additional "intermediate" TRBs to physically isolate contractor-defined subareas and thereby prevent recontamination during construction.

Figure 6. Perimeter and interior temporary resuspension barriers.

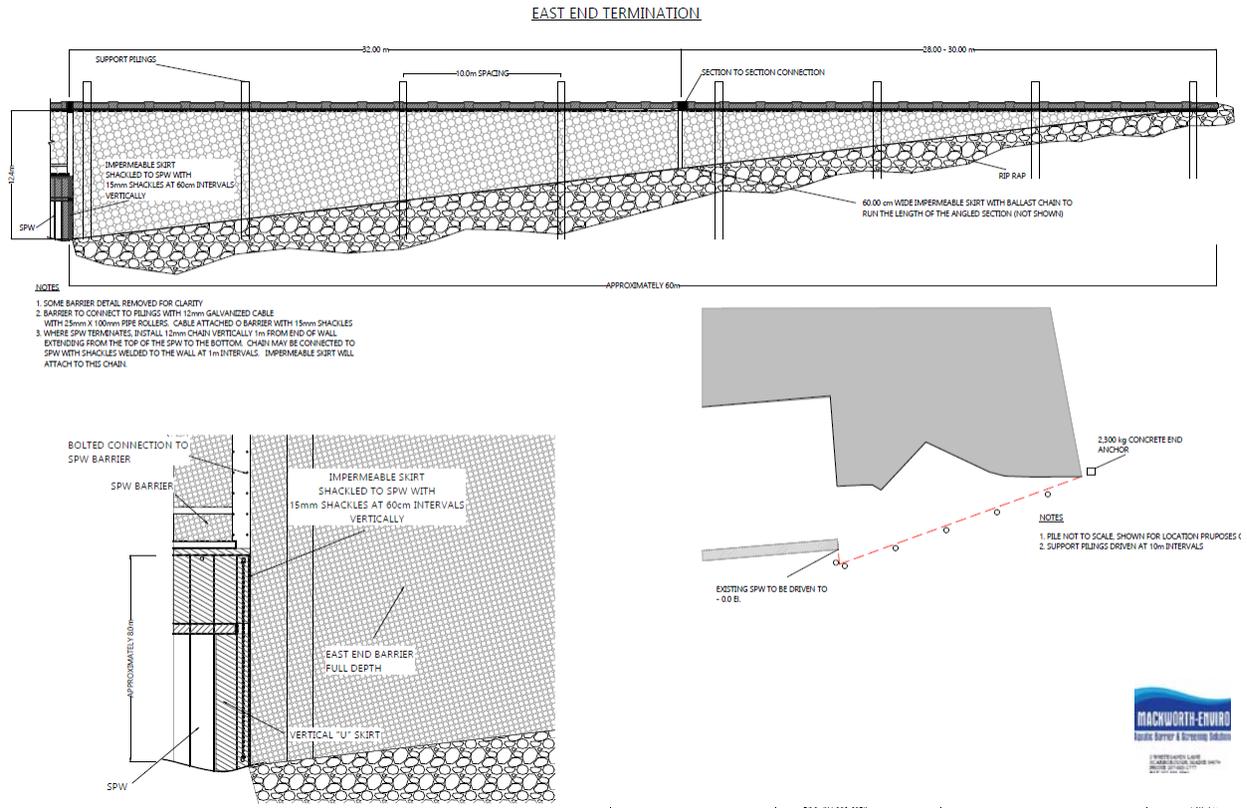
Figure 7. East end profile – full length curtain.

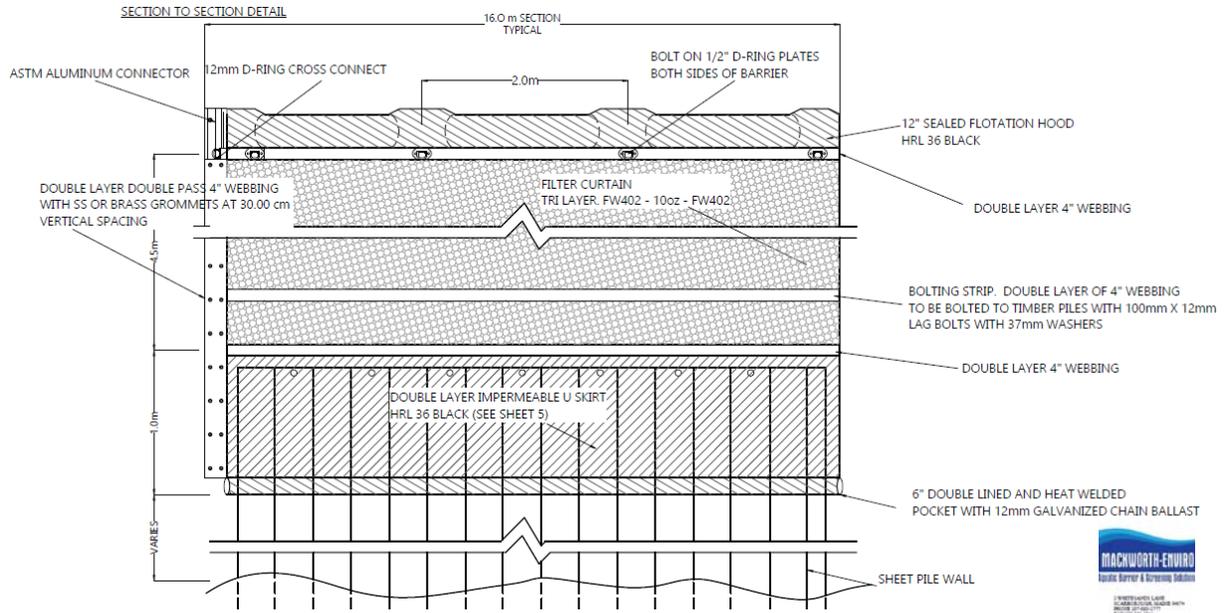
The silt curtains used for the TRBs were made of flexible, reinforced, thermoplastic material, including a tri-layer filter media (FW402 – 10 ounces [oz]), suspended from a 2.5-centimetre flotation hood constructed of 36-oz CoolThane-coated nylon (Figure 8). The bottom of the curtain was constructed with an impermeable layer U-skirt, which overlapped on both sides of the top of the sheetpile wall that was anchored with a 12-millimetre chain ballast (Figure 9). TRBs are most effective on projects where they are not opened and closed to allow equipment access to the dredging or disposal area; however, for Phase 2 of the project, it was necessary to allow several openings of the TRB to facilitate ingress and egress of the contractor’s equipment into and out of the TRBCA.

Figure 8. Typical perimeter temporary resuspension barrier curtain.

The TRB system was procured and installed prior to the extraction of timber piling completed as part of South Jetty demolition activities for the project. Schedule delays were realized during design and fabrication of the silt curtain system which resulted in delay in delivery of the system materials to the project site. Installation challenges included deploying the TRB system and anchoring it to temporary mooring piles and the seabed in accordance with the requirements of the third-party engineer design. Additionally, fabrication of the full-length curtain shown on Figure 7 and the interior TRB sections (Figure 6) did not match the seabed profile, and in-field modifications to the system were required during installation to better fit the curtain to the bathymetry profile for the project site (Figure 8).

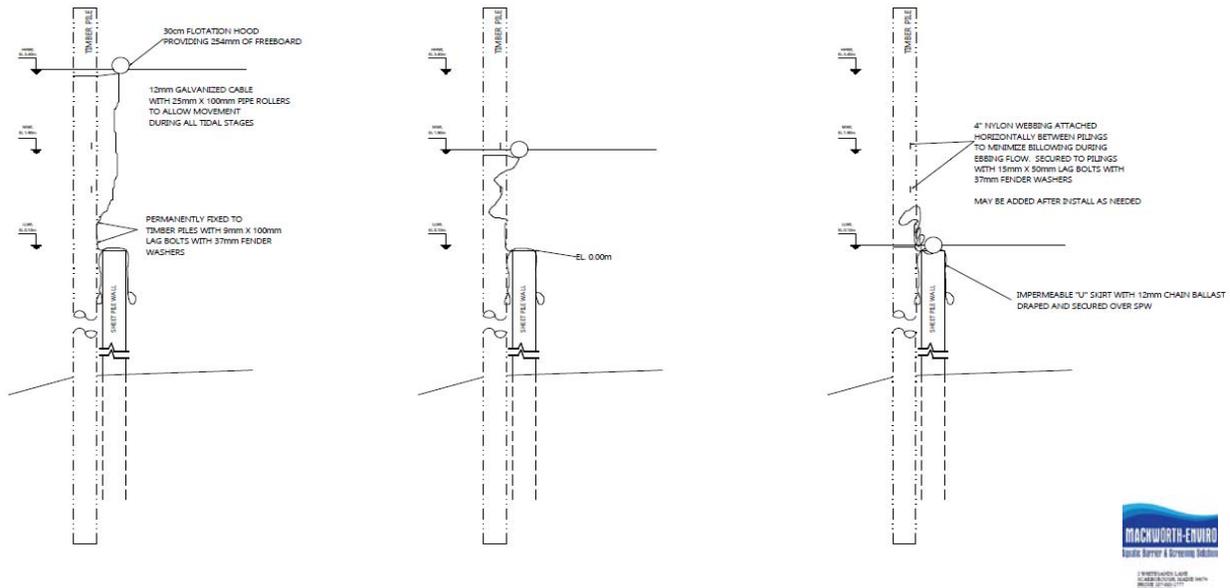
Figure 9. High/low water perimeter temporary resuspension barrier profile.

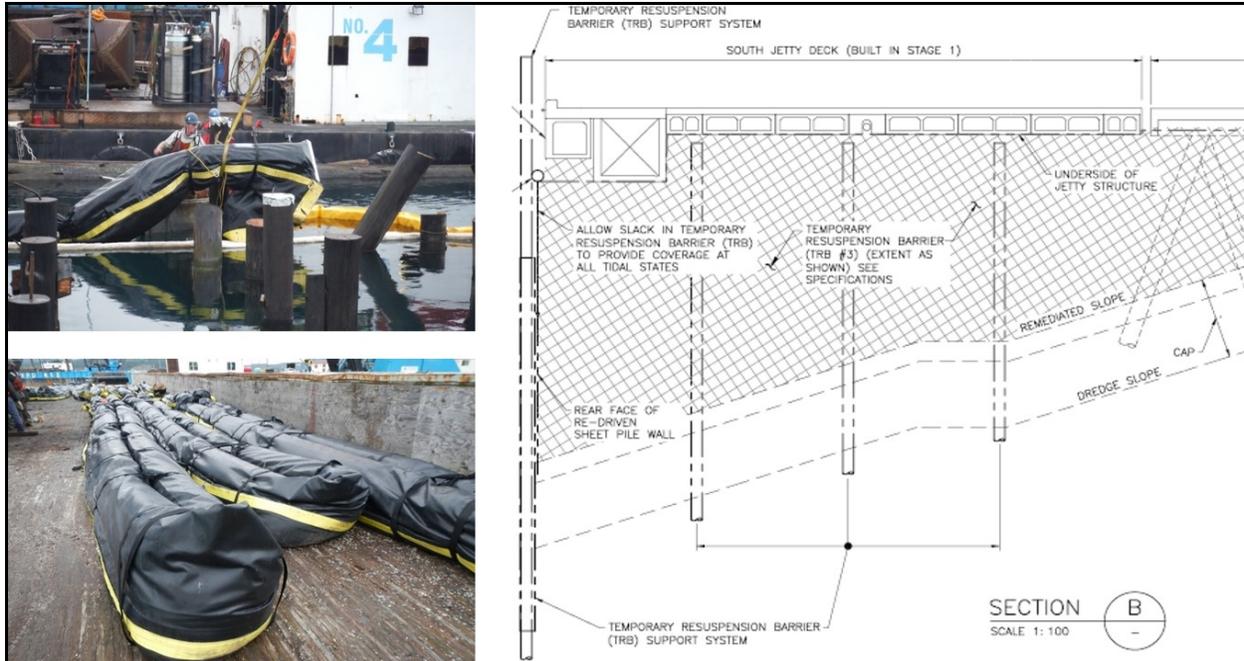
**Figure 10. TRB system deployment and bathymetry profile fitting.**

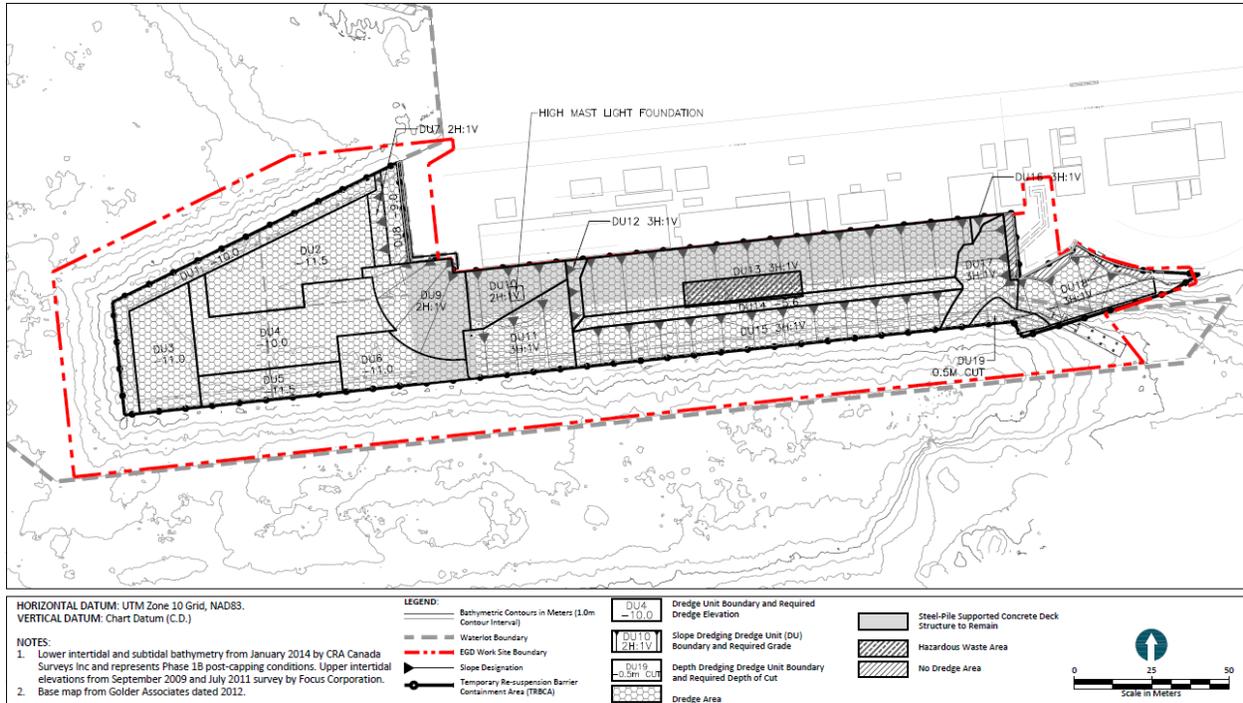
The dredge prism identified the minimum horizontal and vertical extents of required dredging for the contractor as part of the Phase 2 project and is shown in Figure 11. The dredge prism has two components: the required dredge prism and the allowable overdredge. The required dredge prism represents the elevation, grades, and horizontal extent of sediment that a dredging contractor is required to remove. The allowable overdredge is a constant thickness of sediment below the required dredge prism that design engineers typically allow to account for equipment inaccuracies and tolerances. The design of the dredge prism accounts for the fact that it is not possible for any dredge to excavate to an exact surface and that the dredge ends up removing excess material below the required dredge prism.

Figure 11. Phase 2 dredge plan.

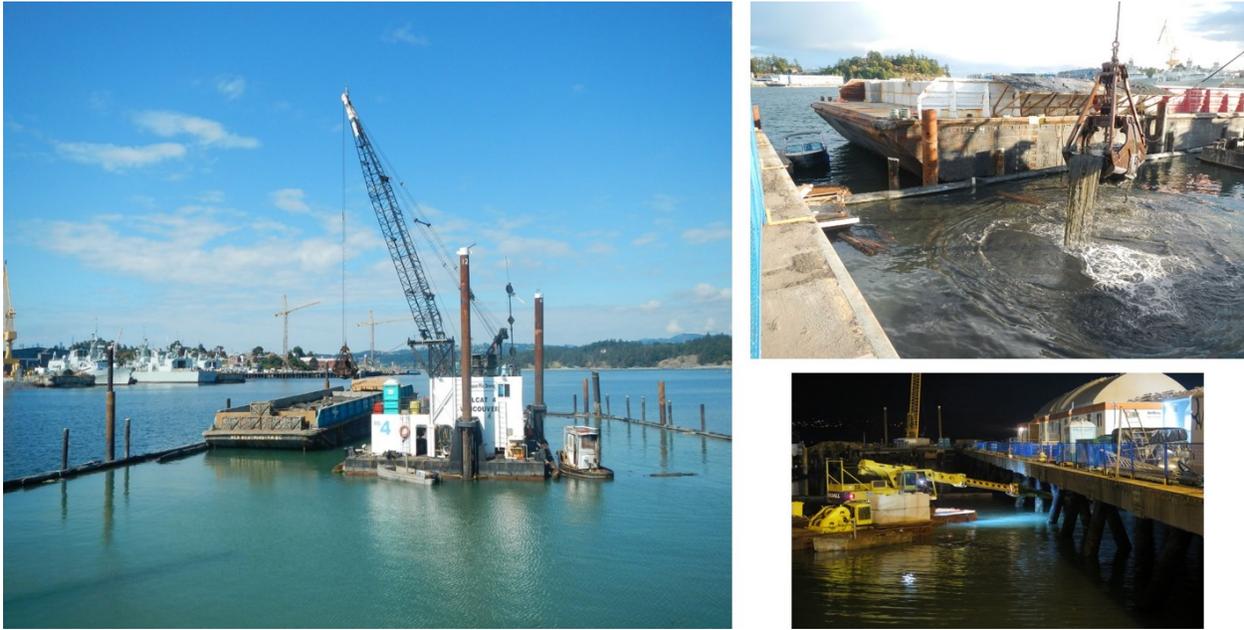
The type of mechanical dredging equipment used for this project ranged from a traditional clamshell dredge for debris removal operations, environmental buckets for cleanup pass and water quality considerations, and articulated and/or telescoping dredges (e.g., Gradall) in the areas beneath the steel-piled concrete deck structure. In addition to

the mechanical dredges, a small excavator was used to remove material in intertidal under-jetty areas where access was feasible. Examples of some different dredging equipment types are shown in Figure 12.

**Figure 12. Mechanical dredging equipment.**

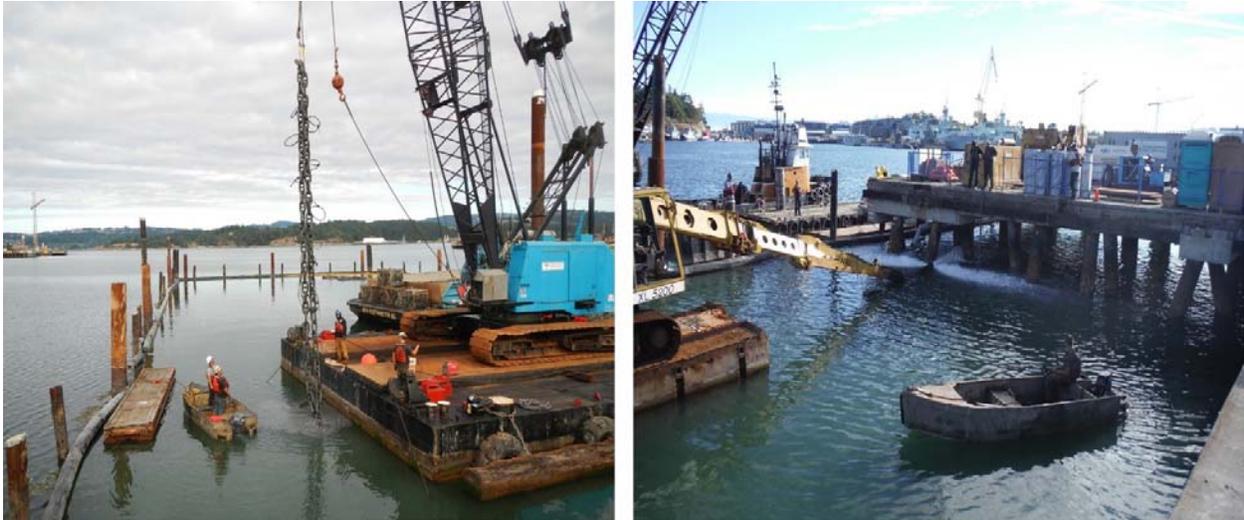
Several areas of the Phase 2 project site involved removal of contaminated material below existing pier decks and around support piling that were to remain in place and not be damaged during implementation of the project. In some cases, the equipment selected to complete the dredging activities was limited in access to these areas and could not meet the removal requirements of the design. The contractor was required to come up with innovative dredging technologies in an attempt to meet the design requirements, including implementation of non-conventional dredging technologies such as chain dredging (e.g., fabrication of articulated steel chain to pull back and forth between pile bents in under-pier areas where mechanical dredge equipment could not access) and the use of hydraulic jetting to loosen dense material and debris and move them to locations where they could be removed with the mechanical dredge equipment. Figure 13 shows examples of these innovative technologies that were implemented in under-pier and difficult-to-access areas for the project and assisted with removal of additional material that could not be accessed with the conventional dredging equipment.

**Figure 13. Innovative dredging technologies (left, chain dredge; right, hydraulic jetting)**

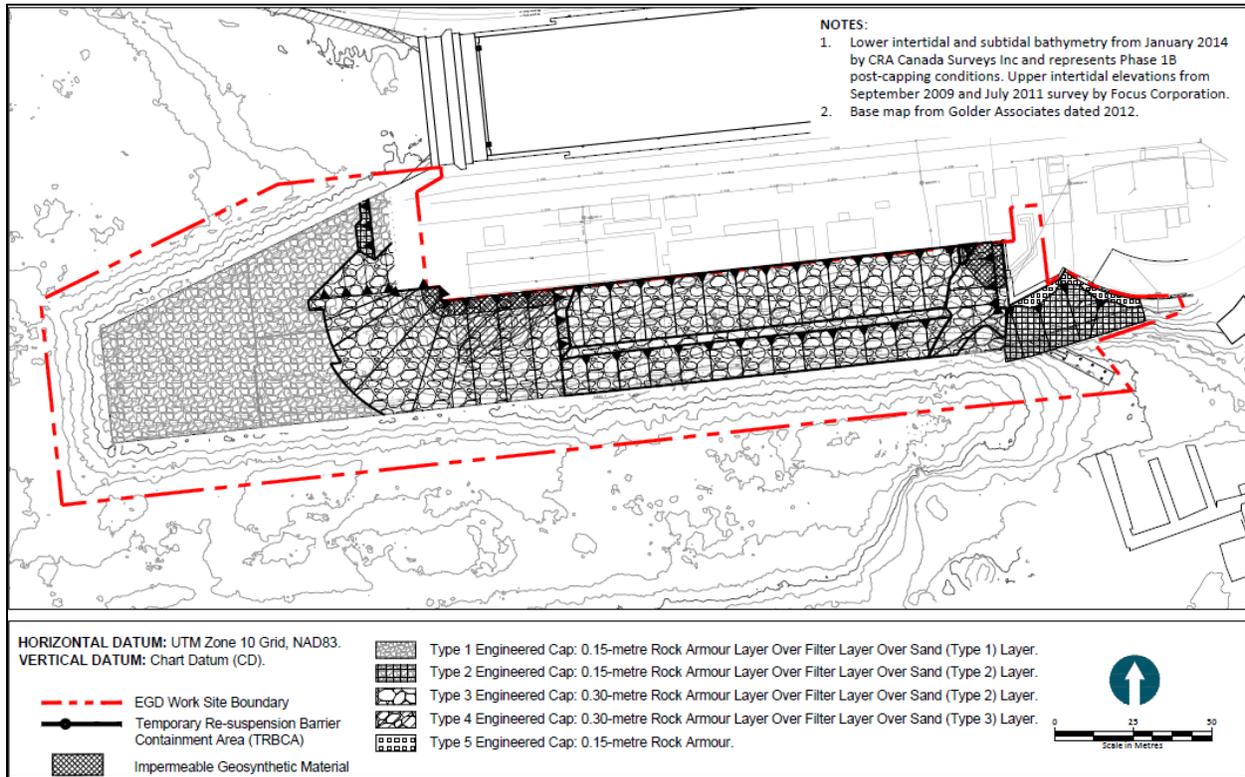
Due to differences in slopes, propwash forces, chemical concentrations, and other parameters, several different cap types were designed for construction around the South Jetty structure. Specifically, five different caps varying in composition of the required isolation material (sand) and armour material were designed for Phase 2 (Figure 14) consisting of combinations of rock armour, filter layer, and sand isolation material.

**Figure 14. Phase 2 capping plan.**

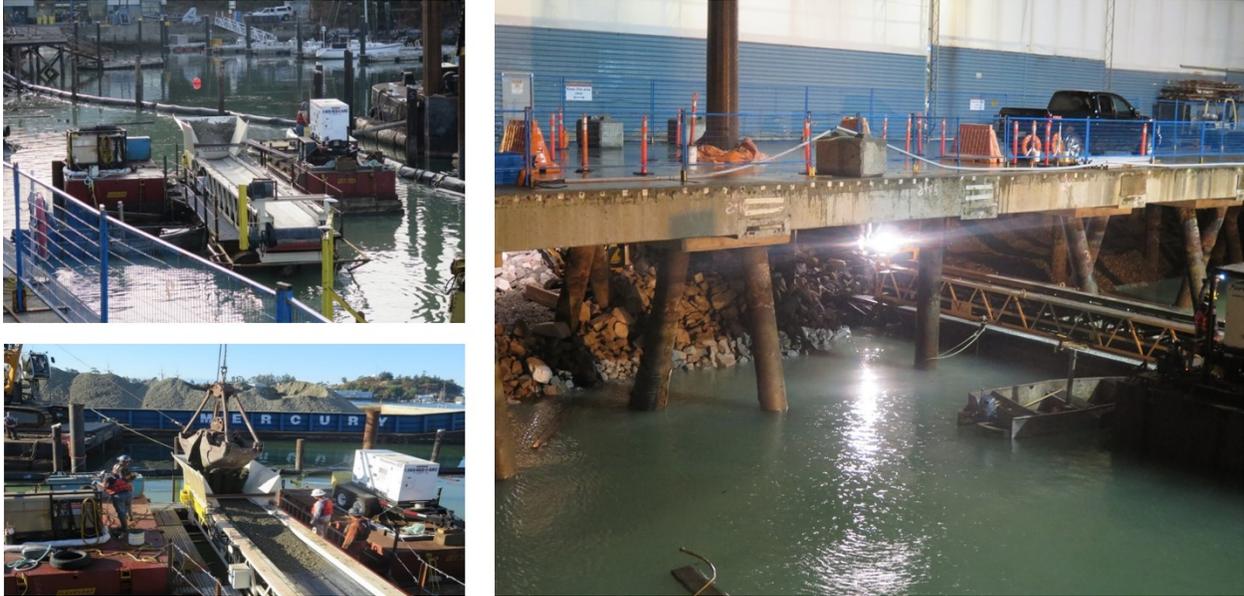
Construction challenges in placement of the engineered sediment cap materials primarily included equipment access to the under-pier areas. The contractor developed an innovative approach to place material in the under-pier areas using a material conveyor staged on an engineered Flexifloat system. The equipment set up was small enough that it could move within the TRBCA, and a larger derrick barge and material barge could be staged outside the TRBCA to load and conveyor as it placed the different capping materials. Additionally, the contractor built an access road along the upper slope areas (beneath the jetty deck) to allow for access of small dozers and excavators that assisted with movement of the material as it was placed from the conveyor system. Figures 15 and 16 provide some examples of the equipment and configurations that were used for construction of the engineered sediment caps.

**Figure 15. Conveyor equipment for placement of engineered capping material.**

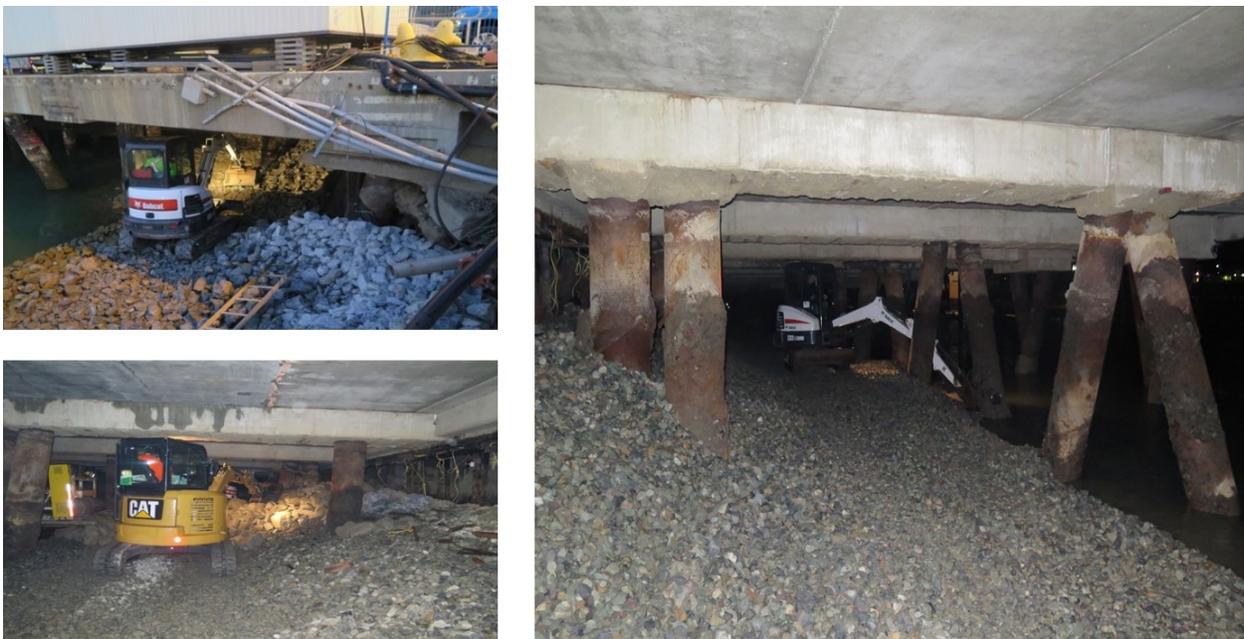
**Figure 16. Under-pier road access and engineered cap construction.**
