CONTROLLING RECONTAMINATION DURING PHASE 2 REMEDIATION AT THE ESQUIMALT GRAVING DOCK

ABSTRACT

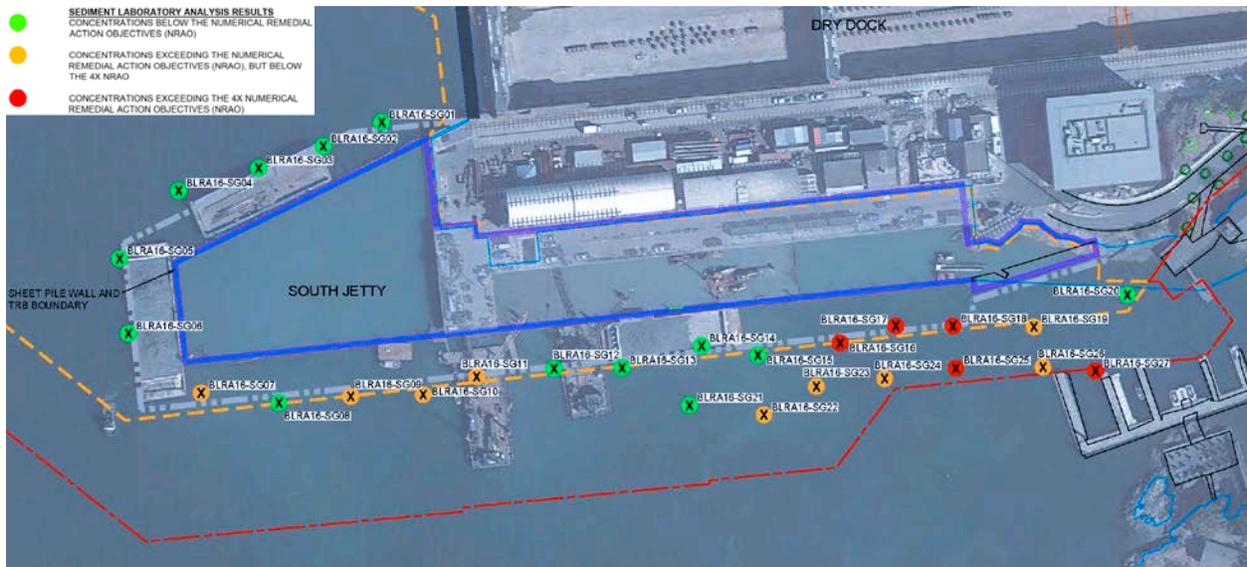
Figure 11. Post-construction sediment quality re-assessment locations and results compared to NRAOs.

Following substantial completion of the Phase 2 project, sediment quality was again re-assessed to determine whether recontamination occurred outside the TRBCA as a result of the Phase 2 construction work. Surface sediment samples were collected once all dredging activities were completed at each baseline and additional step-out location. Samples were submitted for analytical testing of total metals, PAHs, PCB, TBT, pesticides, and dioxins and furans, similar to the baseline sampling event. Results were compared to the Phase 1B NRAOs, as well as baseline conditions. Sediment chemistry indicated localized areas of higher concentrations of select contaminants of concern, particularly along the eastern portions of the site. The spatial extent of sediments with chemistry in excess of the remedial thresholds was limited, as shown in Figure 11. Increases in contaminant concentrations in surface sediments outside the TRB may be attributable to periodic release of suspended sediment from the Phase 2 work area; however, influx of contaminated sediments from other adjacent areas of the harbour may also have contributed to elevated contaminant concentrations. As noted above, water quality monitoring results are consistent with the observed increase in sediment contaminant concentrations within localized areas at the eastern portion of the site.

Consideration of these results combined with results of the water quality and environmental monitoring program during Phase 2 aided in determining whether additional remedial action was required outside the TRBCA. Potential

- If results are less than NRAOs: no action;
- If results are greater than 1x NRAO but less than 4x NRAO: RMC placement; and
- If results are greater than 4x NRAO: re-dredge.

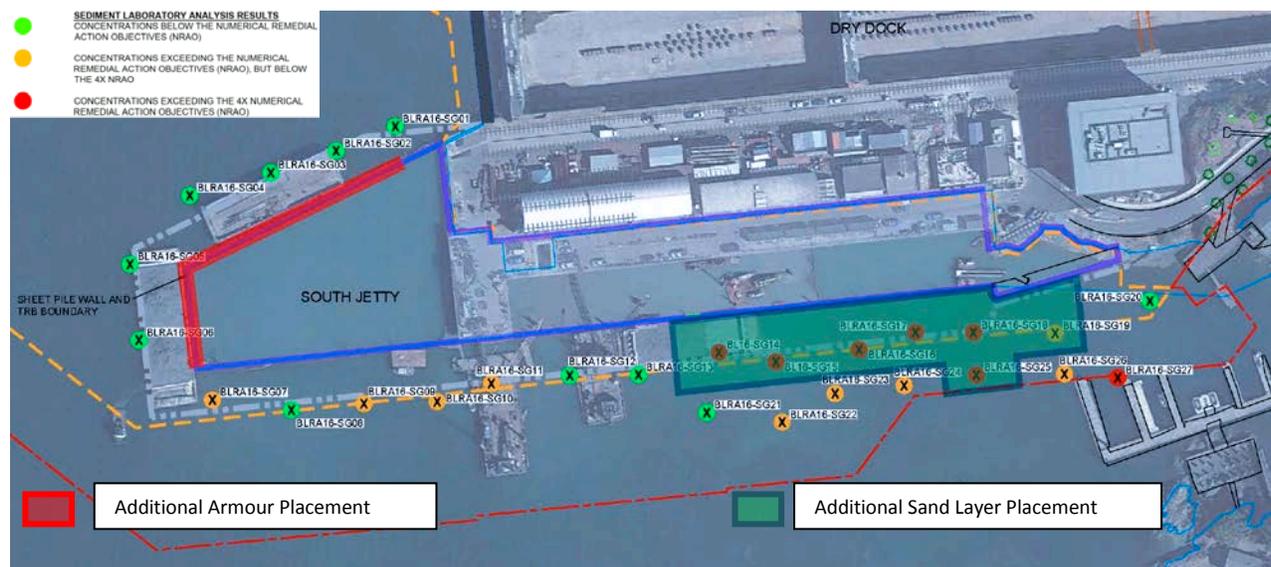
Figure 12. Locations of sand layer and additional armour placement.

Due to scheduling and cost constraints, re-dredging of areas outside the Phase 2 boundary was not practical. In order to address the elevated concentrations of contaminants of concern observed in the interim and post-construction sampling events, the contractor placed a sand cover in areas with higher concentrations outside the Phase 2 work area to provide a clean surface at the end of construction. The sand layer was placed with a thickness of 0.30 m in areas where exceedances of the 4x NRAO multiple were noted during the May, June, or October 2016 sampling events. This sand layer is expected to mix with underlying sediments over time to achieve overall remedial targets at the site, and will be monitored for performance in the long term. Figure 12 shows sand layer placement locations.

Post-construction diver surveys were also conducted along the armoured slopes and within the Phase 2 area for comparison to baseline conditions and to document evidence of dredgegate spillage or other conditions not meeting design requirements of the project. During these surveys, it was noted that along the northern and western boundaries of the site, exposed sediments were present due to extraction of the sheetpile wall in these areas. Additional armouring was installed by the contractor to limit exposure of these sediments and provide a consistent isolation barrier between the Phase 1B and Phase 2 armouring. Figure 10 shows locations where additional armour was placed at the conclusion of the Phase 2 project.
