REVITALIZING A PUBLIC TREASURE: SEDIMENT CLEANUP AND RESTORATION OF THE EDDON BOATYARD PROPERTY IN GIG HARBOR, WASHINGTON

Michael P. Whelan P.E.¹, Ed Berschinski², David Templeton³, Stephen Misiurak P.E.⁴, Joe Pursley⁵

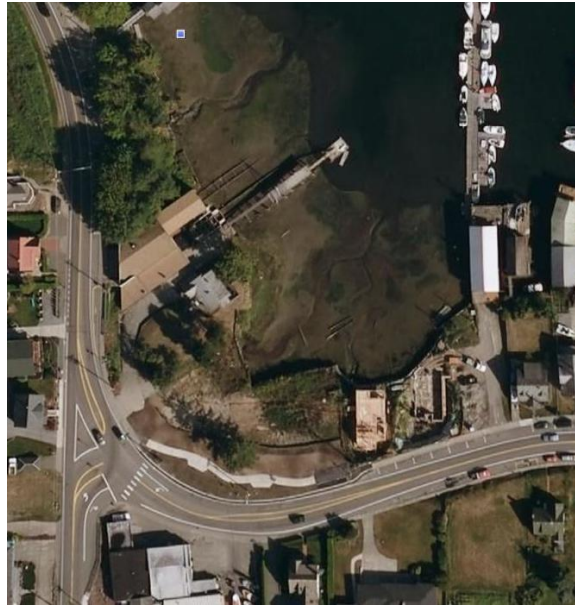
Figure 1. Aerial view of pre-construction Property, Gig Harbor, Washington.

The Property, shown in aerial view on Figure 1, is located in the City of Gig Harbor (City), Washington, where it is recognized as a significant portion of the City's historic waterfront. In 2004, the residents of the City approved the \$3.5 million Proposition No. 1 Land Acquisition and Development General Obligation Bond (Proposition No. 1) to preserve this portion of the historic waterfront. After completing a review of environmental conditions, the City purchased the Property in March of 2005 with the intention of developing it into a waterfront park and housing an interactive shipbuilding museum at the Property's historic boathouse. To meet this objective, initial park development activities included hiring an environmental consultant through a competitive bid process, selective building demolition, land clearing, and necessary environmental cleanup of upland and aquatic portions of the Property where necessary, while preserving a historical boathouse and related structures located on site. Environmental remedial actions were coordinated and partially funded through the U.S. Environmental Protection Agency (USEPA) Brownfield Cleanup Grant Program and the Washington Department of Natural Resources (DNR) creosote piling removal program.

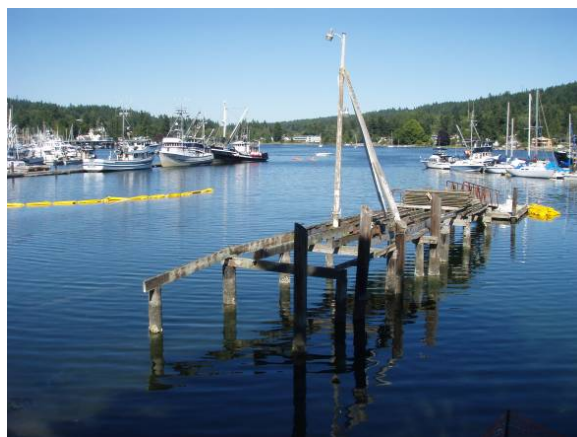
Figure 3. Timber pier structure to be removed prior to dredging.

A set of marine railways and a timber pier (Figure 3) were present within the area requiring sediment removal. As part of the process of gaining concurrence from Ecology, the City elected to demolish the marine structures (i.e., a timber pier and two sets of boat haul-out rails), including their timber support piling; while relocating and preserving a floating dock, gangway, and carriageways assembly as that these features could be rebuilt at the site in the future. The demolition actions would greatly facilitate the contractor's ability to accomplish full removal of impacted sediments.

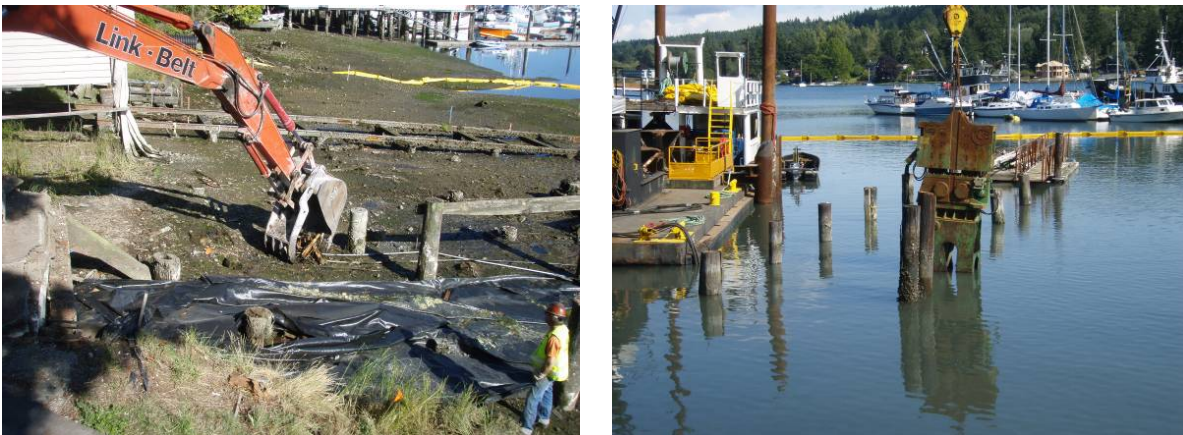
Figure 4. Extraction of timber piles using land-based excavator (left) and vibratory hammer (right).

- **Marine Railways.** A total of 78 creosoted piles were removed from the railway area. The marine railway piles consisted of relatively short piles ranging in length from 2 to 4 feet (0.7 to 1.2 m). The visible marine railway piles were removed by an excavator and additional buried piles were removed during dredging activities.

- **Boatyard Pier.** A total of 41 creosoted piles were removed from the boatyard pier and pier footprint. The boatyard pier piles consisted of piles ranging in length from 8 to 20 feet (2.5 to 6 m). Nearly a third of the piles were removed by excavator from land and the remaining removed from waterside by floating crane and barge.

- **Wooden Bulkhead.** A total of 39 creosoted piles were removed from the wooden bulkhead structure. The wooden bulkhead was comprised of both piles and horizontal timbers. Both creosoted piles and horizontal timbers were removed by excavator.

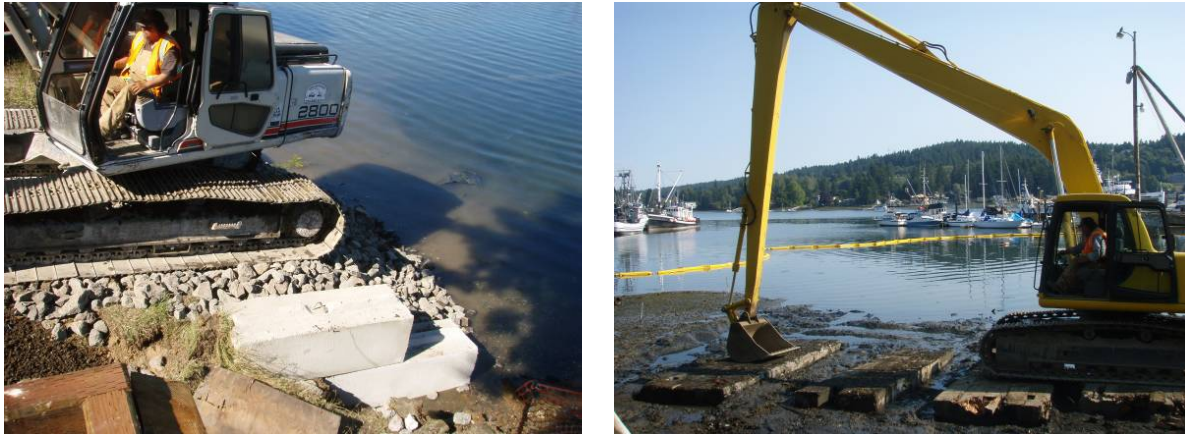
Figure 6. Use of gravel ramp and log mats to provide access for land-based dredging equipment.

Approximately 2,250 tons (2,000,000 kg) of sediment were dredged from the Property, generally to a depth of 2 feet (0.7 m) below mudline. Access ramps and log mats were placed (Figure 6) to allow access to intertidal and nearshore areas by a combination of a long reach track hoe and short reach track hoe (Figure 7). Dredging in areas farther offshore and not reachable at extreme low tides was performed over water by mechanical dredging equipment (clamshell bucket) during medium to high tide events.

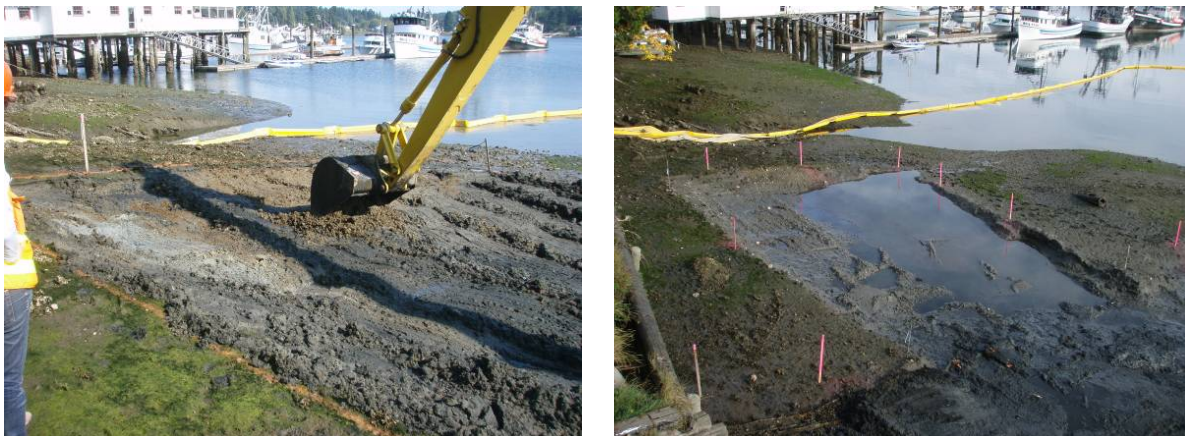
Figure 7. Dredging with long-reach trackhoe, with area delineated using survey stakes.

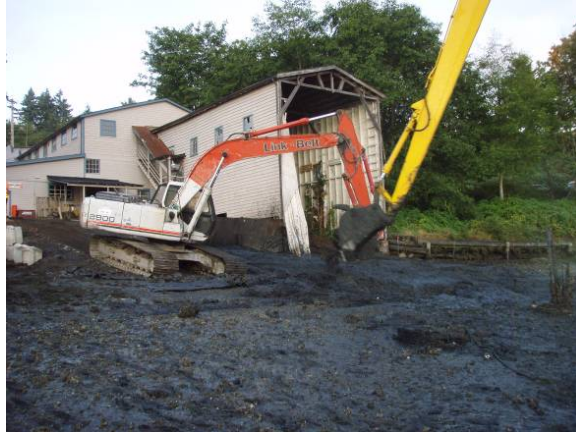
Figure 8. Transferring dredged sediments from the long reach to the excavator to the staging area.

Dredged sediment was hauled to off-site disposal locations via different methods for the land-based equipment dredging and the water-based equipment dredging. Sediment and soil that was removed using land-based equipment was stockpiled at the established on-site staging area. When the long-reach excavator was being used for dredging from areas farther offshore, it transferred the material to a smaller trackhoe, which moved it to the stockpiling area (Figure 8). From the on-land stockpile area, sediment was loaded into trucks for transport to the upland staging area and ultimately transported to the Pierce County Recycling and Disposal Facility located in Graham, Washington. Truck transport and landfill disposal required that the sediment be sufficiently dewatered to pass the “paint-filter” test, ensuring that free water was minimized during its transportation. Since stockpiling area was limited, the contractor elected to accelerate the dewatering process by adding sawdust and diatomaceous earth to the stockpiled sediment (Figure 9), which allowed it to be sent off-site sooner.

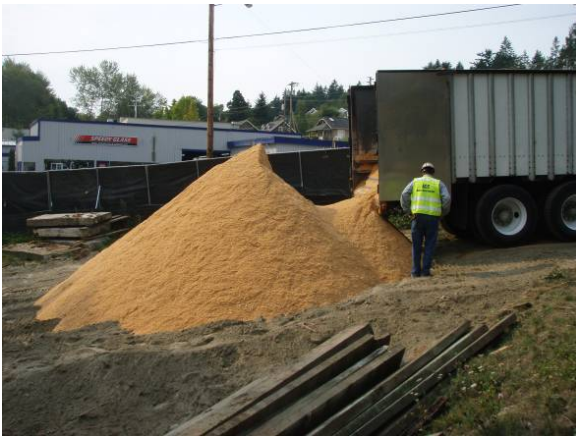
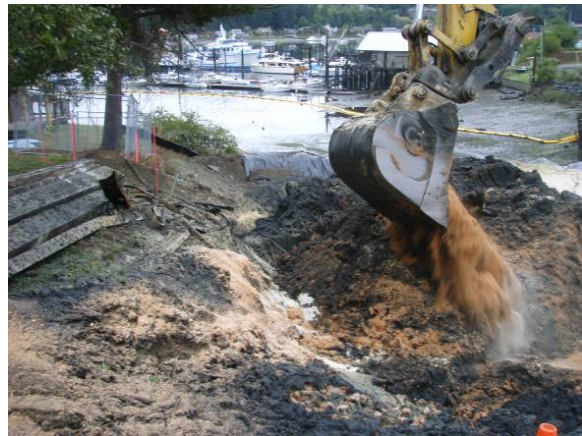
Figure 9. Mixing of sawdust and diatomaceous earth into sediment to promote dewatering.

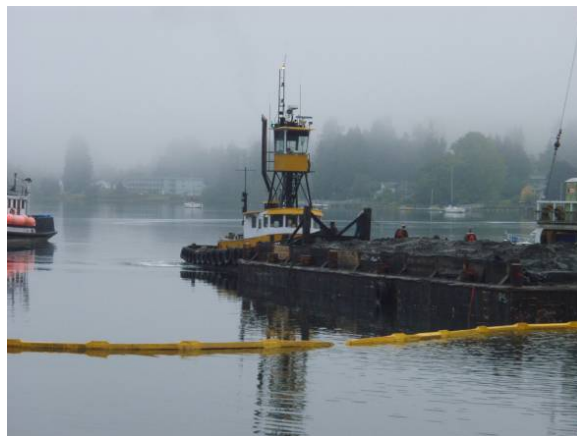
Figure 10. Removal of dredged sediments by barge.

Dredged material produced by on-water activity was stockpiled on a barge and transported by tugboat (Figure 10) to an offloading area in Tacoma, Washington. Dredged sediment was then loaded into trucks for transport to the LRI Landfill.

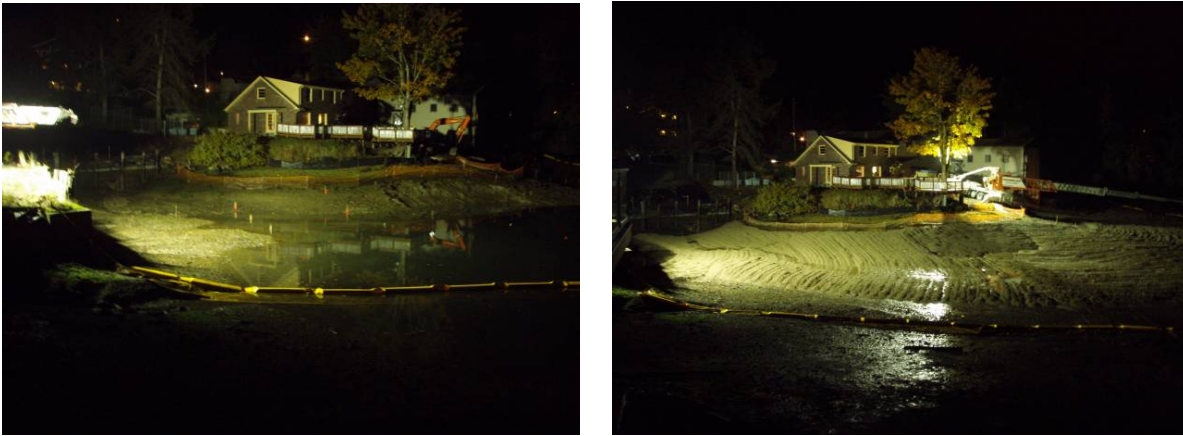
Figure 11. Views of site prior to cap placement (left) and following cap placement (right)

Altogether, approximately 2,300 (2,100,000 kg) tons of sand and approximately 1,950 tons (1,770,000 kg) of gravel were placed at the site. Figure 11 shows the site as it appeared after dredging and just prior to material placement, and then as it appeared after all materials had been placed.

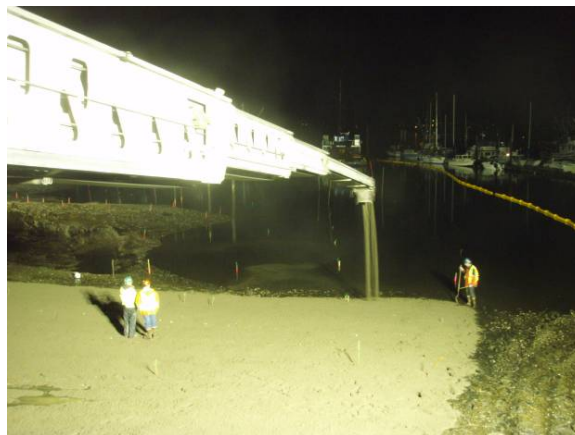
Figure 12. Placement of sand cap using a telescoping conveyor belt.

Capping material was placed using a land-based, long-reach, telescoping conveyor belt (Figure 12). A majority of the capping activities were conducted during late-night hours and at low tide in order to precisely place and control the depth of sand and habitat mix and to ensure quick and traffic-free transport of the sand and rock from the off-site staging area. Grades and layer thicknesses were controlled through the use of interim land surveys and grade control survey stakes laid out on a grid and visible during low tides (Figure 13).

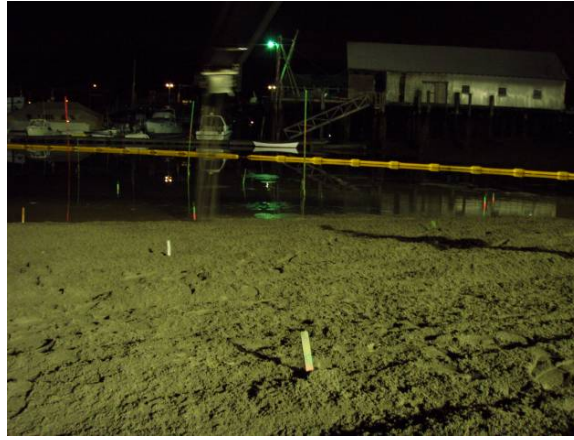
Figure 13. Precision placement of the sand cap with grade control survey stakes showing remaining 6 feet of surface gravel needed.

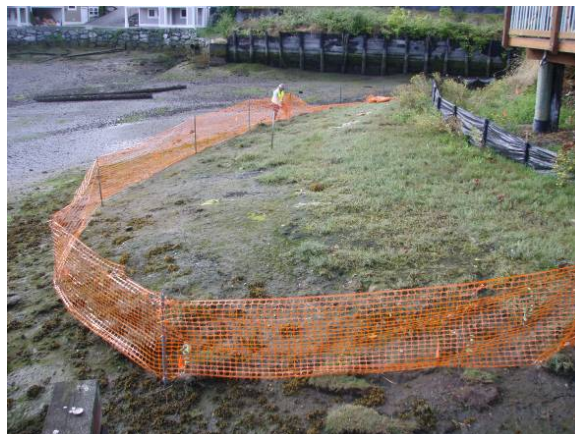
Figure 15. Installation of high-visibility construction fencing around saltmarsh vegetation area.

Project permits required that construction activities be done using environmental BMPs, including continuous and full enclosure of the waterside work area with a floating boom and silt curtain (Figure 14), to contain suspended solids (turbidity) and any material that may have been disturbed into the water. The pre-existing saltmarsh vegetation area needed to be protected throughout the construction work and was surrounded by high-visibility construction fencing (Figure 15).
