LONG-TERM INVESTIGATION OF CAPPING REMEDIATION OF CONTAMINATED SEDIMENT

H. Blischke¹ and J. Olsta²

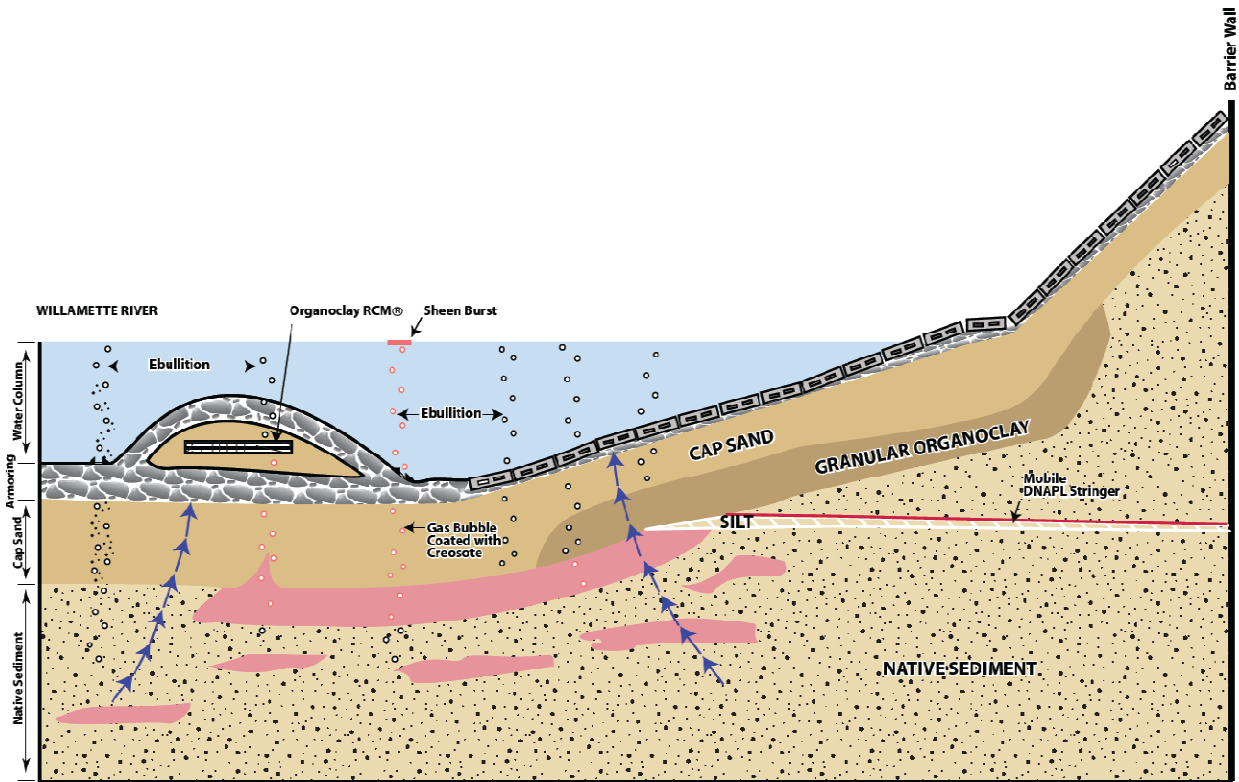
Figure 3. Ebullition-induced sheen conceptual model for McCormick & Baxter.

Subsequent to emplacement of the sediment cap, ebullition-induced sheens were observed in the nearshore environment in locations where known residual NAPL was present in the sediments underlying the cap. Figure 3 shows the conceptual understanding of the generation of sheen resulting from ebullition.

Historically, NAPL migrated from the upland and was also discharged directly into the river as a wastestream, resulting in the presence of residual NAPL in the sediment. When gas bubbles are produced beneath or within these areas of residual NAPL, NAPL coats the bubbles as they rise to the surface. In several locations where bulk granular organoclay was not placed and residual NAPL is present in the sediments, ebullition periodically has resulted in transport of NAPL to the overlying surface water, resulting in a sheen burst at the water's surface (Figure 4). Although ebullition has been prevalent otop of the bulk granular organoclay footprint, no sheen has been observed associated with the ebullition. In most locations above the sediment cap footprint, there is no visual sign of contamination associated with the ebullition. However, in a few spatially discrete locations, sheen bursts were observed at the water surface in association with ebullition (Figure 4). The estimated volume of NAPL present in the ebullition-induced sheen is small; therefore, placement of organoclay-filled Reactive Core Mats® (RCM) in these select areas was determined to be the appropriate remedial action (see Figure 3).

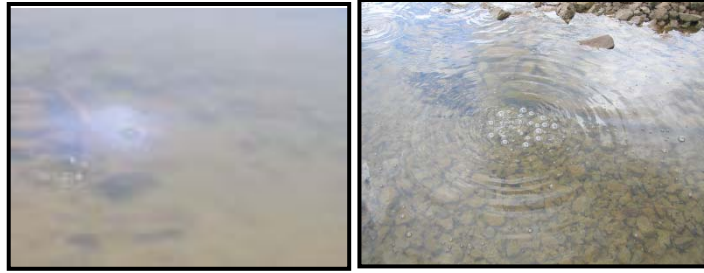
Figure 4. Ebullition-induced sheen (left) and ebullition without sheen (right) (2005).

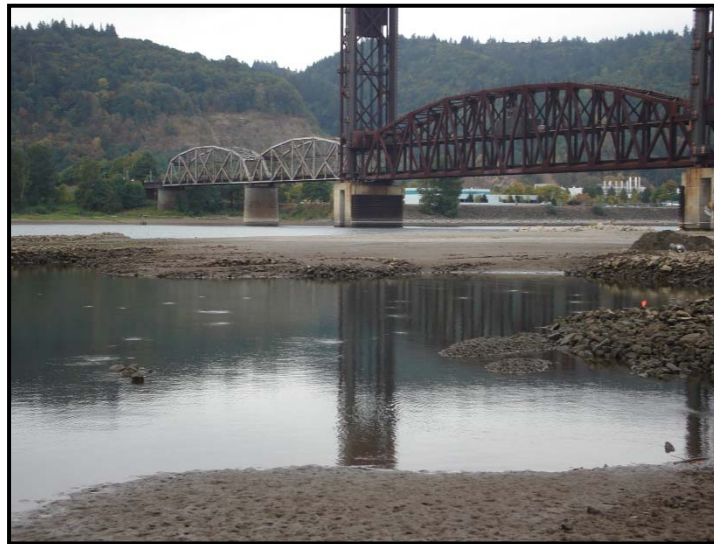
Figure 5. Ebullition in the former Tank Farm Area (2006).

Ebullition is prominent at the site, emanating from the sediment in the summer and fall months (Figure 5). Before installation of the sediment cap and barrier wall, ebullition was observed along the shoreline when the Willamette River stage was low. Since installation of the sediment cap and barrier wall, ebullition has increased significantly. Originally, the increase in ebullition was attributed to settlement of the sediment cap; however, the increase in ebullition has remained constant in the 4 years since sediment cap installation, discounting the possibility of being caused primarily due to sediment cap settling. The increase in ebullition may in part be attributed to the presence of the 88-foot subsurface upland barrier wall which significantly reduced the upland flow of shallow groundwater into the Willamette River along the shoreline where the barrier wall is present subsequently allowing the gas to accumulate in the sediments instead of being flushed out by groundwater discharge. The gas production is primarily the result of biodegradation of organics producing methane and carbon dioxide which was confirmed with the sampling of gas from flux chambers in 2008 where methane was found to comprise up to 100 percent of the gas produced from the bulk granular organoclay while a mixture of carbon dioxide and methane was observed from the flux chambers located within the sediment outside of the granular organoclay footprints.

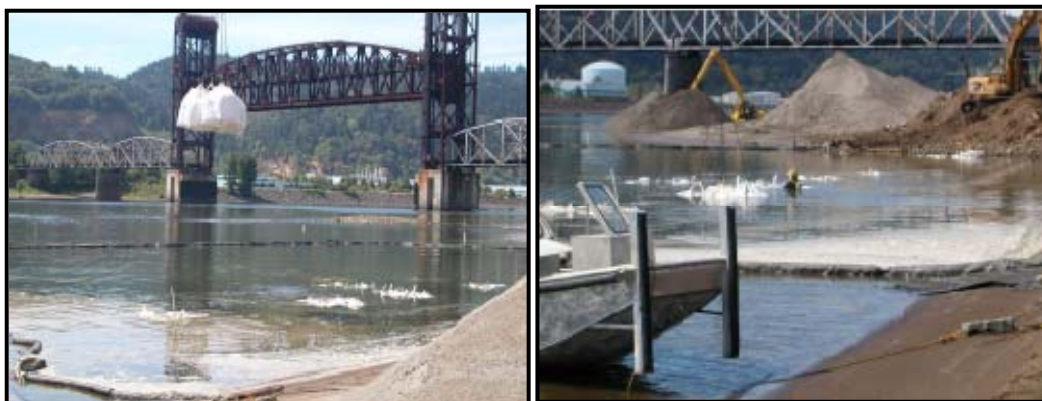
Figure 6. Placement of granular organoclay (2004).

organoclay retains air causing the organoclay to float. To reduce the amount of organoclay lost to the river, the organoclay was placed into the river in “Super Sacks”, allowed to hydrate before divers cut the bags as shown in Figure 6.

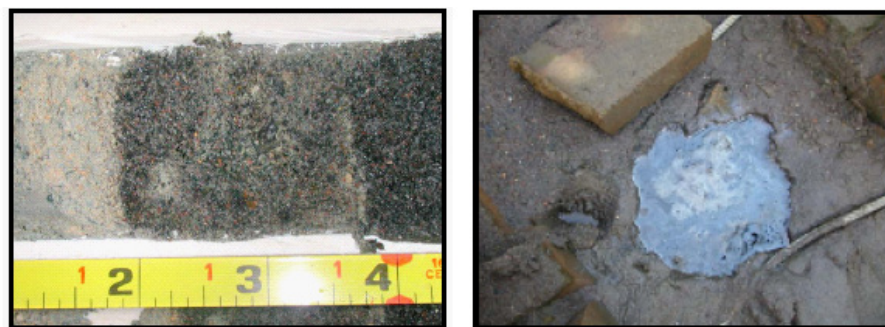
Figure 7. Bulk organoclay and native sediment in a core (left) and resulting NAPL in a core from penetrating the sediment cap after coring prior to abandonment (right) (2006).

In 2006, cores were collected to determine the effectiveness of the granular organoclay cap placed in 2004 to contain potential mobile NAPL in Willamette Cove and the former TFA. The thickness of organoclay also was measured to determine whether the correct thickness (1 foot) was achieved during placement. Figure 7 shows a representative picture of organoclay from a core and NAPL that migrated to the surface through the open borehole after coring prior to abandonment. The organoclay was generally 1 foot thick, verifying that placement was according to design. The contact between the native contaminated sediment and the overlying cap sand was typically sharp. At the upper surface of the organoclay and within the bottommost portion of the overlying cap sand, there was evidence of biological or chemical activity: gas voids, discoloration to dark gray, and a strong odor.

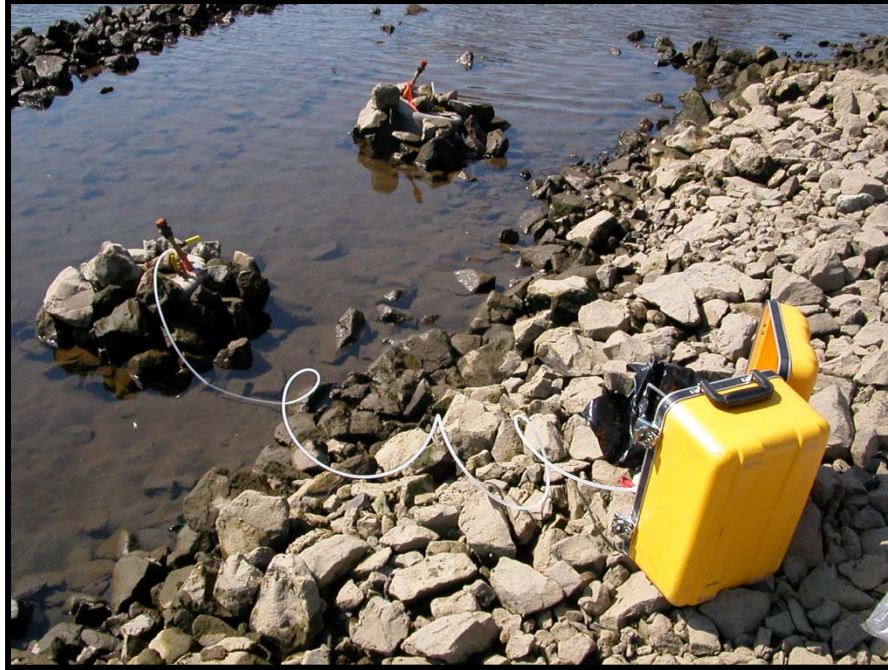
Figure 9. Flux chamber set (2008).

Ten sets of flux chambers were placed in the sediment cap area (see Figure 9). Each set had one flux chamber placed overtop of an ebullition pathway and an adjacent flux chamber placed where no ebullition was observed. Porewater samples collected from flux chambers suggest that ebullition is a pathway for contaminant transport as indicated by consistently higher concentrations of polynuclear aromatic hydrocarbons (PAH) in the porewater from the flux chambers placed overtop of the ebullition pathways as compared to the adjacent flux chambers. However, the PAH concentrations measured from both ebullition and non-ebullition flux chambers were generally below risk-based ambient water quality standards.

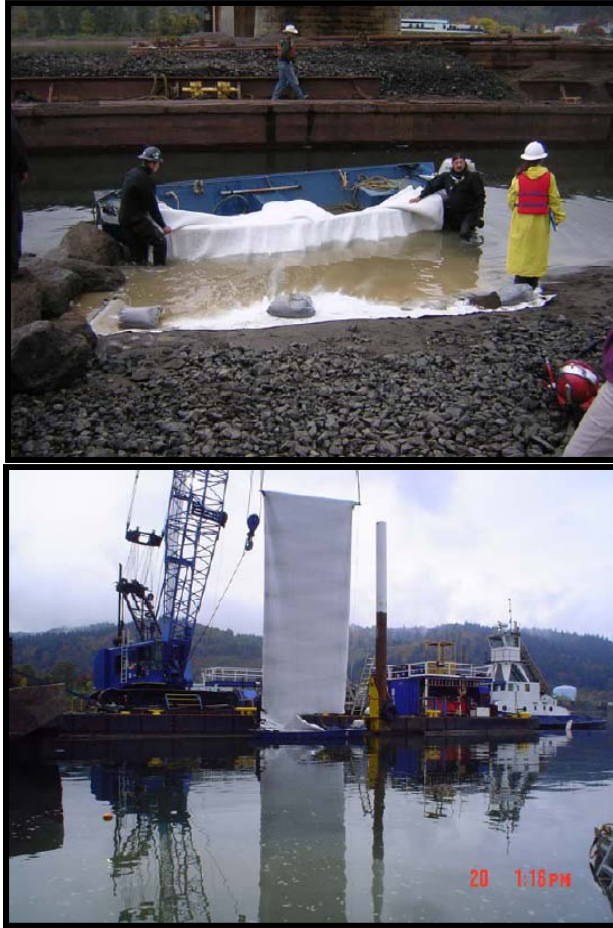
Figure 10. Organoclay Reactive Core Mat® placement under the BNR bridge (2005).

In addition to the test mat area, a 300-foot-long area (18,000 ft²) along the shoreline upstream of the granular organoclay in the former TFA and a 115-foot-long stretch (6,000 ft²) beneath the BNRR bridge were capped with primarily double layer organoclay mats (see Figure 2). Figure 10 shows the placement of the RCM beneath the BNRR bridge.

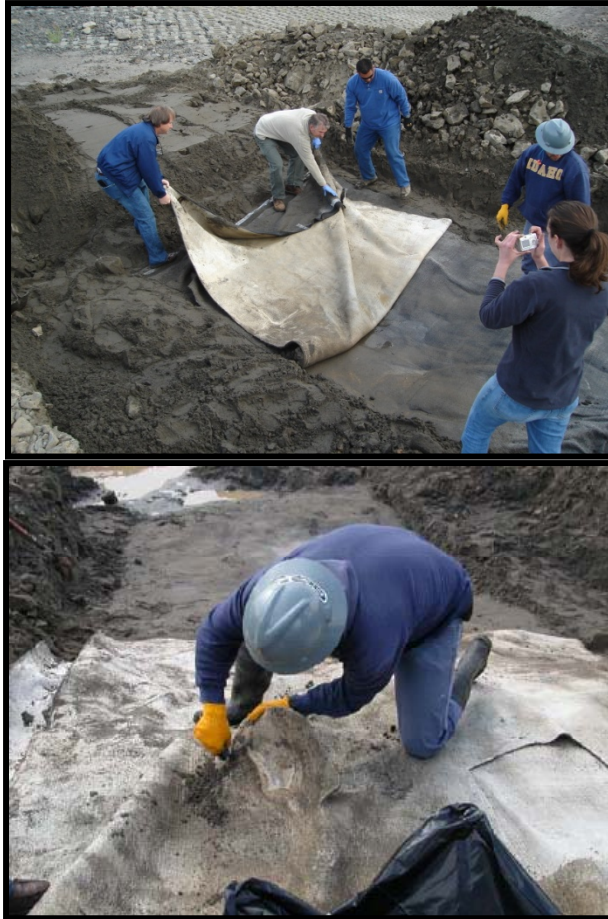
Figure 11. Exhumation of the “test” Reactive Core Mat® for sampling (2006).

In 2006, the test mat was exhumed for observation and sampling. No visual signs of NAPL staining were present on the mat. Portions of the mat were cut out and samples of sand were collected from beneath the cap and were analyzed by Dr. Reible under contract to the Oregon Department of Environmental Quality (ODEQ) (see Figure 11). The measured sorption capacity of the organoclay from the mat was 3.99 g NAPL/g organoclay, which is near the full sorption capacity of fresh CETCO PM-200 that was used in the RCM.
