TURNING FAILURE INTO SUCCESS WITH INNOVATIVE DREDGING SOLUTIONS FOR AQUATIC PRESERVE RESTORATION

John. B. Adams, Jr., P.E.¹, William J. Coughlin, III², Jacob E. Sheets³

Adams, Jr., J.B., Coughlin, III W.J., Sheets, J.E. "Turning failure into success with innovative dredging solutions for aquatic preserve restoration," *Proceedings of the Western Dredging Association and Texas A&M University Center for Dredging Studies' "Dredging Summit and Expo 2015"*, Houston, Texas, USA, June 22-25, 2015.

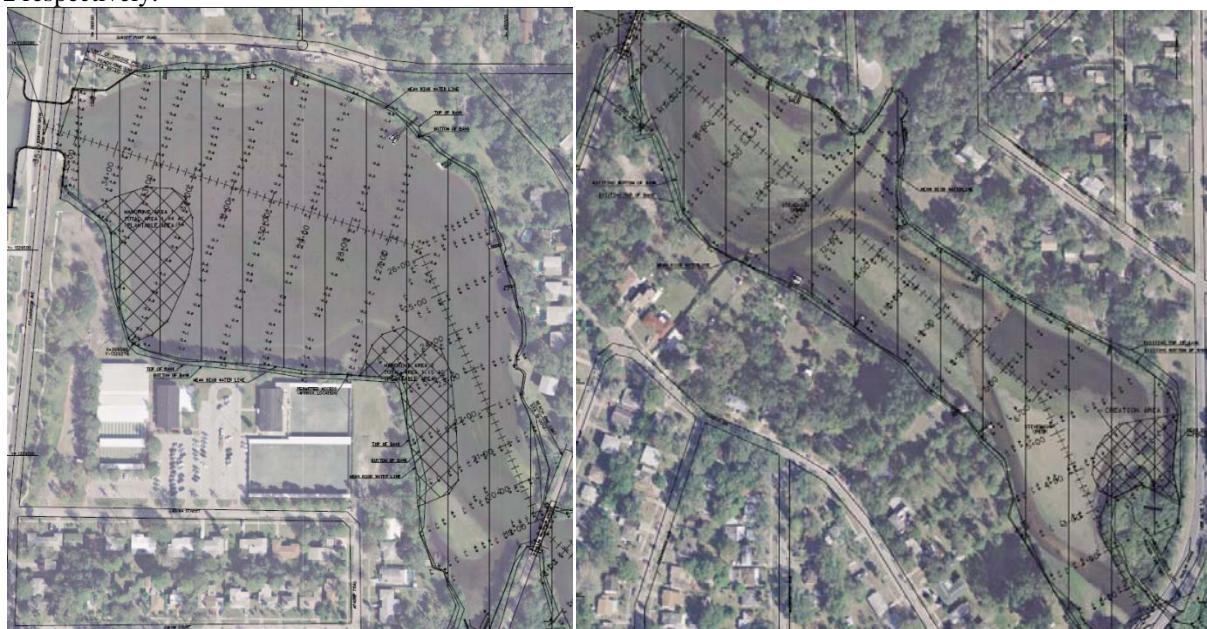
Figure 1. Map of Reach 1 shown on the left, Reach 2 shown on the right.

Following a new bidding process and lengthy consultation in mid-2013 Gator Dredging was hired to ensure original design and permitting conditions were met to restore the delicate estuary. The revised project scope involved dredging approximately $69,000\text{m}^3$ ($90,000\text{yd}^3$) of sediment from the creek. Reach 1 was identified as the northwest portion of the estuary and called for the removal of $38,000\text{m}^3$ ($50,000\text{yd}^3$) of sediment from 518m (1,700 linear ft). This area would be dredged to a depth of -4.4 feet NGVD. The second portion, identified as Reach 2, was located in the southeastern part of the estuary. It called for the removal of approximately $30,500\text{m}^3$ ($40,000\text{yd}^3$), from 580m (1,900 linear ft) of the creek to a depth of -3.5 feet NGVD. Figure 1 is provided below showing Reach 1 and Reach 2 respectively.

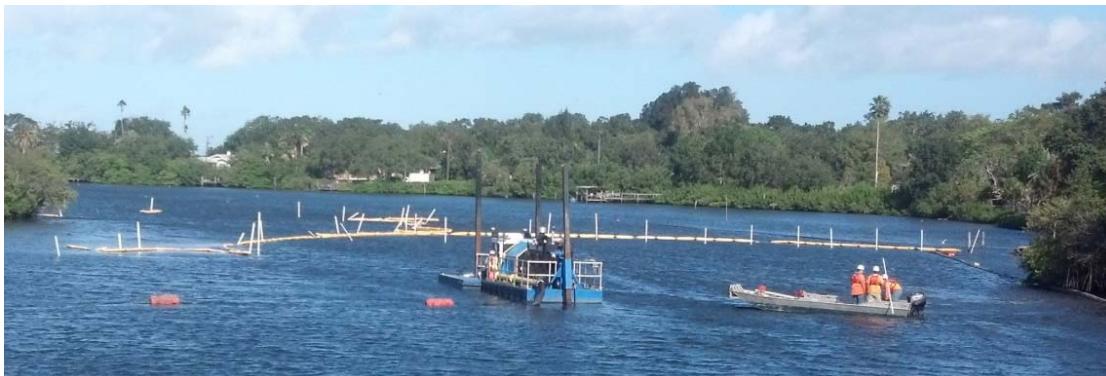
Figure 2. 2011 Ellicott Dredge in Reach 1.

Gator Dredging deployed a 2011 Ellicott 300SL Swinging Dragon 203 mm (8 in) cutter head hydraulic dredge into Reach 1 (Shown in Figure 2). To assist this dredge, an Ellicott 302 mm (10 in) booster pump was deployed on a barge to facilitate pumping to the proposed dewatering facility located at Overbrook Avenue shown in Figure 4.

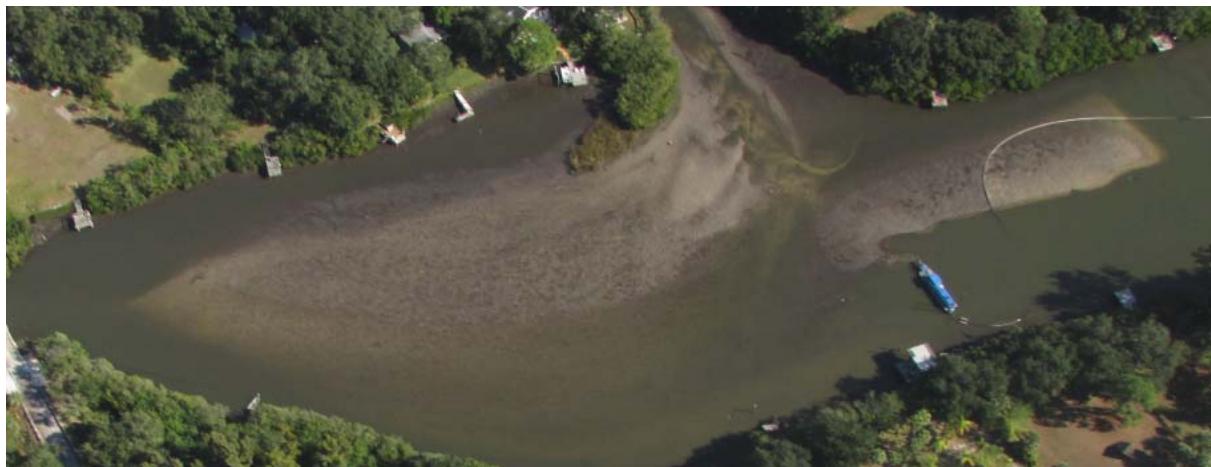
Figure 3. 2005 IMS 5012 Versi Dredge in Reach 2.

As the project progressed Gator Dredging deployed a 2005 IMS 5012 Versi augerhead/paddlewheel dredge in Reach 2 (See Figure 3). Geotechnical investigation indicated that the material in Reach 2 was mostly sandy material. The dredge material was pumped from Reach 2 to a temporary sand separation basin at the Calumet Avenue site onshore of Reach 1.

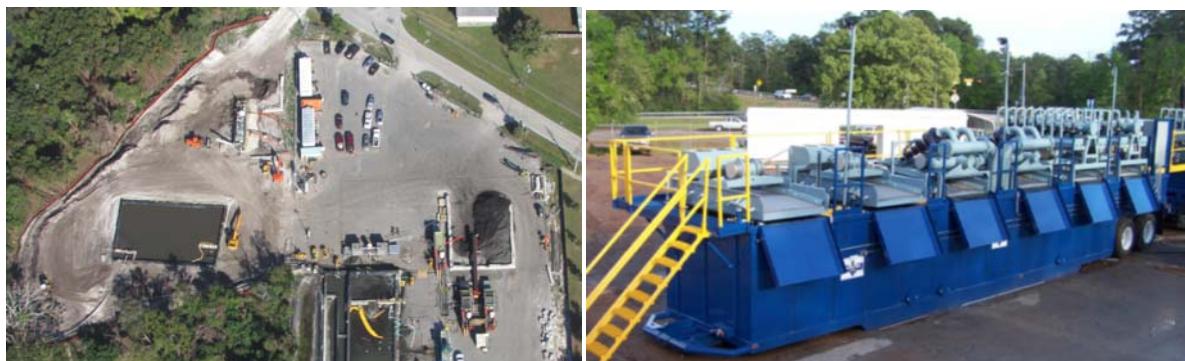
Figure 4. Overbrook Ave. dewatering site and DSS2000 Tri-Flo.

Dredged sediment from Reach 1 was pumped to the Overbrook Avenue dewatering facility for separation of sand and organic/silt. Sand and debris was then separated using a Tri-Flo DSS2000. The DSS2000 is designed to remove particles with sizes exceeding 40 microns. The dredge material passed through a series of screens and finally hydro-cyclones. Sand separated by the DSS2000 was then transported to a stockpile by a conveyor at the north end of the Overbrook site and either loaded for disposal or pumped via a 203 mm (8 in) hydraulic pump to the proposed Mangrove Creation Area. The Overbrook site and the Tri-Flow DSS2000 are shown in Figure 4.

After de-sanding, the overflow water was sent to the mixing basin at the muck dewatering facility. The fines, silts, and organics not separated by the Tri-Flo were then pumped to the adjacent muck dewatering facility at the Overbrook Site. As the water overflowed the mixing basin weir, it was dosed with polymer (Flopam C-3227) by automated equipment supplied by SNF Environmental at rates below the maximum rates approved by the FDEP, to facilitate settling of solids. The polymer dosed water then entered a clarification basin for settling. The clarification basin, the mixing basin, and the polishing area all had an impermeable liner installed over the existing asphalt and up the side walls. The impermeable liner was a 30 mil liner provided by Colorado Lining International (designated "Non-Skid PE") underlain with a Mirafi 160N nonwoven geotextile for liner protection.

The Overbrook dewatering system was designed to handle up to 19,000 liters/minute (5,000 gallons per minute) of flow. The basin was sized such that the water residence time was approximately 30 minutes. Clean over-flow water then spilled into the polishing maze and underwent additional clarification by way of gravity settling prior to return to the project waters. The consolidated sediment from the bottom of the clarification tank was then pumped by a series of pumps at a rate of 1900 liters per minute (500 gallons per minute) to three (3) 2.0 meter belt presses for final dewatering. Prior to entering the belt presses from the clarification basin the slurry could be dosed again with polymer to facilitate the belt press operation. The polymer dosing at the belt presses was automated and controlled by instrumentation integral to the belt presses. The dewatered muck was then moved from the presses via conveyor to a stock pile for loading and disposal. Processed water from of the belt presses was returned to the mixing basin. Sand that had been scalped was stockpiled and either loaded for disposal or pumped via a 203 mm (8 in) hydraulic pump to the proposed mangrove creation area(s).
