*New Jersey Department of Transportation  
Office of Maritime Resources*

Restoration of an Historical Subaqueous Borrow Pit  
for Management of Navigational Dredged Material  
in Coastal New Jersey

WEDA – Dredging Expo and Summit, June 2021

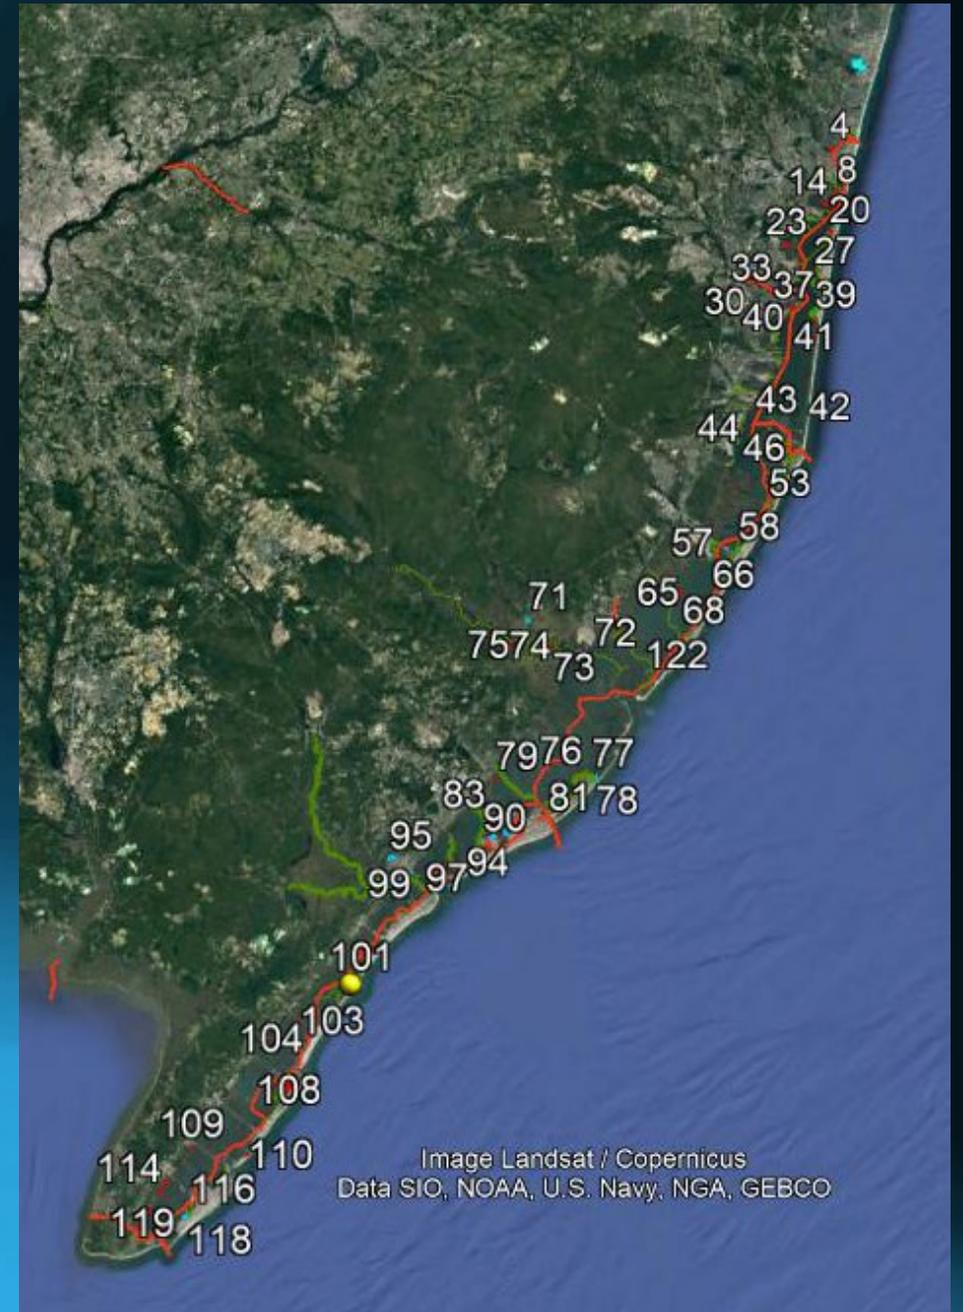
# Site Selection

- 122 subaqueous sites identified
- Sites screened by size, habitat value and proximity to needed dredged material management capacity
- Anoxic or hypoxic conditions all or part of the year, no benthic life, limited fisheries utilization
- Filling will restore shellfish and/or SAV habitat or improve hydraulic circulation
- 5 priority sites selected
- 1.7 MCY of capacity identified, potentially more if filled to surrounding elevation

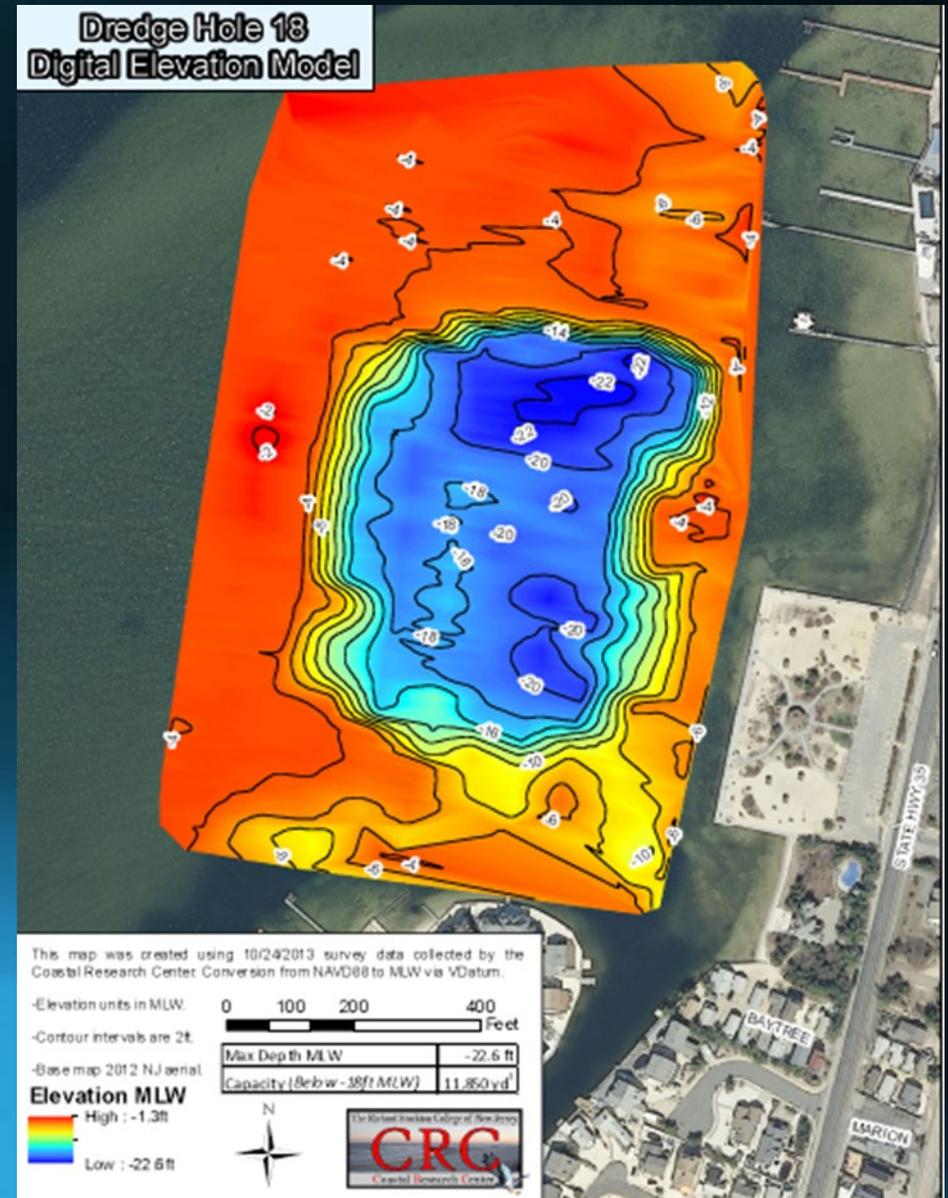
# Dredged Hole 18

- Upper Barnegat Bay, Ocean County, NJ
- Hole dredged in 1962 for beach replenishment after hurricane
- >20 feet deep, nearly vertical sides
- Surrounding elevation <-4' MLW
- Fine silt and clay bottom
- Hypoxic during summer
- Extensive surrounding beds of *Ruppia maritima* (widgeon grass)
- At least 180,000 CY of "air space" to fill to surrounding elevation
- Surrounding material >90% sand

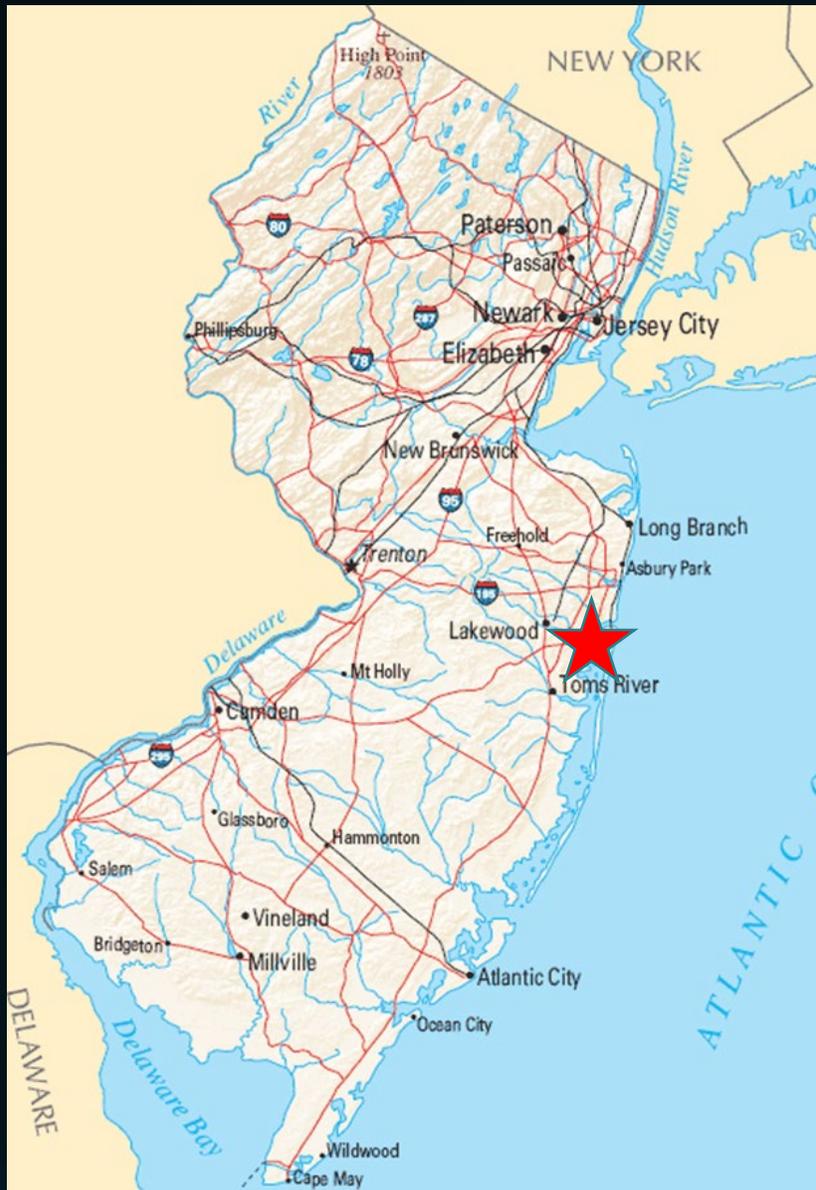
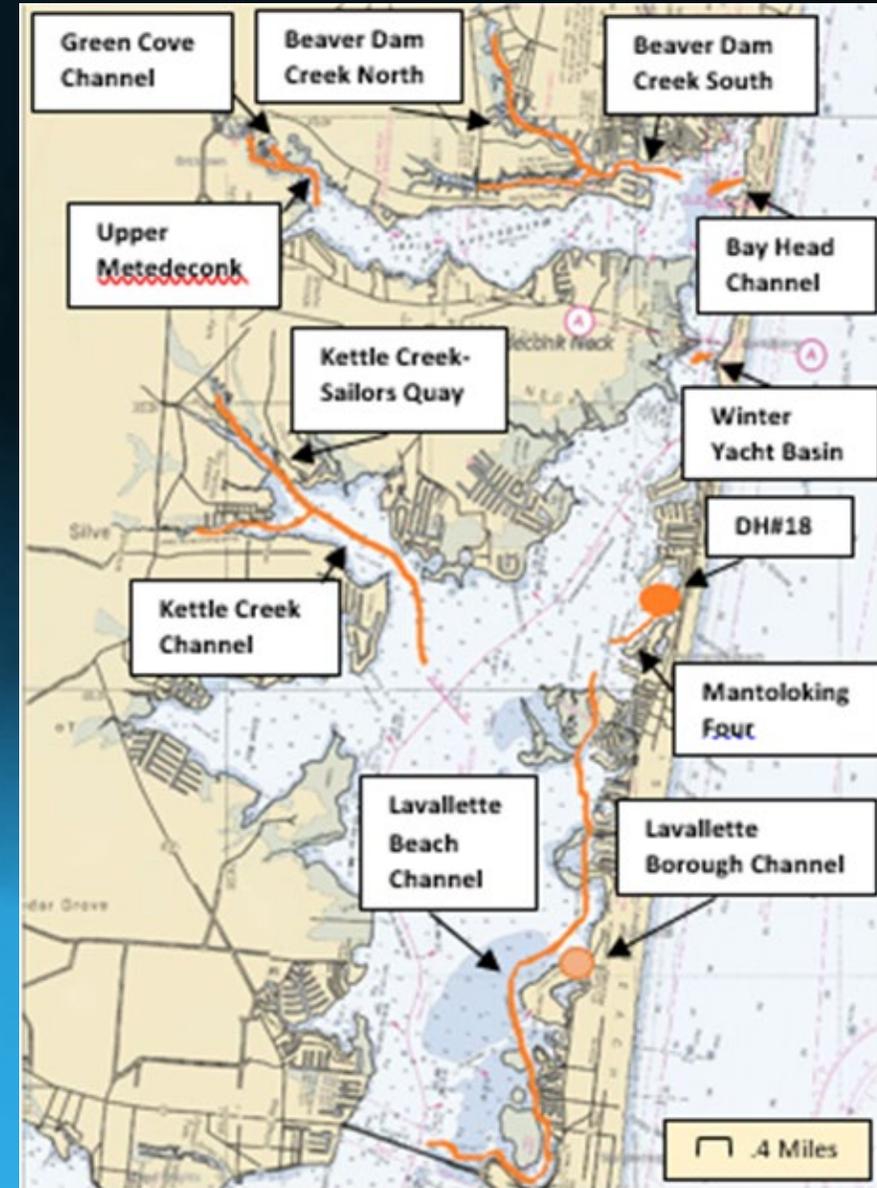
# Upper Barnegat Bay

- 10 channels (6 were severely shoaled)
- 1 municipal boat ramp
- 145 water dependent businesses and facilities, including 112 marinas
- 13.25 miles of channel
- 6-7 ft x 100 ft
- 240,000 cyd of mostly clean material
- Lack of disposal options

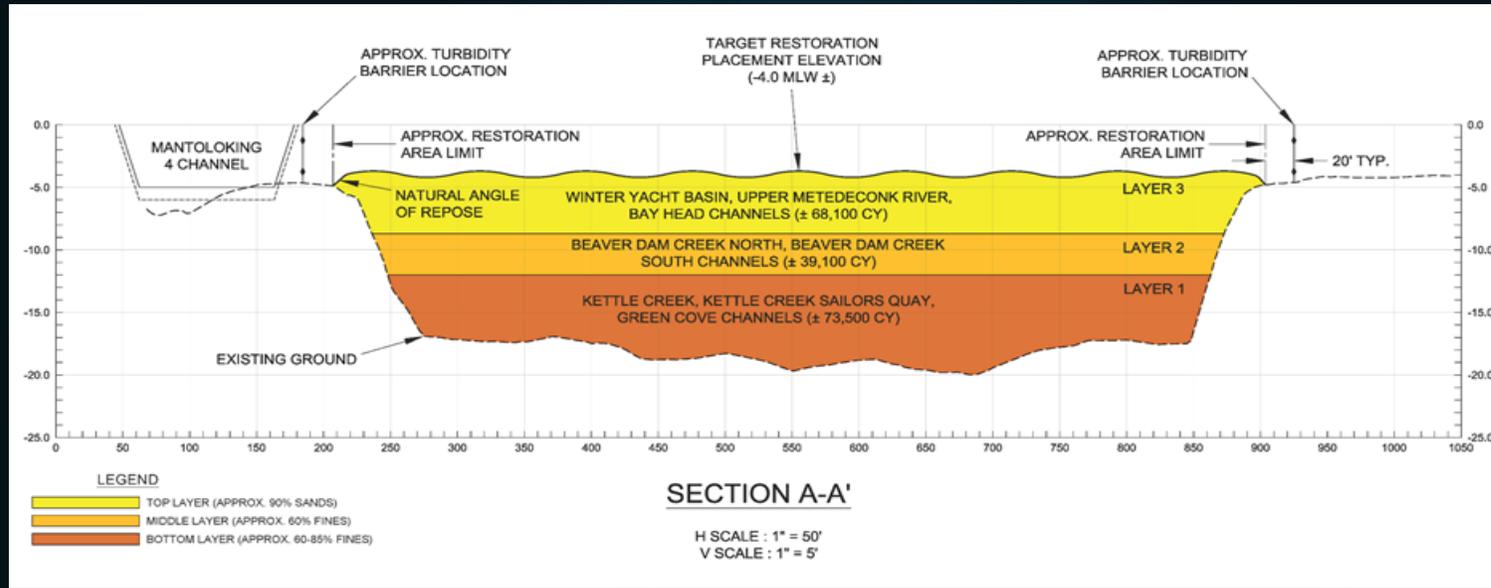
# Placement Strategy

- Bottom Layer: 70,100 CY contaminated fine grained material from Green Cove, Kettle Creek and Kettle Creek Sailors Quay
- Middle Layer: 33,000 CY clean fine grained material from Beaver Dam Creek North and South
- Top Layer: 105,100 CY clean coarse grained material from Winter Yacht Basin, Upper Metedeconk River, Bay Head, Lavallette Beach and Lavallette Boat Ramp

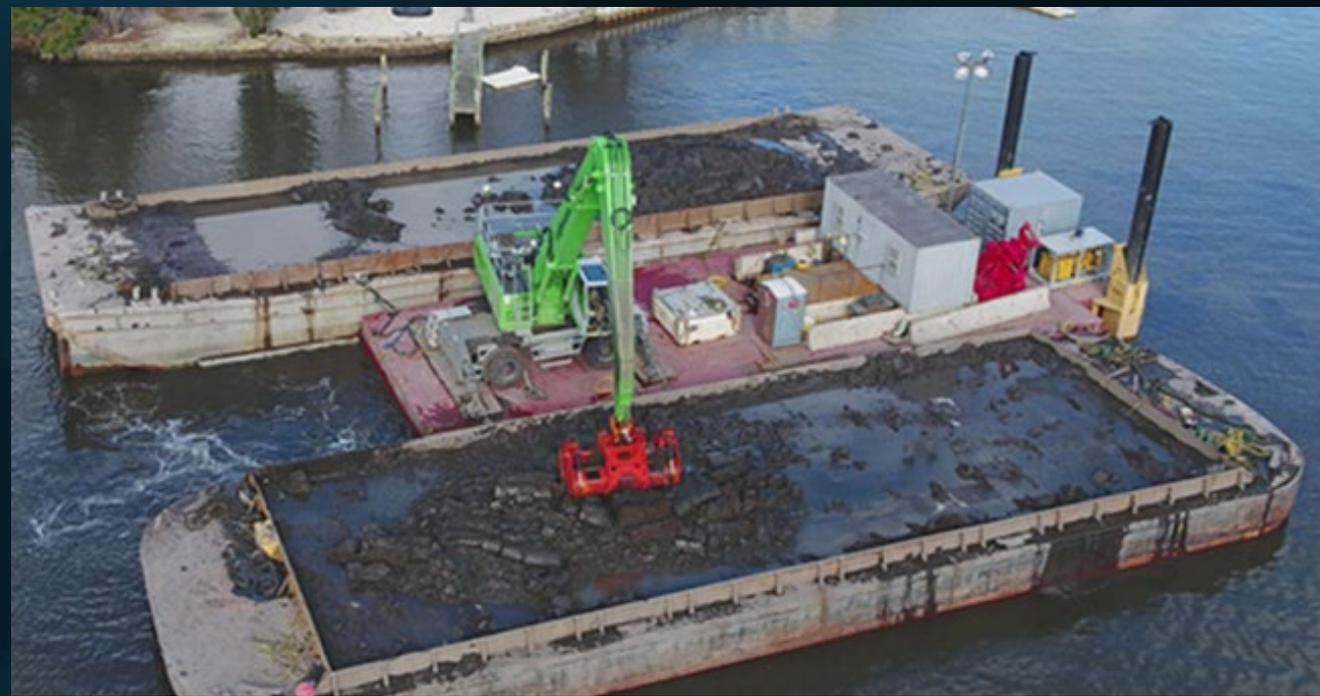
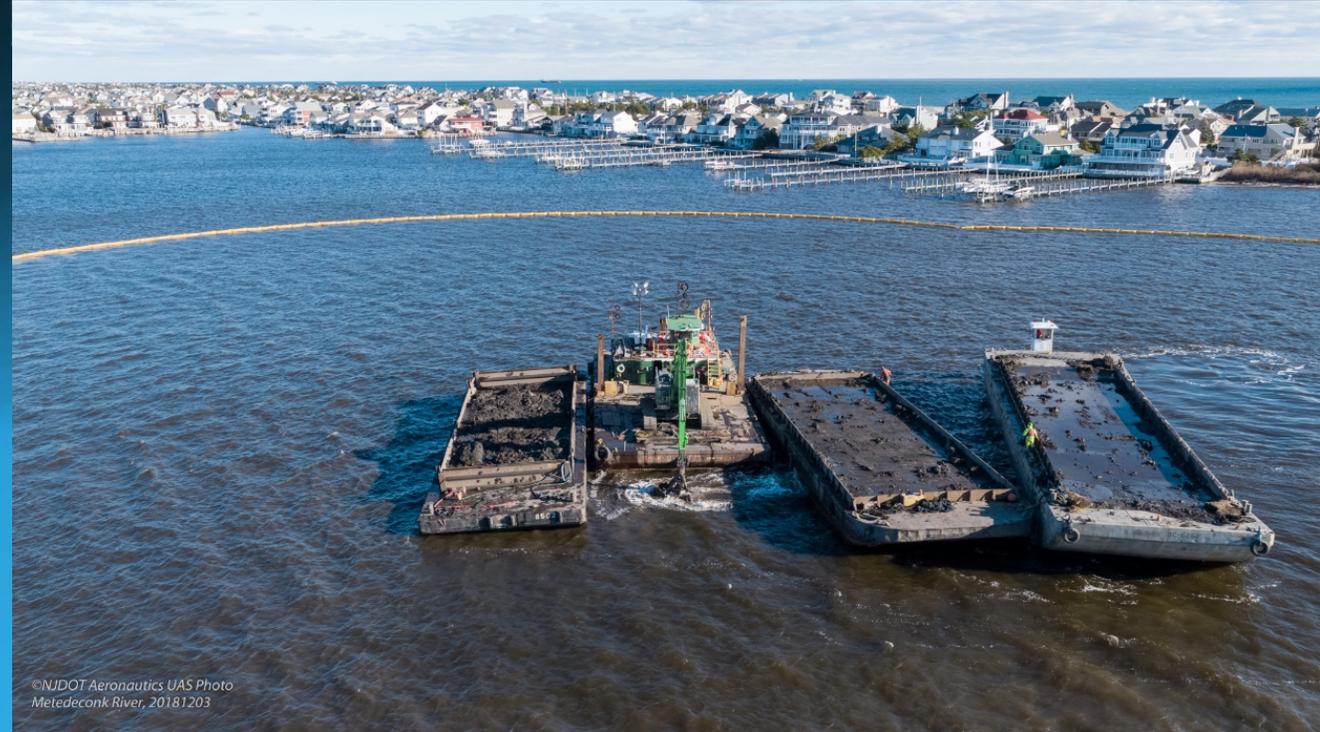
# *Placement Technique*

- Mechanical Dredging with closed clamshell over two dredging seasons
- Tug and Barge Transport
- Mechanical offloading below surface
- Turbidity barrier surrounding site

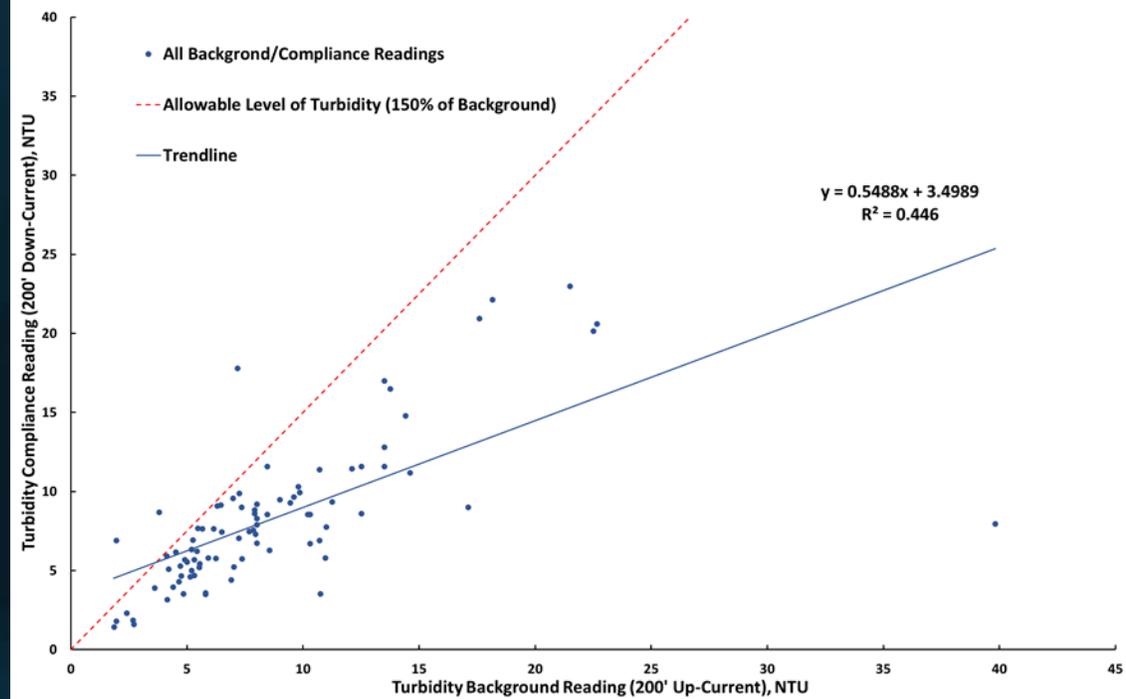
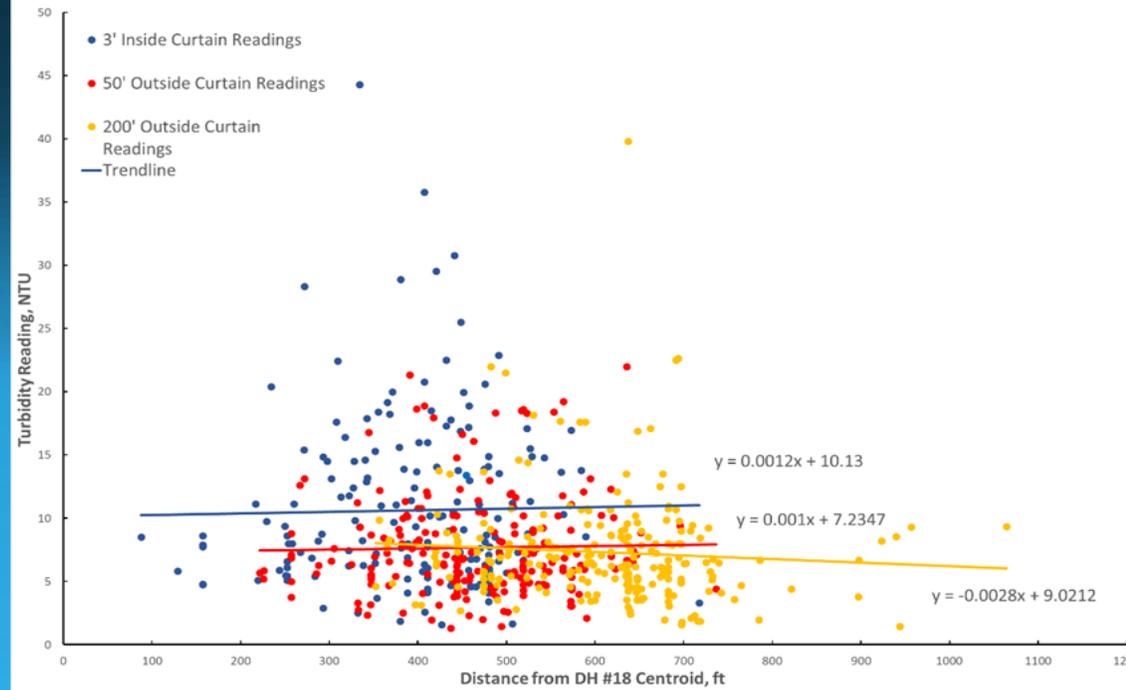
# Turbidity Compliance

- Typical Background TSS in Barnegat Bay is 3-6 NTU, but regularly exceeded water quality standards
- Turbidity was monitored at several locations up current and down current twice daily
- Permit limit was 1.5 times background
- Turbidity ranged from 1.5 to 40 in Season One
- No correlation with distance from placement
- Turbidity curtain not required in Season Two

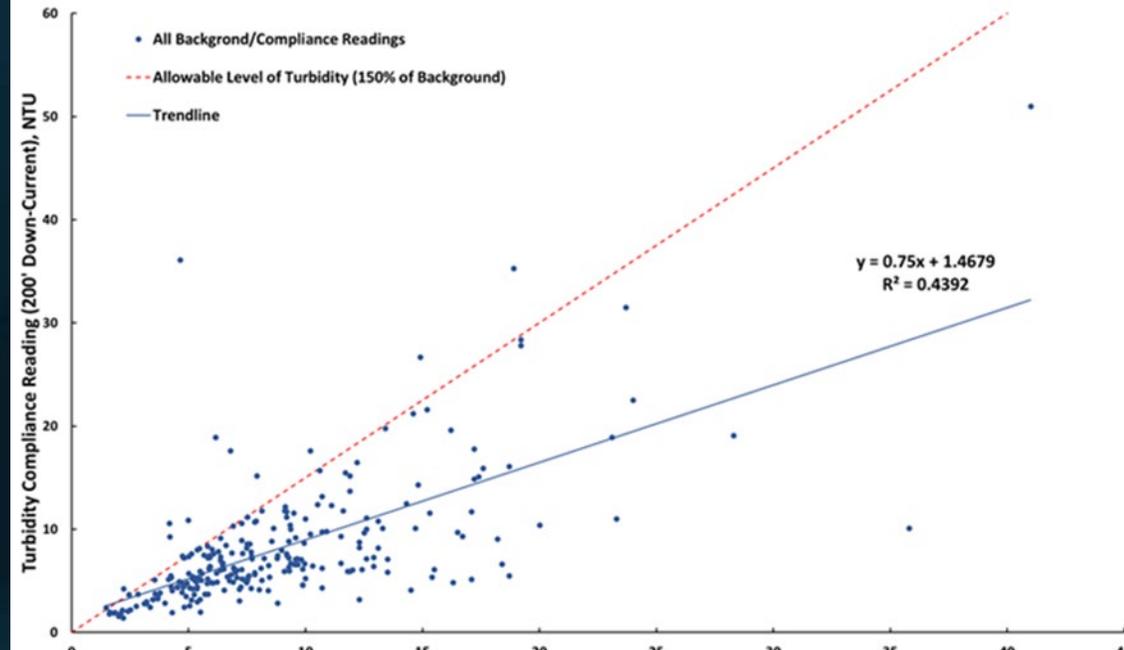
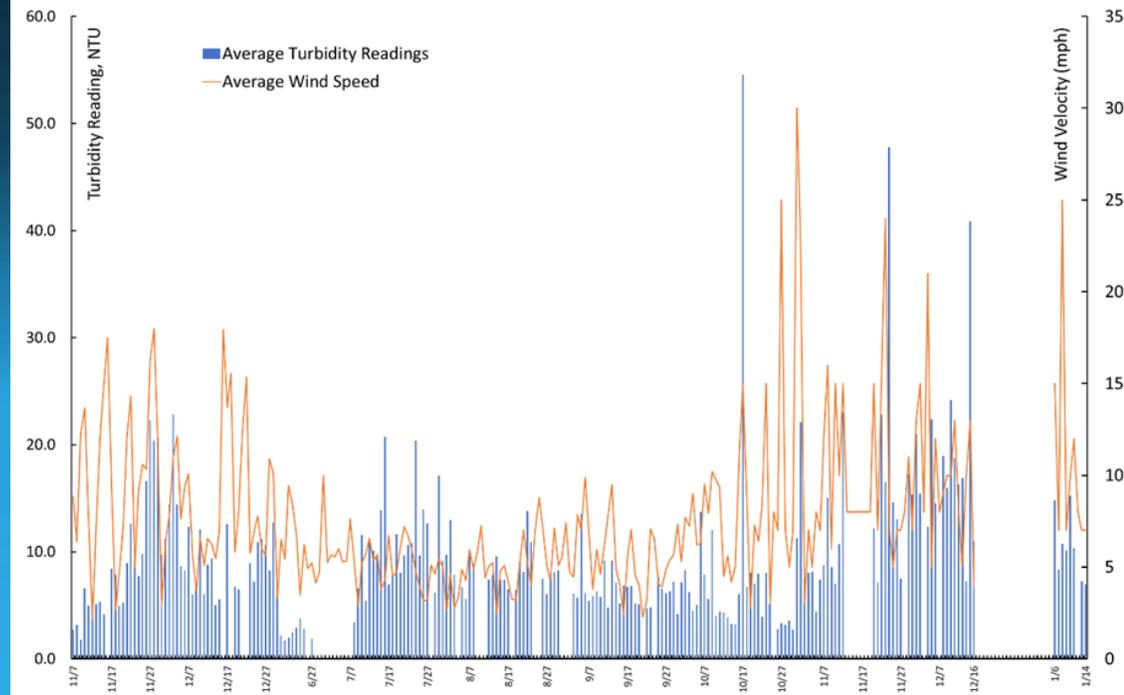
# Turbidity Compliance

- Turbidity ranged from 1.5 to 70 NTU during Season Two
- Turbidity curtain was not deployed
- No correlation with distance from placement activity
- Strong correlation with wind events and equipment movement

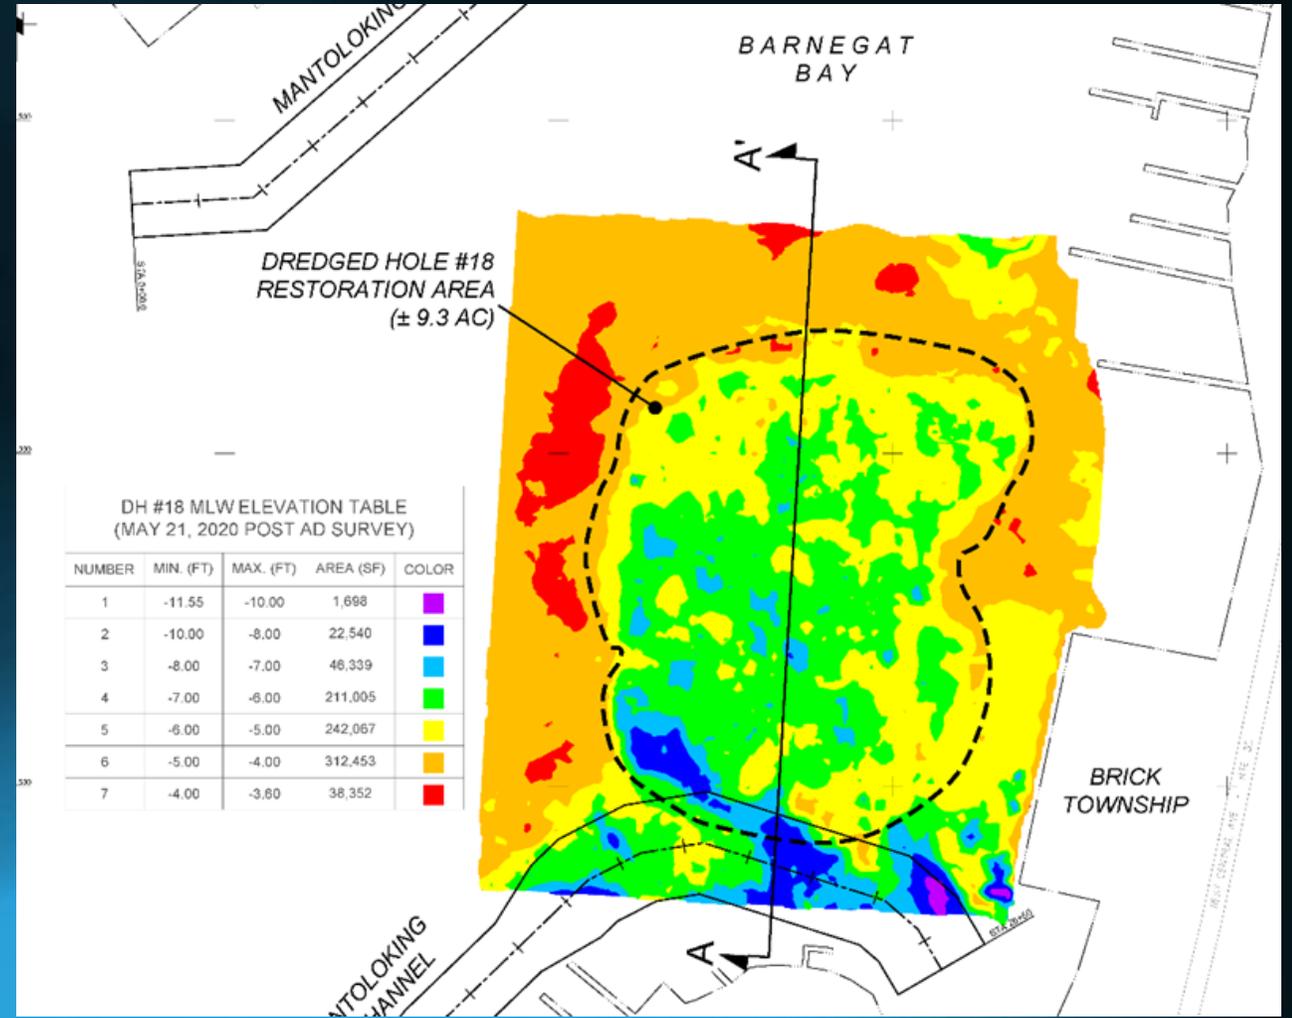
# Final Elevations

- 209,000 CY placed at site
- Sandy material added last
- Elevations ranged from -3 to -8 MLW, with most areas being -5 to -6.
